Name of Dam: South Rivanna

Location: Albemarle County, State of Virginia

Inventory Number: VA 00302

PHASE I INSPECTION REPORT
NATIONAL DAM SAFETY PROGRAM

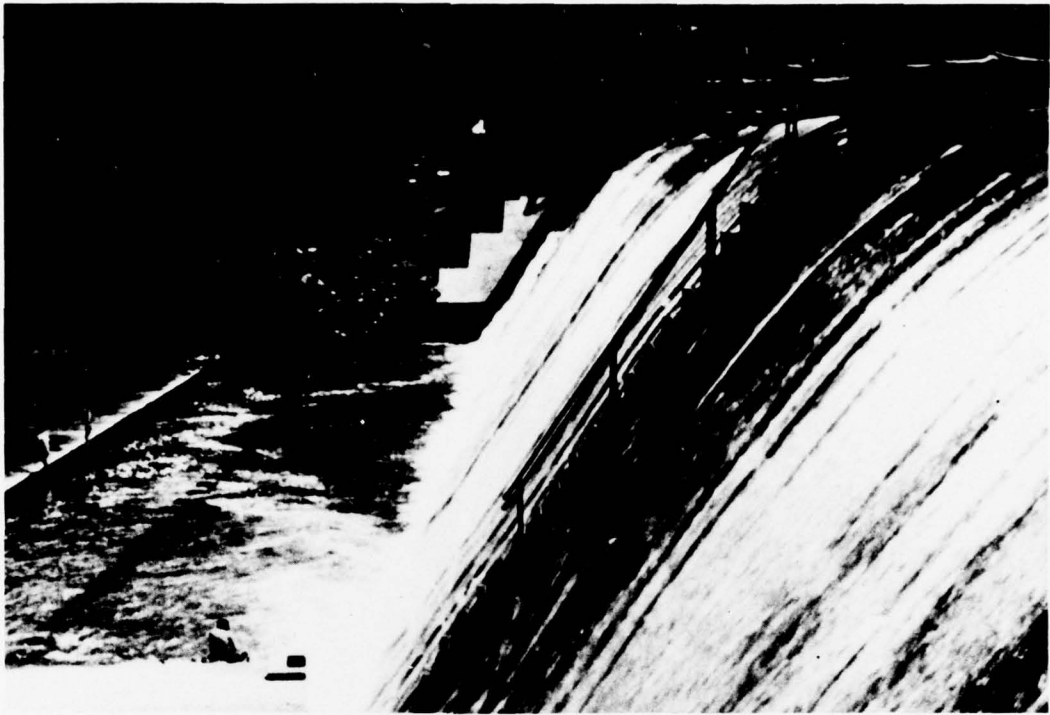
PHOTO 1. View of Dam, Left Chute and Stilling Pond From Abutment Area

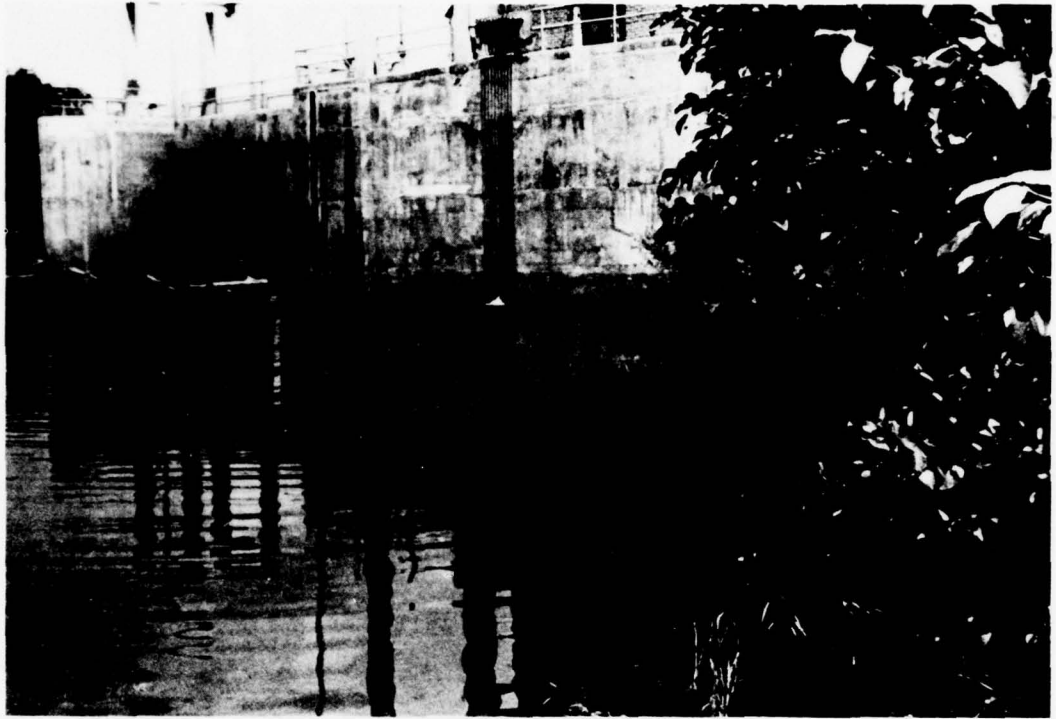
PHOTO 3. View of Upstream Face of Right Non-Overflow Section Directly Above Sluice Gates

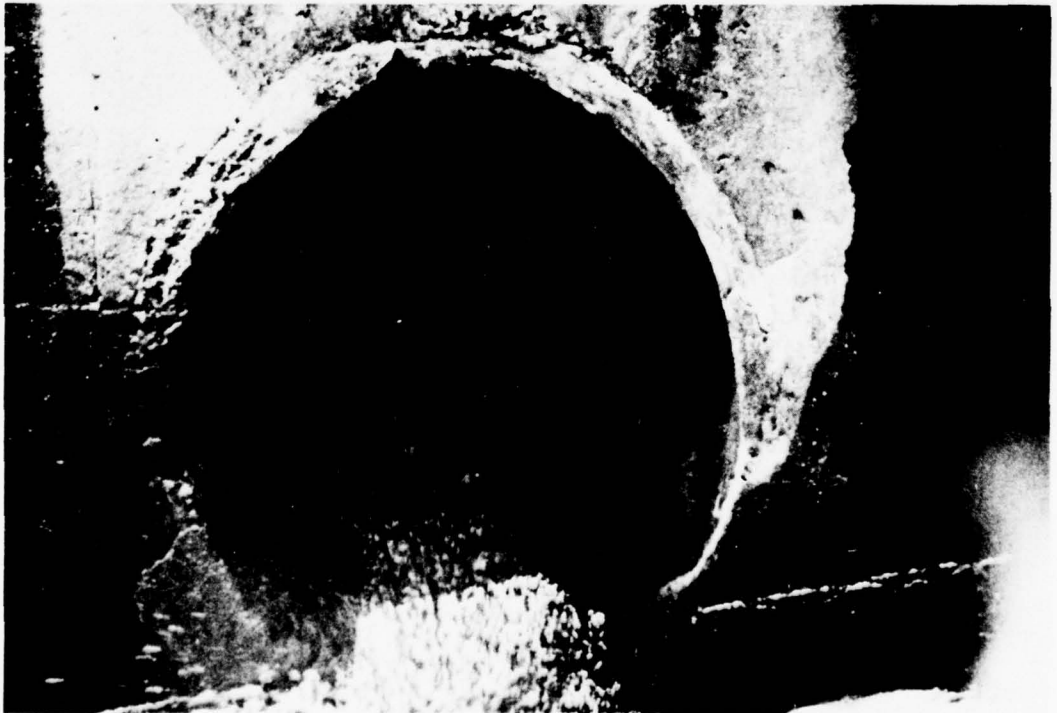
PHOTO 4. View of Outlet of 36 Inch Diameter North Control Conduit

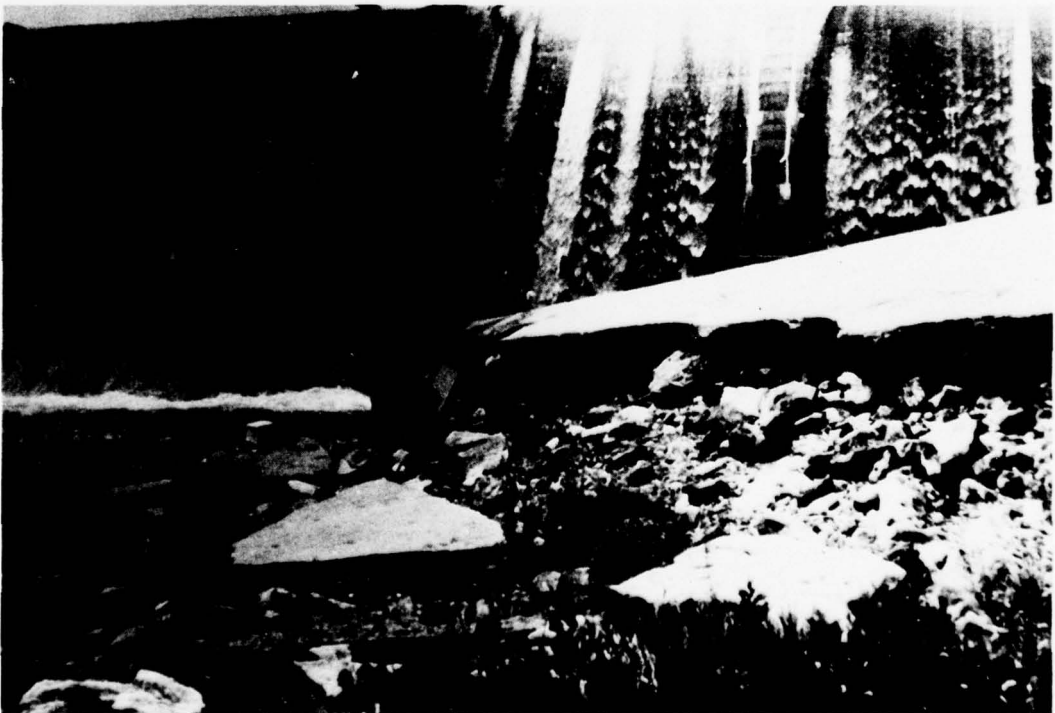
A concrete apron just downstream from the chute in the left abutment area was undermined by the high flows of 1969 and is in poor condition (Photo 6). This apron was eroded and repaired previous to 1969.

3.1.3 Appurtenant Structures: No inadequacies were observed in the concrete of any appurtenant structures. The only deficiency observed was the concrete apron downstream of the chute in the left abutment area.

PHOTO 6. View of Deteriorated Concrete Apron Downstream of Left Abutment Area

VISUAL EXAMINATION OF	OBSERVATIONS	REMARKS OR RECOMMENDATIONS
SURFACE CRACKS CONCRETE SURFACES	A small number of hairline surface cracks were present in the dam and its appurtenances. The concrete apron downstream from the chute in the left abutment area has been undermined and is in poor condition.	The concrete apron should be repaired to prevent erosion during periods of high flows.
STRUCTURAL CRACKING	No structural cracking was observed and all concrete appeared to be in good condition.	
VERTICAL AND HORIZONTAL ALIGNMENT	No horizontal or vertical misalignment was observed at the time of inspection.	
MONOLITH JOINTS	All monolith joints were in good condition.	
CONSTRUCTION JOINTS	All construction joints were in good condition. No spalling or calcite stains were present in these areas.	
ROCKFILL	Large blocks of very hard rock of various types were placed on the downstream slopes on both sides adjacent to the concrete to act as backfill and riprap for the stilling basin. The surface was covered with approximately five inches of concrete.

3.2.2 Appurtenant Structures: The concrete apron downstream of the chute should be repaired to prevent bank erosion during periods of high flow.

- 7.1 Dam Assessment: Design drawings and a flood plain investigation provided adequate engineering data to conduct a Phase I investigation. The dam is generally in good condition. The spillway passes the P.M.F. without an overtopping of the dam. In addition, the dam meets the stability criteria required by the Recommended Guidelines for Safety Inspection of Dams for normal pool with an ice load and during the P.M.F.
- 7.2 Recommended Remedial Measures: The inspection revealed one item of repair which should be incorporated with dam maintenance by the owner. The eroded concrete apron on the left downstream side of the dam should be repaired to prevent further progressive erosion.
