Name of Dam: Ragged Mountain No. 1
Location: Albemarle County, State of Virginia
Inventory Number: VA 00304

PHASE I INSPECTION REPORT NATIONAL DAM SAFETY PROGRAM

PREPARED BY
MICHAEL BAKER, JR., INC.
BEAVER, PENNSYLVANIA 15009

79 01 16 200
SEPTEMBER 1978

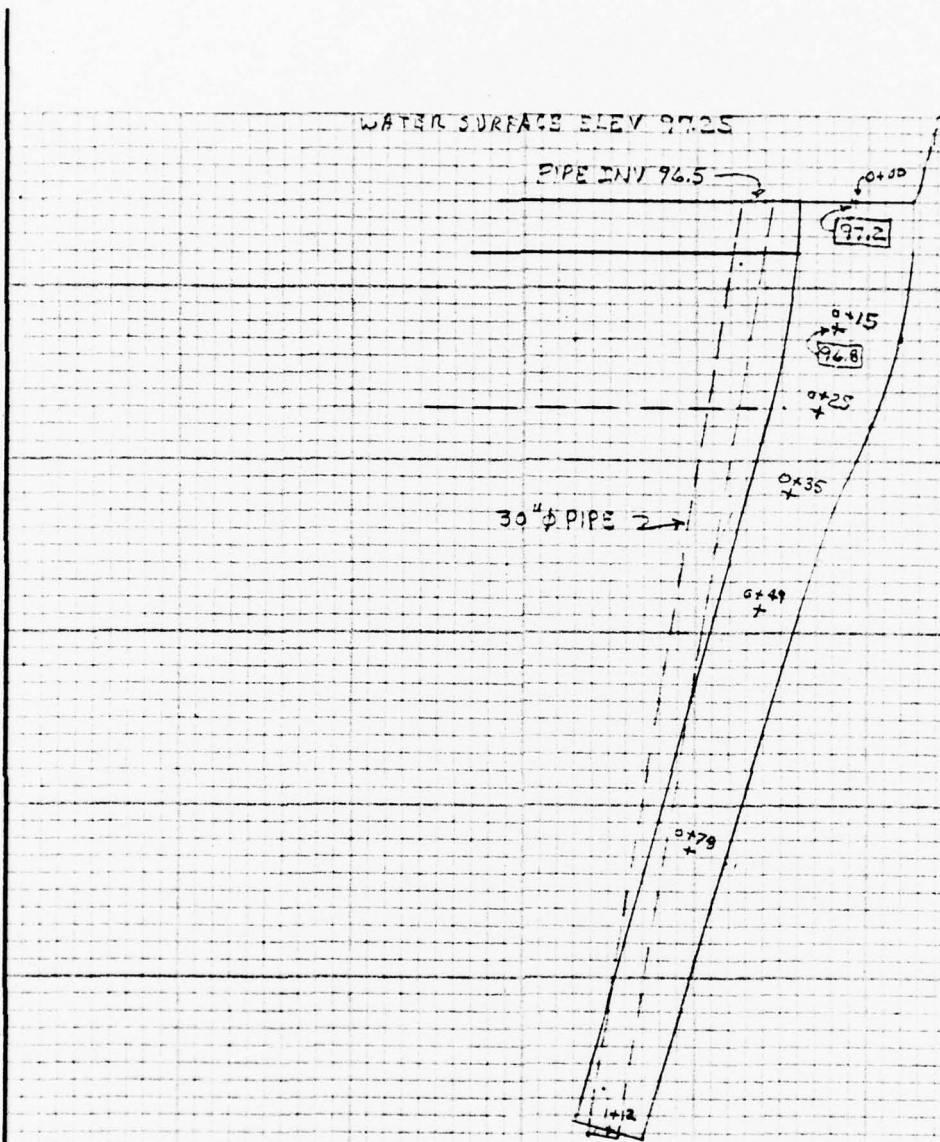
PLATE 3
 MICHAEL BAKER JR. SKETCH
 PLAN OF SPILLWAY
 SCALE 1" = 20'

BOARD OVER END
 OF PIPE INCREASES
 WATER SURFACE
 ELEVATION.
 TOP OF BOARD 97.5'

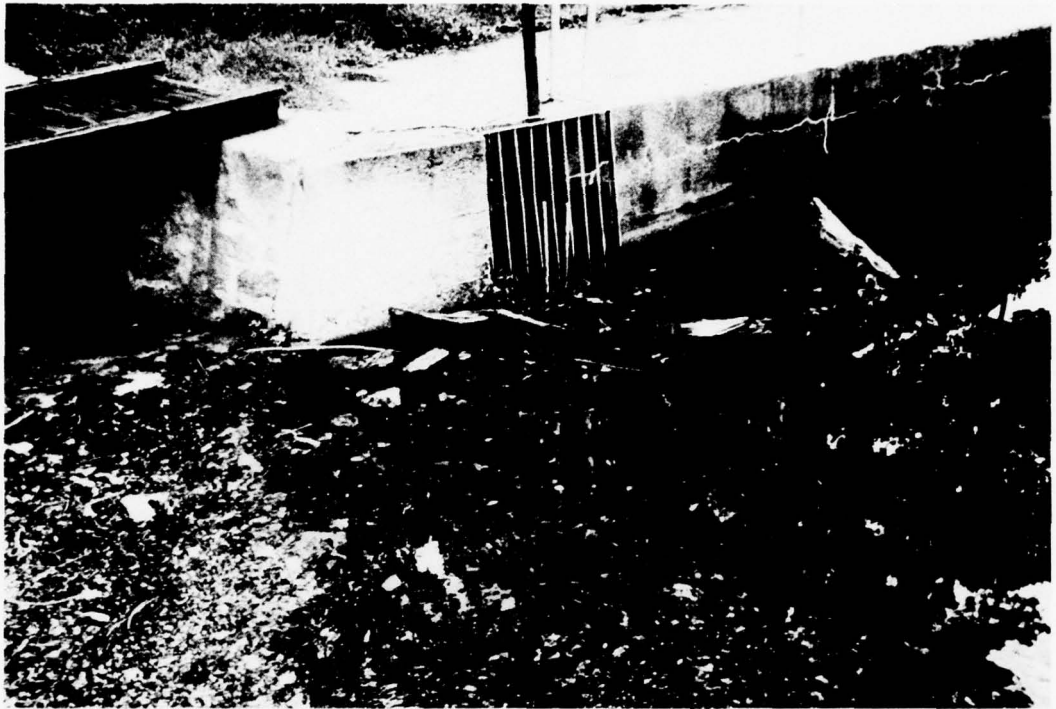
PHOTO 5. View of 30 Inch Intake Pipe and Trash Rack Adjacent to Emergency Spillway

A 30 inch diameter cast-iron pipe keep is located four feet to the right of the open channel spillway. The pipe has two flashboards placed in front of the intake and behind a trash rack (see Photo 5).

3.2.2 Appurtenant Structures: The 30 inch diameter high water pipe adjacent to the spillway needs no repair at this time.

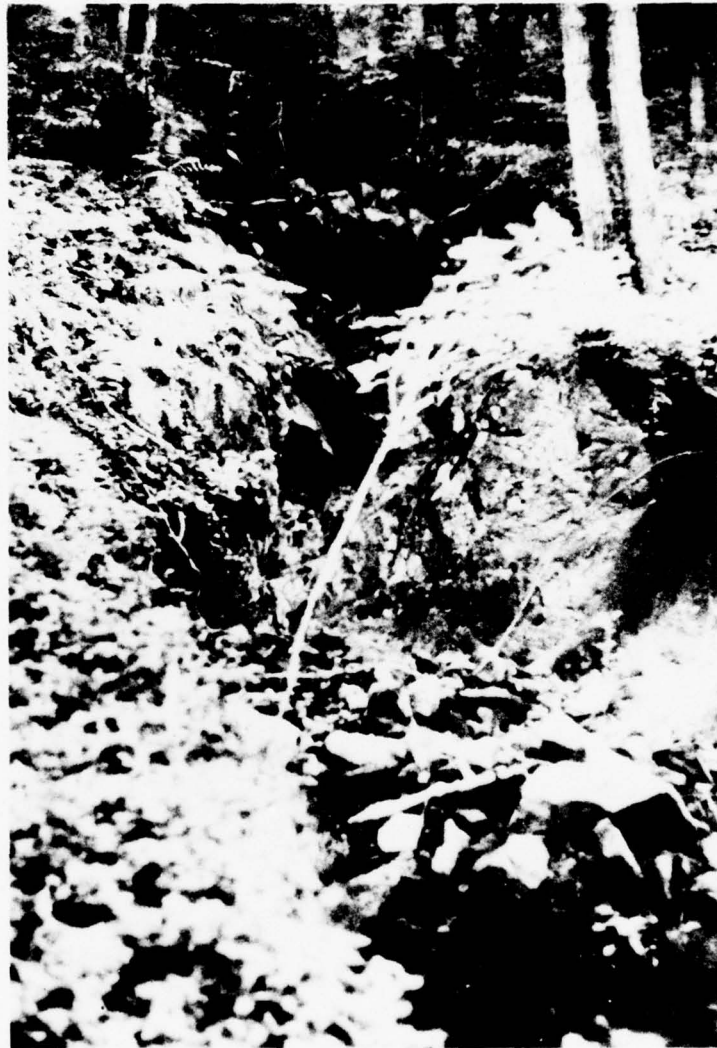
PHOTO 7. View of Scoured Downstream Channel

| VISUAL EXAMINATION OF | OBSERVATIONS | REMARKS OR RECOMMENDATIONS |
|---|--|--|
| DOWNSTREAM CHANNEL. | Hard coarse quartz monzonite with steep to vertical joints comprises the open channel below the end of the paved spillway and 30 inch pipe beneath. The flow from the 30 inch pipe was measured downstream at a 30 feet drop as two g.p.m. The channel downstream from the waterfall is cut deep (10-30 feet banks) into soil with boulders and cobbles and highly weathered bedrock. It joins the other stream further in the woods. There are occasional wooden debris and a tree which fell across the deep channel after being undercut by flow. | It is recommended that scattered debris and the fallen trees be removed. |
