Name Of Dam: MOUNTAIN RUN DAM NO. 8A
Location: CULPEPER COUNTY, VIRGINIA
Inventory Number: VA 04701

PHASE I INSPECTION REPORT NATIONAL DAM SAFETY PROGRAM

⑥ National Dam Safety Program. Mountain Run Dam Number 8A (VA-04701), Rappahannock River Basin, Culpepper County, Virginia. Phase I Inspection Report.

**PREPARED BY
NORFOLK DISTRICT CORPS OF ENGINEERS
803 FRONT STREET
NORFOLK, VIRGINIA 23510**

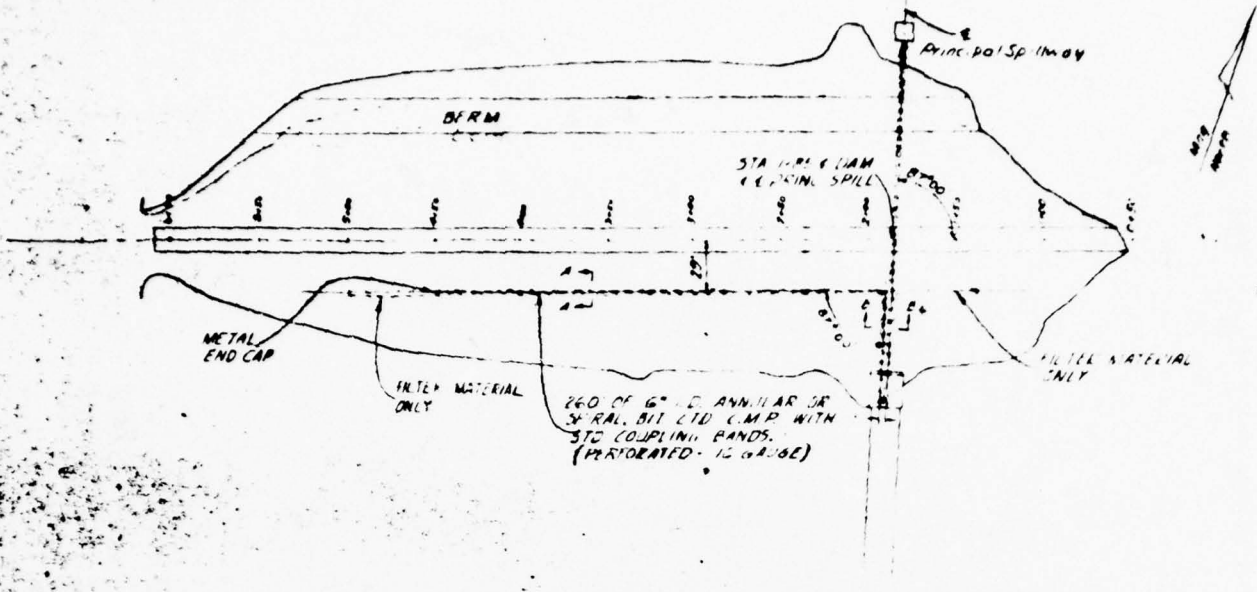
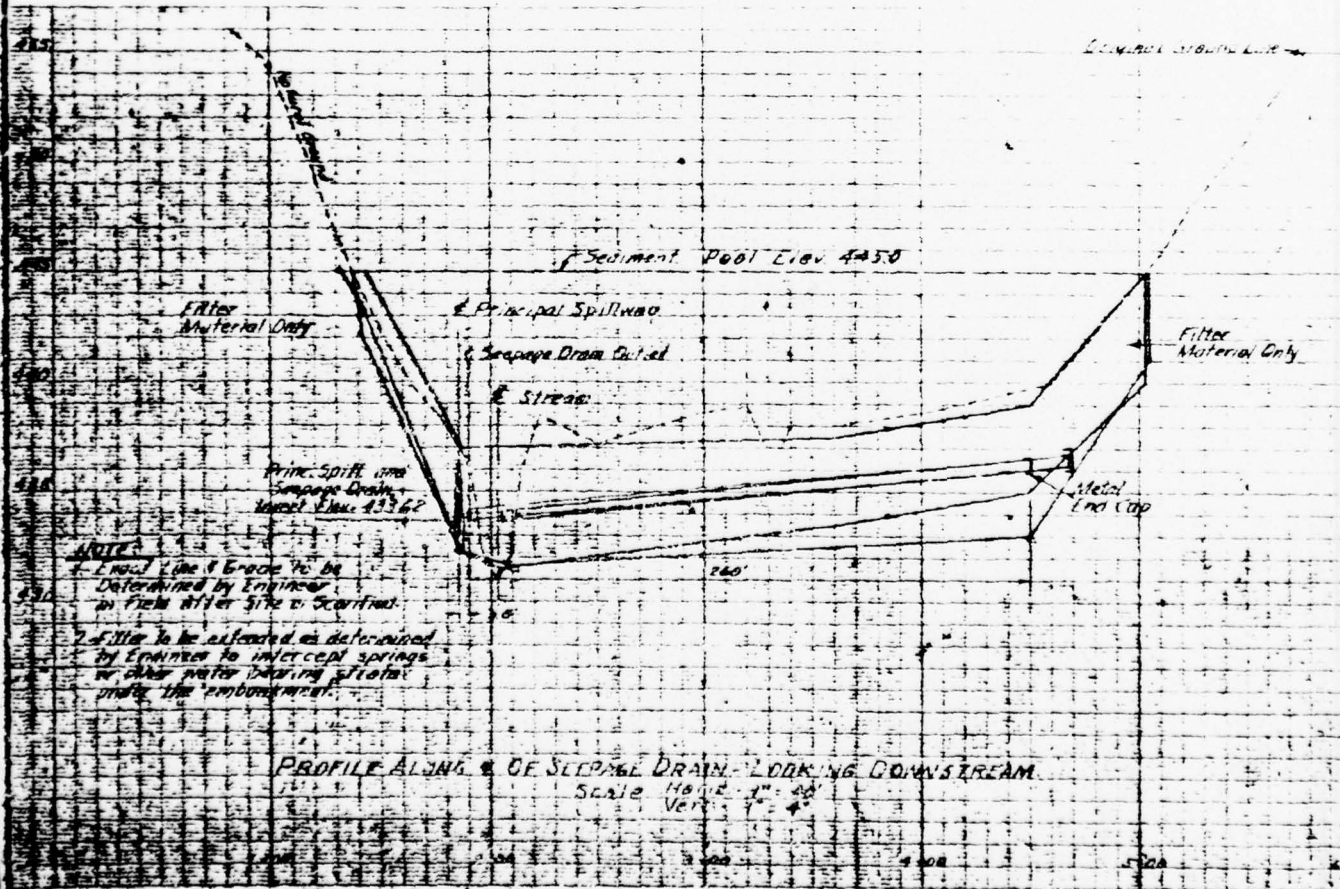
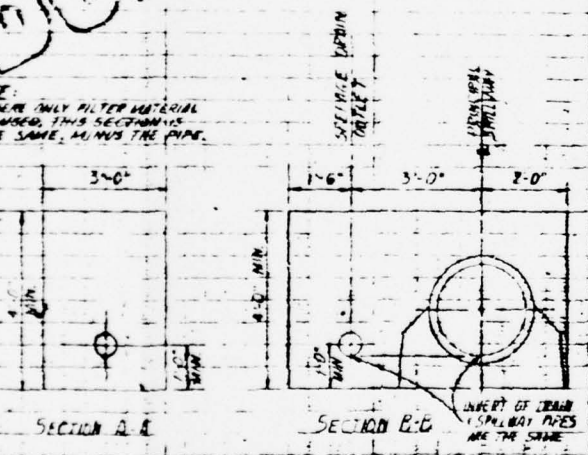
Referring to Plate II, Appendix I, the seepage drain is located at 29 feet from the centerline of dam. The location of drain in the "as-built" condition provides a c/b ratio of less than 0.5.
