PHASE I INSPECTION REPORT
NATIONAL DAM SAFETY PROGRAM

NAME OF DAM: CRYSTAL

Name of Dam: Crystal
State: Virginia
County: Frederick
Stream: Keckley Run
Date of Inspection: 20 July 1978

Crystal Dam is an earthfill dam approximately 48 feet high and 750 feet long, owned and operated by the Shawnee Land Corporation for recreational use.

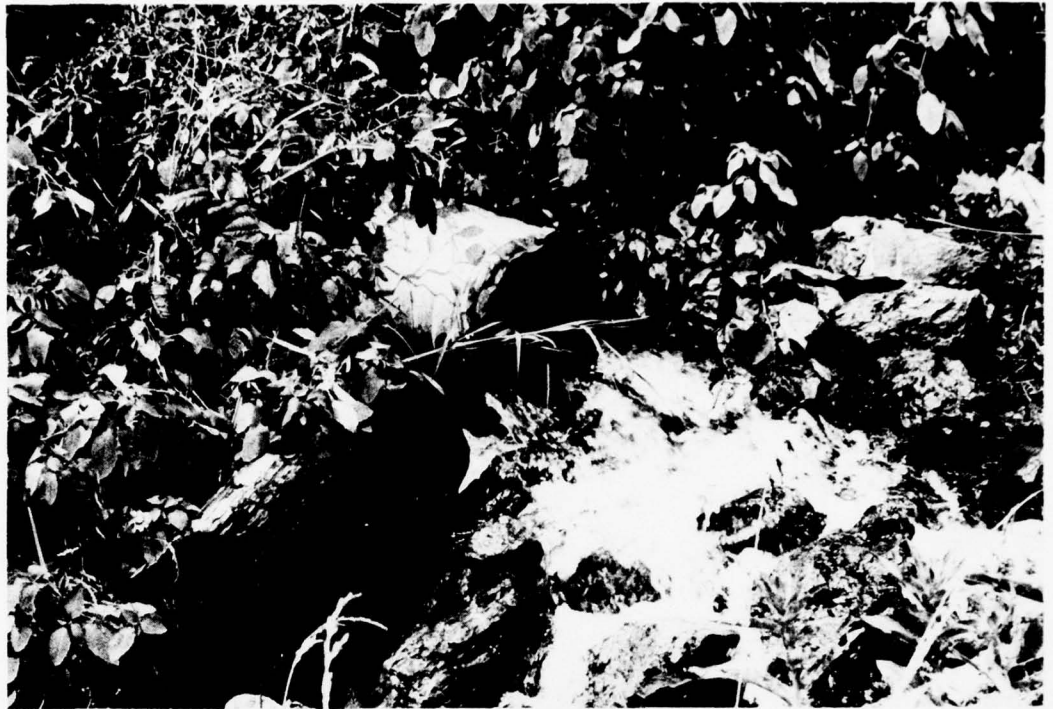
3.1.3 Appurtenant Structures: The corrugated metal riser and outlet pipe were in good condition except for the heavy coating of surface rust on the metal strainer and corrosion at the outlet end.

PHOTO 1. Outlet Pipe at Toe of Embankment

3.2.2 Appurtenant Structures: Further investigation is required to determine if the primary spillway may be blocked with debris at some distance from the inlet and outlet ends.

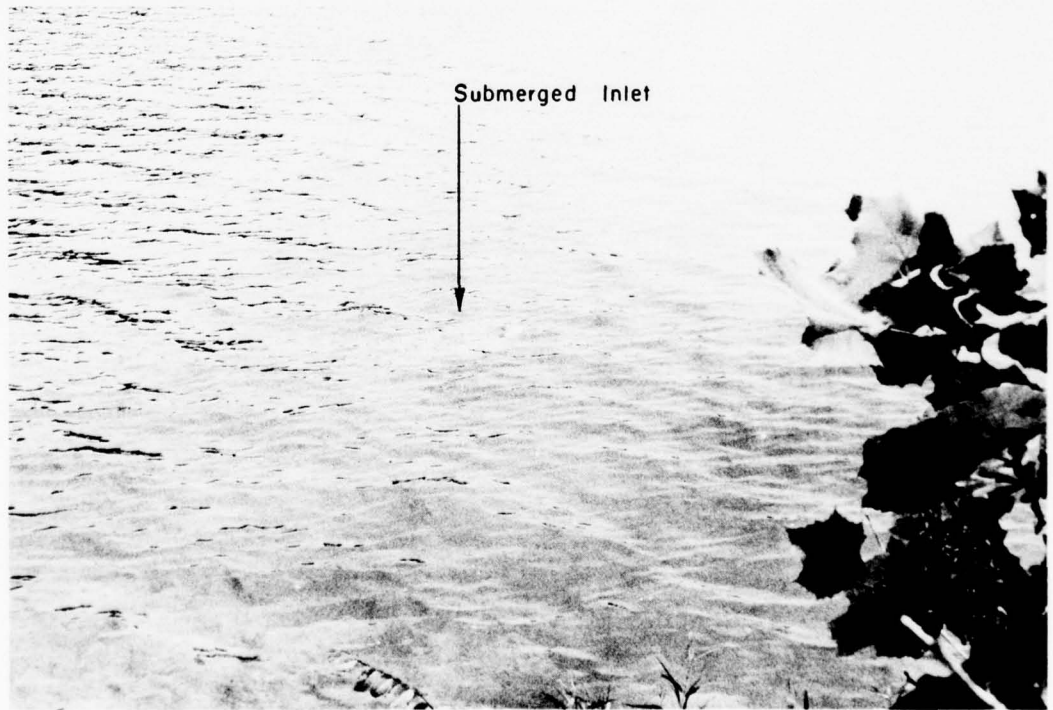
PHOTO 2. Inlet Pipe in Reservoir Submerged About 0.9 Foot

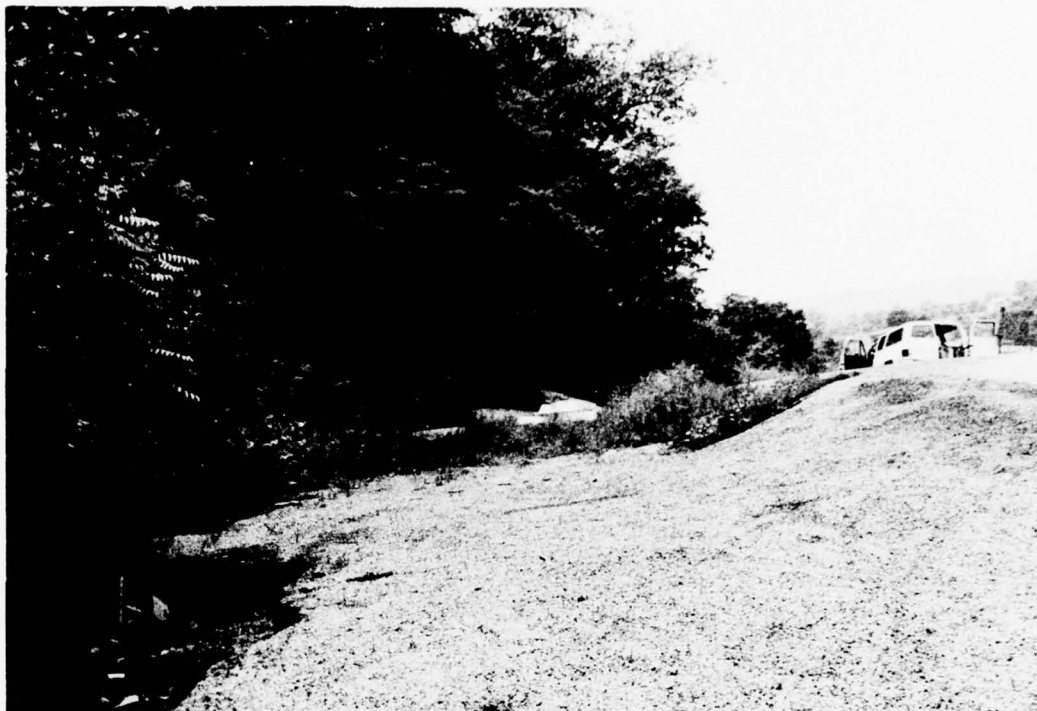
The emergency spillway is severely eroded on its downstream sections where it parallels the road (Photos 3, 4 and 5).

**PHOTO 3. Looking Upstream at Emergency Spillway
From About 100 Feet Downstream**

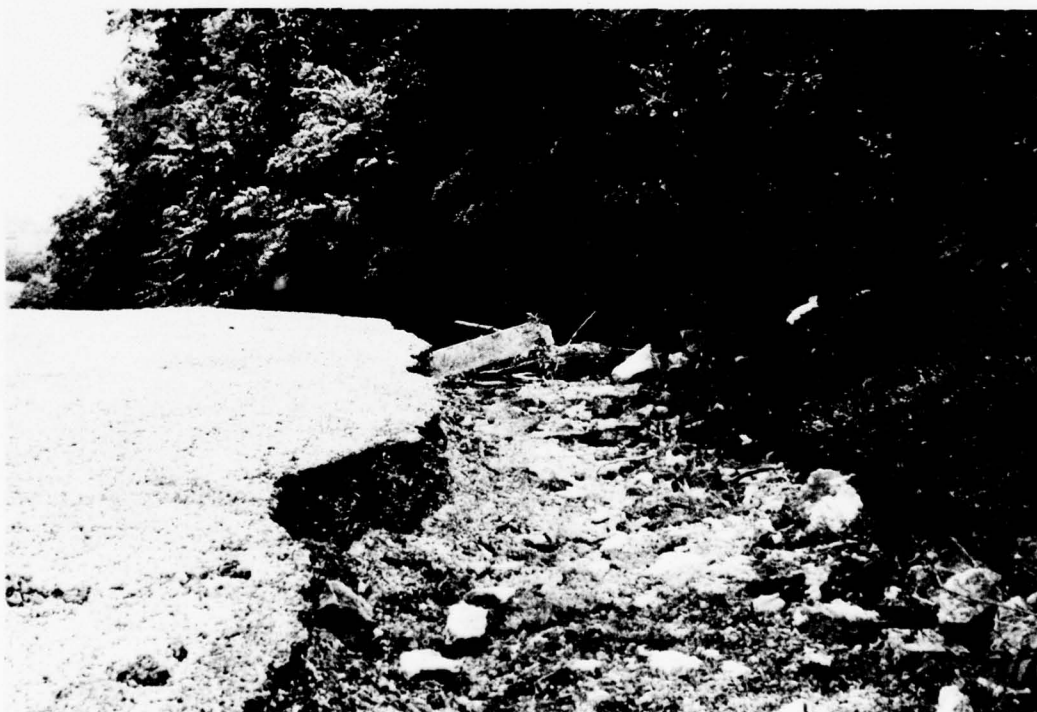
**PHOTO 4. Looking Downstream at Emergency Spillway,
100 Feet Downstream From Crest**

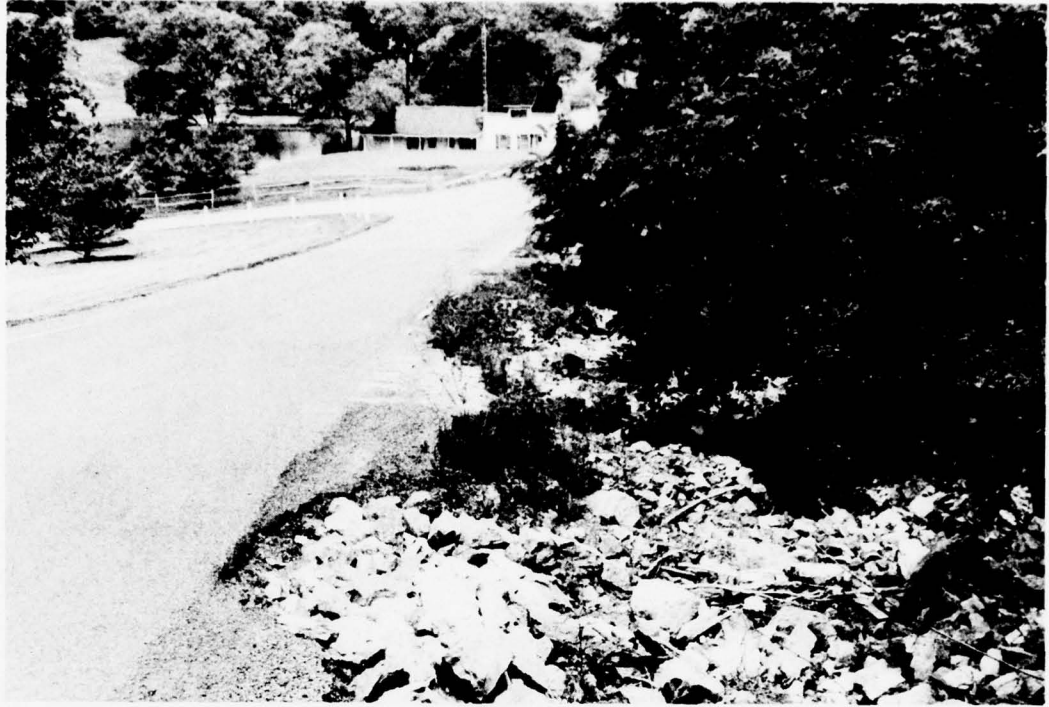
**PHOTO 5. Looking Downstream at Emergency Spillway
From Point in Line With Centerline Bearing**

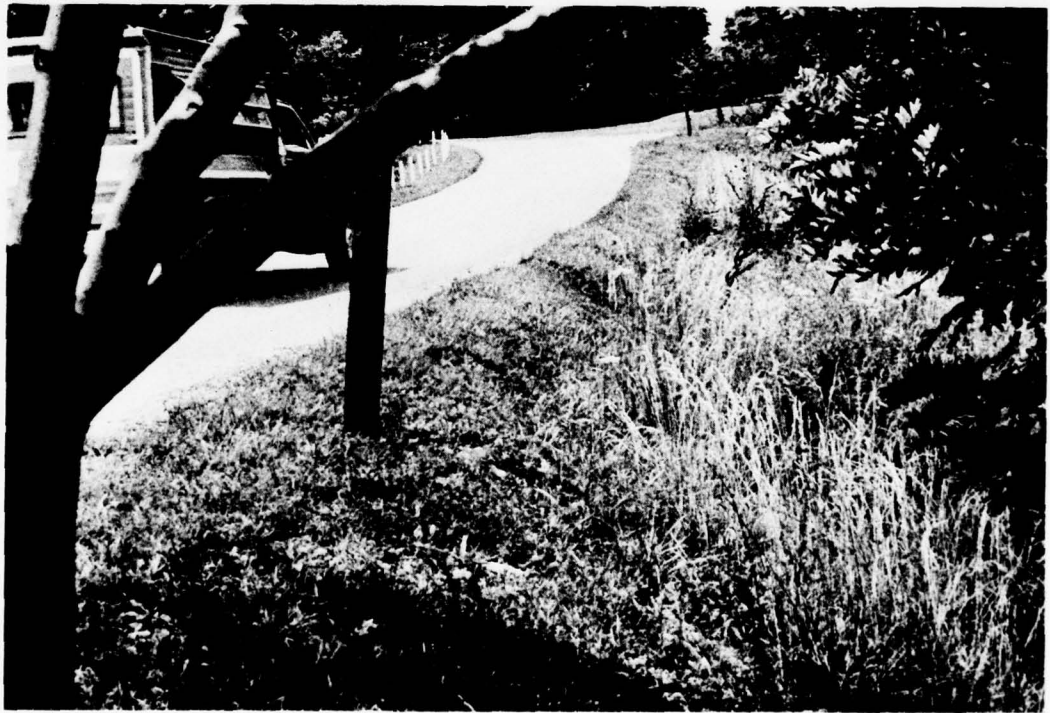
- 1) An old shallow slide, approximately 50 feet in length, was found near the crest of the dam on the downstream face. It is located approximately 250 feet to the left of the 15 inch diameter spillway outlet. The scarp is vegetated, but the slide mass has steep slopes and appears to be unstable. Seepage was not evident at this location.

- 6.3 Evaluation: The dam appeared to have been constructed with slope ratios of 2.5:1 on the downstream side and 3:1 on the upstream side. No tension cracks were observed. Evidence of an old shallow slide was observed on the downstream slope, about 250 feet to the left of the outlet pipe. The vegetated scarp is located near the crest of the dam and has a length of about 50 feet. The slide mass below the scarp appeared to be unstable with steep slopes. Seepage was not noticed at this location. It is recommend that this area should be repaired and an attempt be made to define the failure surface and cause of the slide during the repair work.

PHOTO 6. Location of SLoughing at Top of Downstream Face (Looking Left)

- 1) The slide should be repaired and reseeded. An attempt should be made to determine its cause during the repair operation. No further investigation appears to be necessary at this time.
- 2) The wet area on the downstream face should be monitored to see if it becomes progressively worse and correlated with changes in the lake level. If the condition of this area significantly deteriorates, or if flowing water is observed; then a further investigation should be made.
- 3) The large marshy area should be further investigated to locate the source of its water. If it is

- 3) Repair and reseed the slide near the crest of the dam and assess the cause of the slide. A stability analysis may be necessary.
- 4) Monitor any changes in the soft area on the downstream face near the spillway outlet pipe. If flowing water is observed, further investigation is necessary to define the phreatic surface and assess piping potential and slope stability.

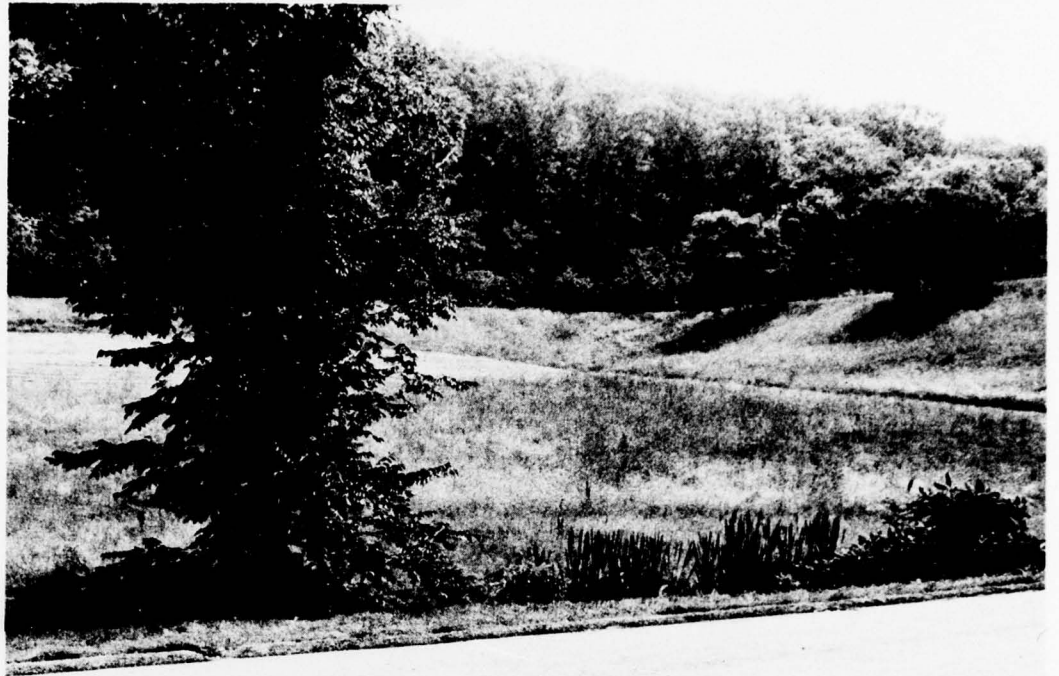
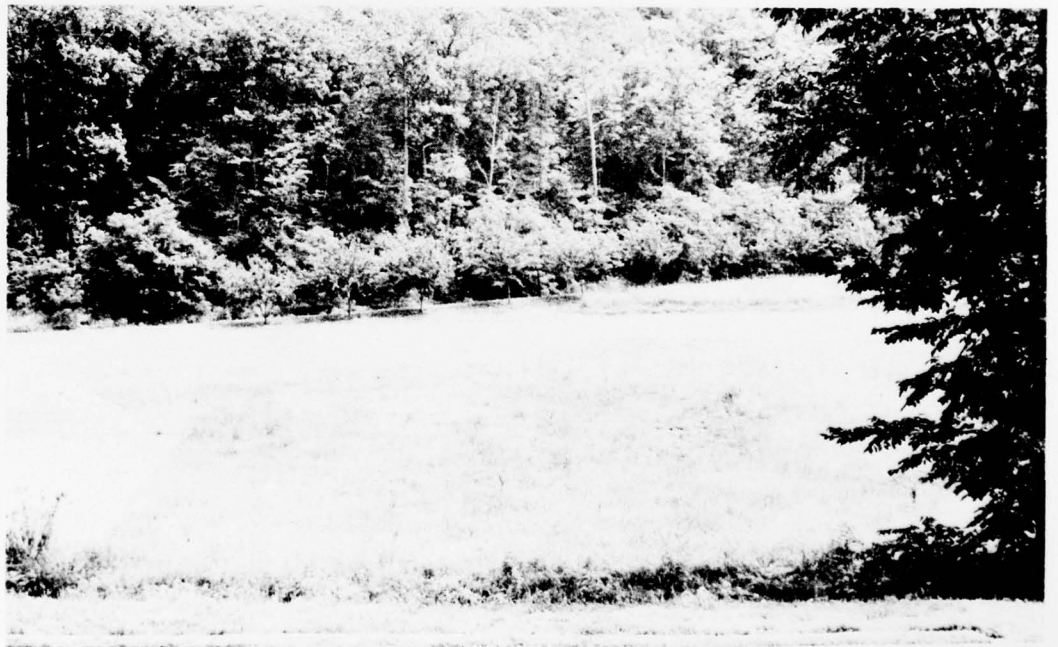
- 3) A large marshy area, approximately 150 feet by 100 feet, was located about 15 feet from the toe and to the right of the spillway outlet pipe. During the visual inspection, it was not possible to locate the source of this water.

The 150 feet by 100 feet marshy area located about 15 feet beyond the toe to the right (when facing the upstream slope) of the outlet channel represents an undesirable condition that requires further investigation. The source of the water in this area could not be determined by visual inspection. Therefore, the purpose of additional investigation by the owner would be to determine its source. If the source is found to be the reservoir, then it will be necessary to assess piping potential through the foundation.

**PHOTO 7. Swampy Area Just Downstream From Toe on Right Side of Embankment
(150 Feet by 100 Feet)**

**PHOTO 8. Swampy Area Just Downstream From Toe on Right Side of Embankment
(150 Feet By 100 Feet)**

determined that the reservoir is the source, then the piping potential of the foundation will need to be assessed. Correlation with lake levels is also recommended.

- 1) Even though no flow was observed at the wet area on the downstream face of the dam, this area should be inspected periodically to prevent a worse condition from going unobserved.
- 2) An additional investigation should be conducted to determine the cause of the marshy area beyond the toe.
