Name Of Dam: SOUTH RIVER NO. 25

Location: AUGUSTA COUNTY, STATE OF VIRGINIA

Inventory Number: VA 01502

# PHASE I INSPECTION REPORT

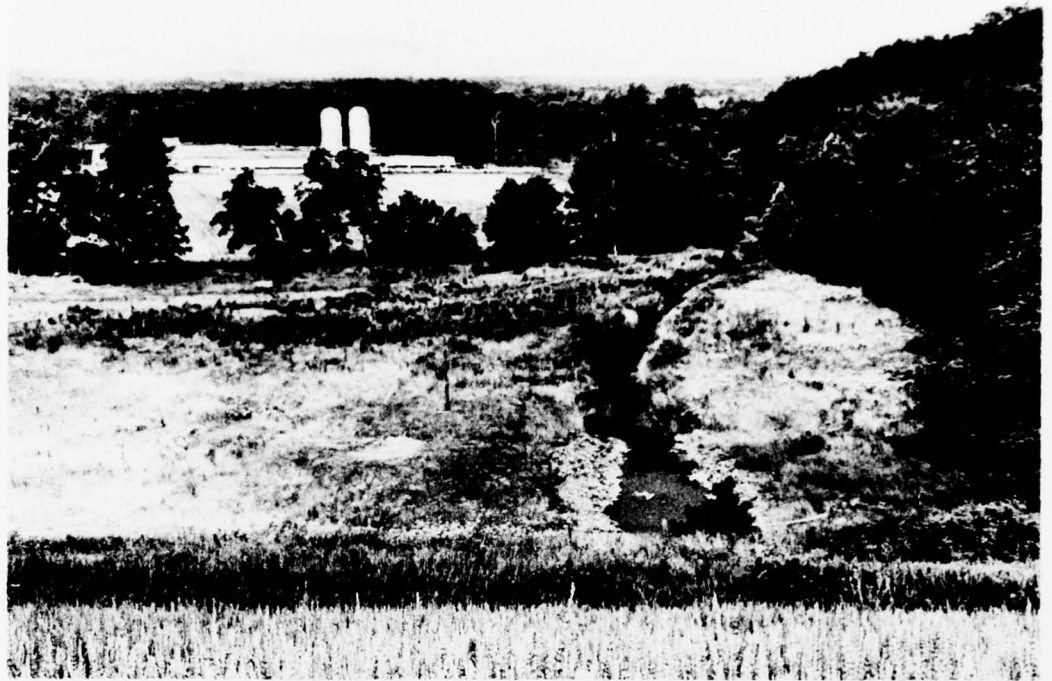
- 3.1.4 Reservoir Area: No serious shoreline erosion was found.
- 3.1.5 Downstream Channel: The downstream channel is composed of gravel, cobbles and small boulders, and is in good condition.

**PHOTO 1. Downstream Channel From Principal Spillway and Farm**

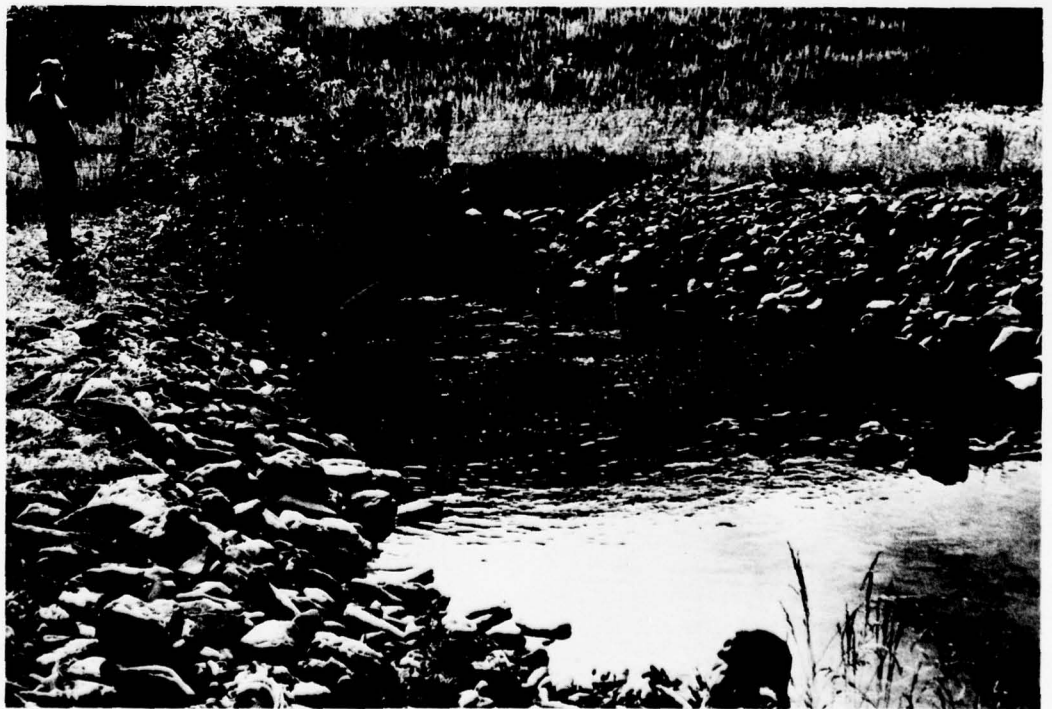
**PHOTO 2. Stilling Basin at Downstream Outlet of Principal Spillway**

| VISUAL EXAMINATION OF | OBSERVATIONS | REMARKS OR RECOMMENDATIONS |
|---|---|---|
| STILLING BASIN | The basin is approximately 30' x 50' x 6' deep. The riprap is in good condition. | |

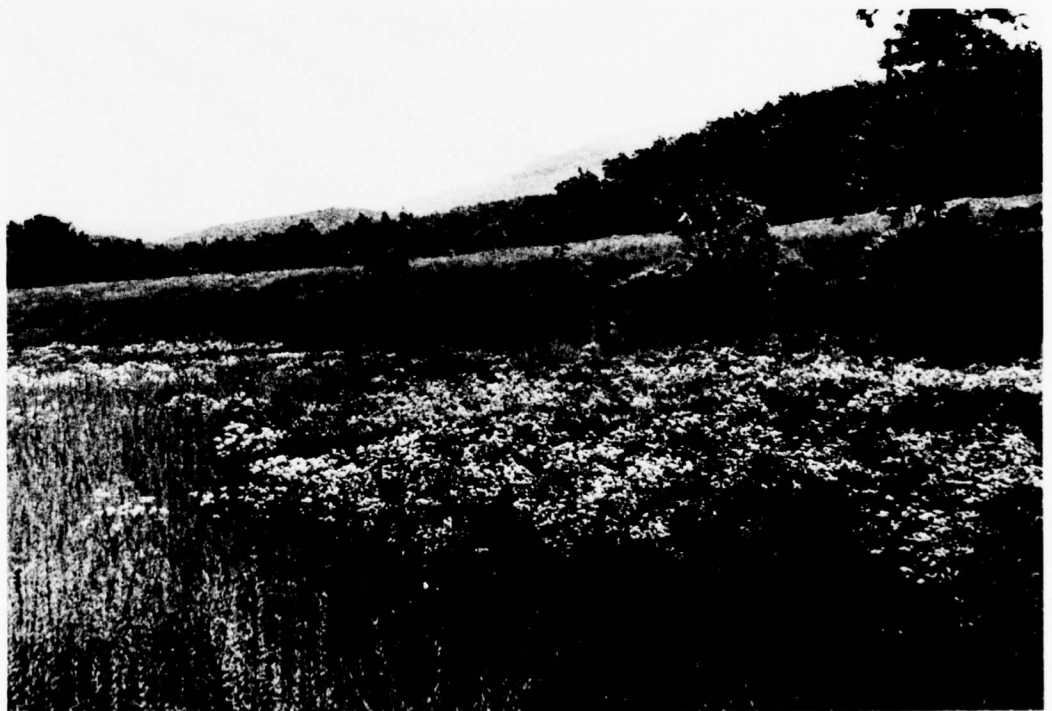
**PHOTO 6. Cut Slope in Rock and Soil on Left Side of Emergency Spillway  
With Borrow Area Beyond**
