Name Of Dam: SOUTH RIVER NO. 27  
Location: AUGUSTA COUNTY, STATE OF VIRGINIA  
Inventory Number: VA 01503

# PHASE I INSPECTION REPORT

## NATIONAL DAM SAFETY PROGRAM

SEPTEMBER 1978

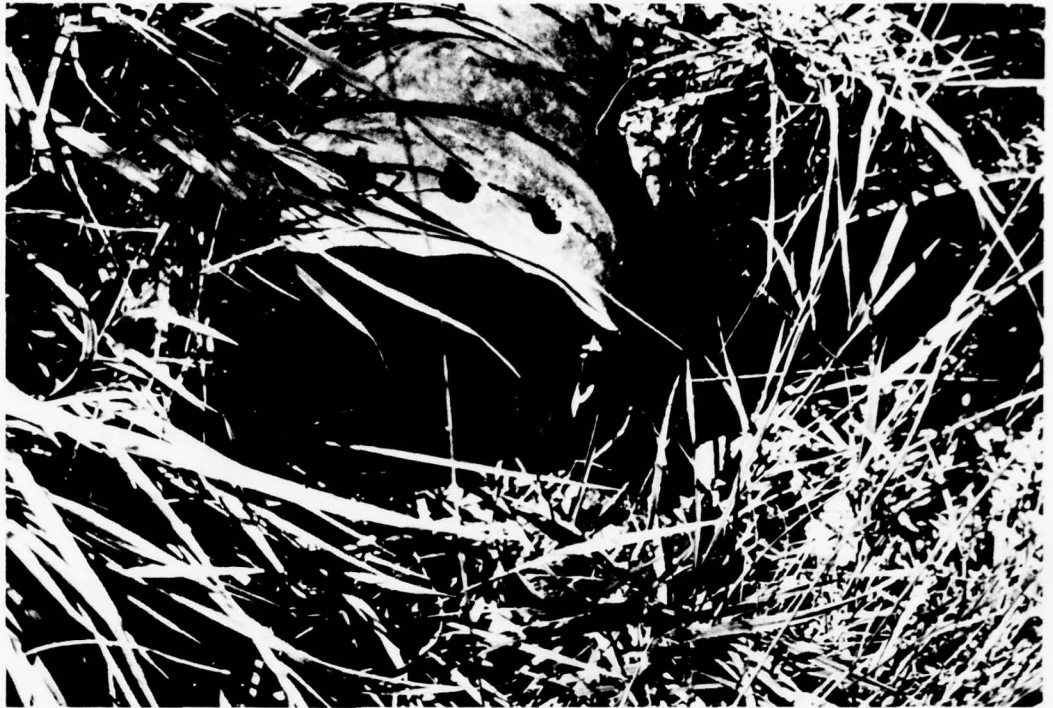
**PHOTO 1. Left Seepage Drain**

- 1.2.1 Description of Dam and Appurtenances: South River Dam No. 27 (Upper Sherando Lake Dam) is an earthfill structure about 950 feet long and 60 feet high. The top of the dam is 17 feet wide and is at elevation 1950.0 feet above Mean Sea Level (M.S.L.). Side slopes are two and one-half horizontal to one vertical (2.5:1) seepage control is provided by an impervious core key way extending one foot into bedrock. A toe drain outletting adjacent to the outlet pipe has been provided (Photo 1).

Small trees (approximately six feet high) were observed growing on both faces of the dam. Two large animal burrows are located on the downstream face of the dam slightly above the outlet conduit. Another animal burrow is located immediately adjacent to the seepage drain outlet on the north side of the principal spillway outlet. The rubble tossed aside from this burrow has blocked the outlet of this seepage drain.

- 1) The trees growing on the embankment should be removed.
- 2) The footpaths on the upstream and downstream faces of the dam should be repaired and reseeded, or a type of stairway should be constructed to prevent future damage.
- 3) Continuous drainage should be restored along the berm on the downstream face of the dam by removal of sediment from the footpaths and regrading.
- 4) The animal burrows, particularly the burrow adjacent to the left seepage drain outlet, should be backfilled. The seepage drain outlet should be cleaned.

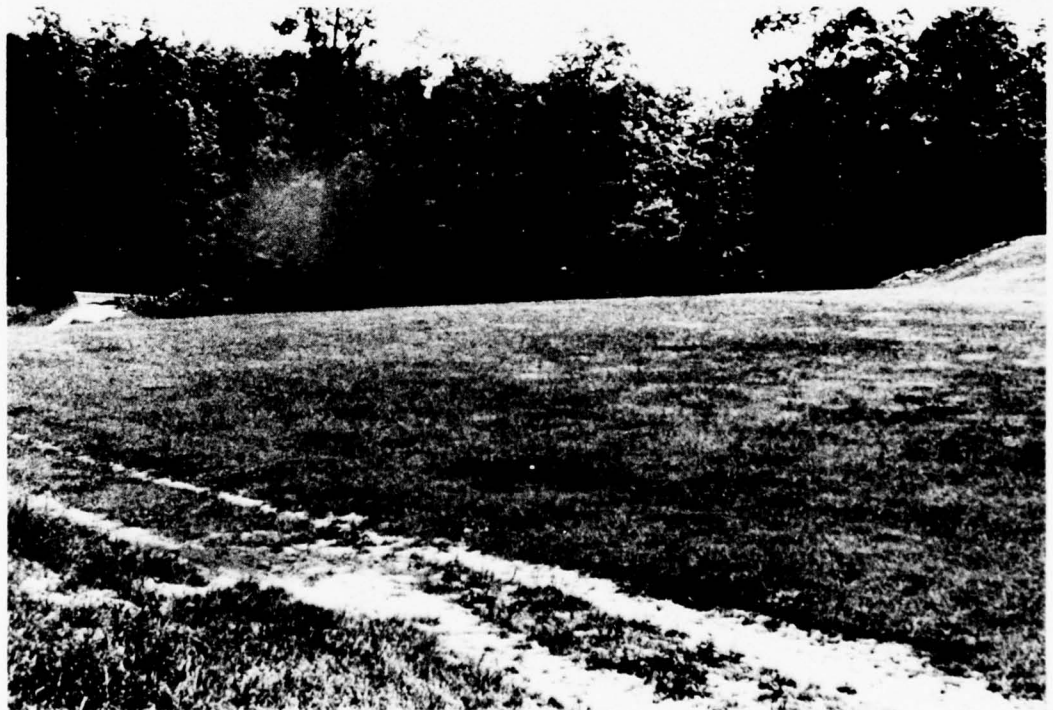
**PHOTO 2. Emergency Spillway**

- The emergency spillway (Photo 2) is a vegetated, rock-cut, side-channel type with a bottom width of 160 feet. It has side slopes of 3:1 and 2.5:1, respectively. The crest of the emergency spillway is at elevation 1942.7.

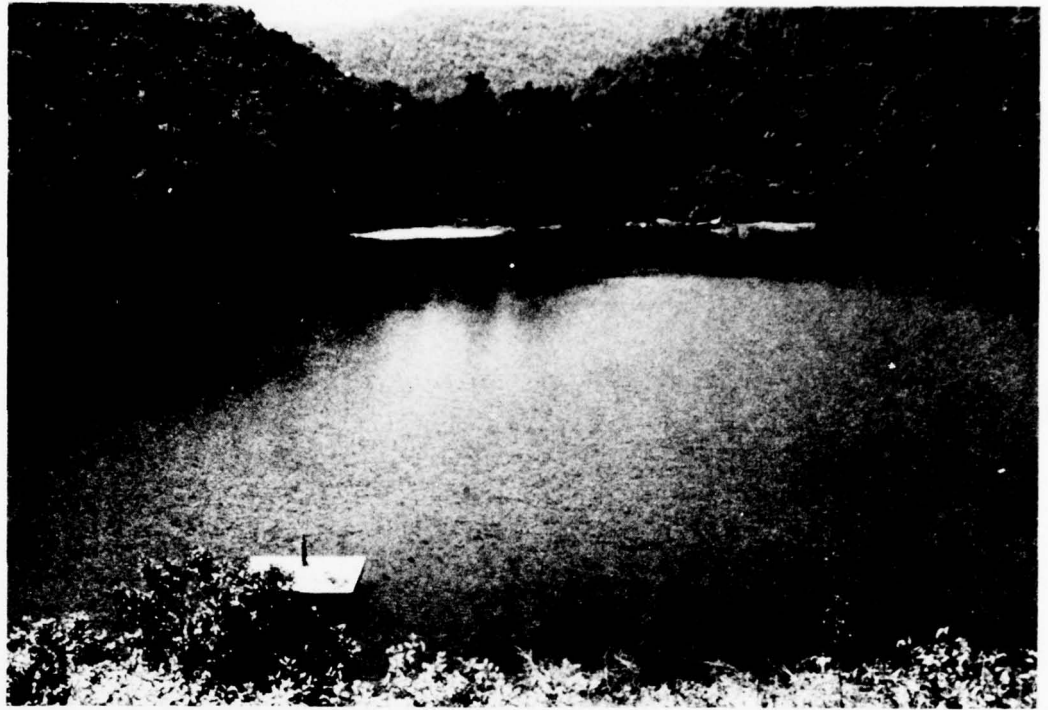
**PHOTO 3. Riser and Reservoir**

- 1.2.8 Normal Operational Procedures: No formal operating procedures are followed on this dam. Normal pool is controlled by the riser (Photo 3) crest elevation of 1910.0 feet. Water rising above the crest of the drop-inlet is automatically passed downstream. Excess flows are diverted through the side-channel emergency spillway. The 30 inch slide gate is not periodically operated.

All exposed steel on the riser (trash rack, cover plate, and gate operating pedestal) has a moderate to heavy coating of surface rust.

Four, short, concrete columns (10 inches square) which support the nine inch thick concrete cap on the riser are spalled one to two inches deep. The reinforcing steel has been exposed in several areas and is heavily rusted.

The spalled concrete on the riser should be repaired due to the possibility that failure of these columns during a high stage situation could cause total blockage of the principal spillway.

- 10) Repair spalled concrete on the riser to prevent a collapse and blockage of the principal spillway.
- 11) Annually check the operation of the slide gate on the riser.

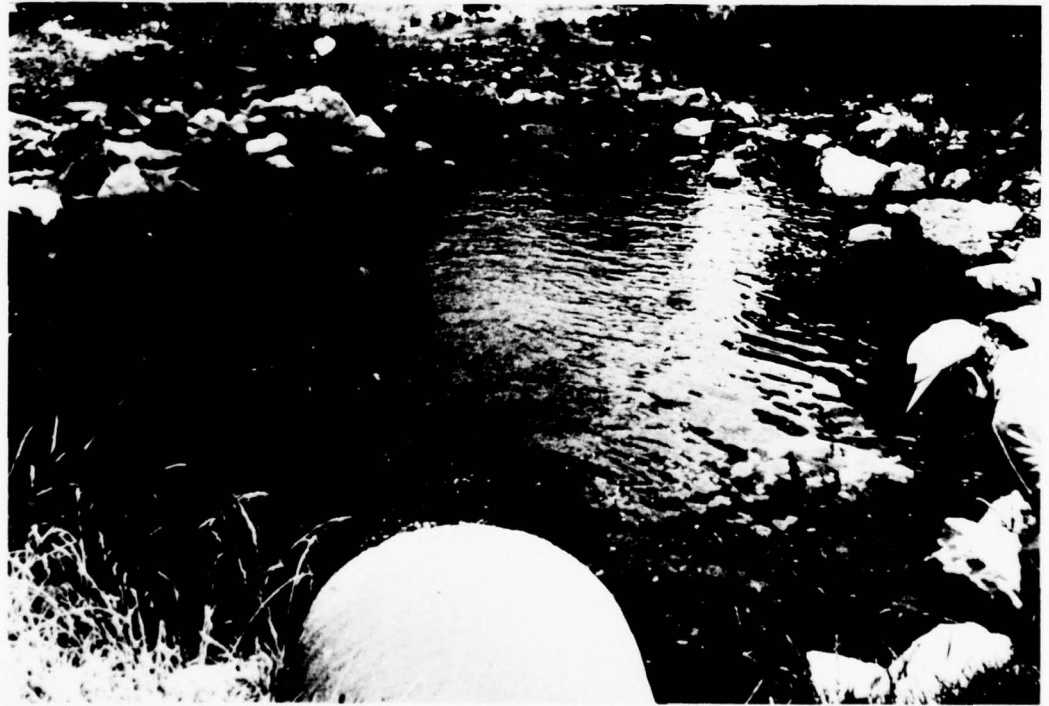
**PHOTO 4. Outlet Pipe and Stilling Basin**

3.1.5 Downstream Channel: The outlet pipe is in good condition and is functioning properly (Photo 4).

The riprap adjacent to the outlet works has been washed away and should be replaced.	
--	--	--
