Name of Dam: Sherando

Inventory Number: VA 01520

PHASE I INSPECTION REPORT  
NATIONAL DAM SAFETY PROGRAM

9 01 16 209  
SEPTEMBER 1978

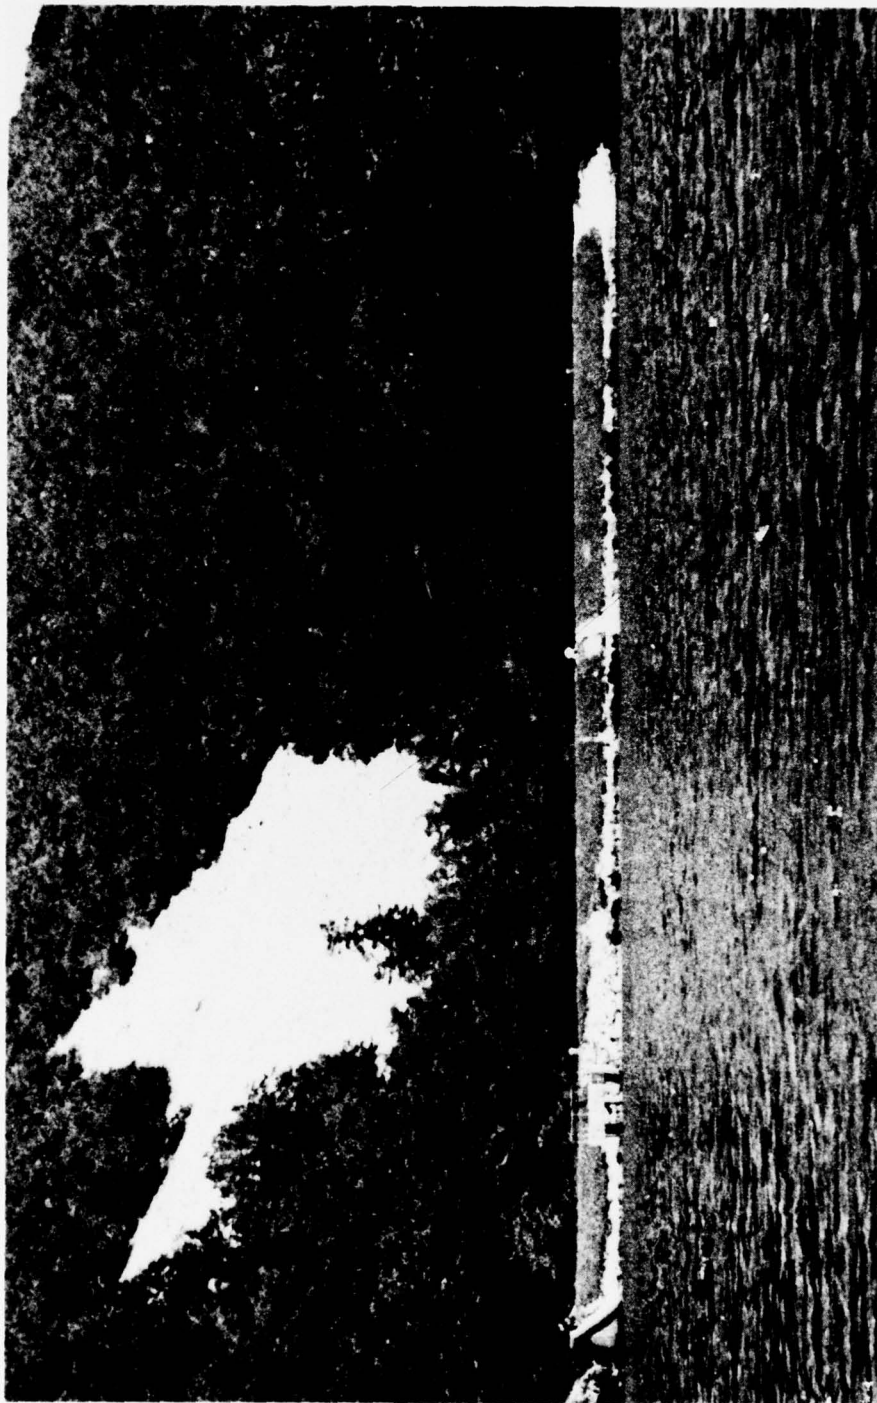
OVERALL VIEW OF DAM

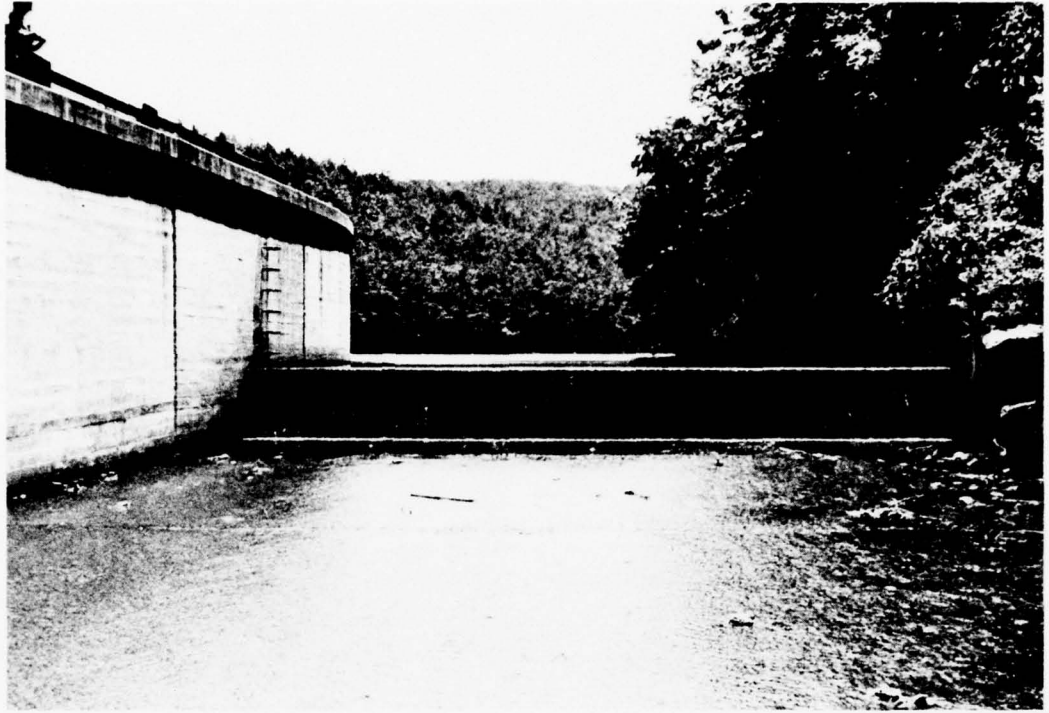
**PHOTO 3. Weir in Principal Spillway With Overflow**

| VISUAL EXAMINATION OF | OBSERVATIONS | REMARKS OR RECOMMENDATIONS |
|---|---|---|
| CONCRETE WEIR | The concrete weir in the spillway is in good condition with only minor erosion from the overflowing water. The weir has a 3.5 feet crest height and is 1.5 feet thick. | |

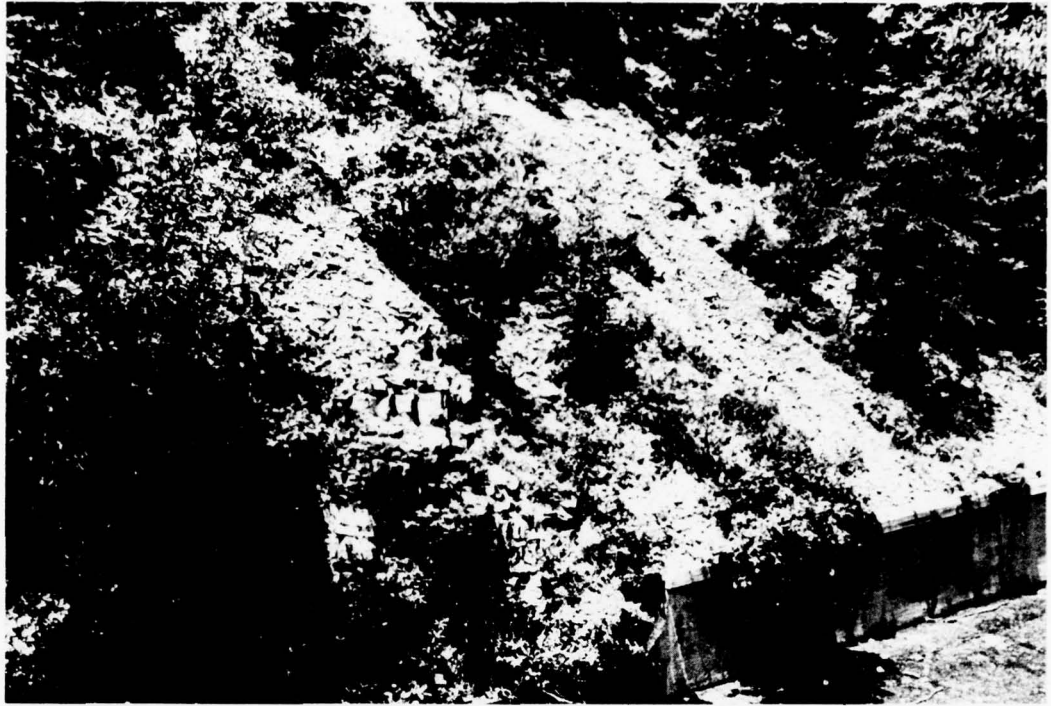
PHOTO 5. Surface Erosion of Slope on Left Bank of Spillway

| VISUAL EXAMINATION OF | OBSERVATIONS | REMARKS OR RECOMMENDATIONS |
|---|---|---|
| LEFT CUT SLOPE | The slope is composed of approximately 30 feet of almost vertically cut very hard quartzite and quartzose sandstone which strikes approximately parallel to spillway with variable 5°-10° dip east into spillway. Seepage and runoff of less than one g.p.m. were observed in several areas. Vertical sets of joints are parallel to spillway. Silty sand and rock fragments (large and small) with some sloughing and traces of clear seeps were exposed on downstream slope. There was scattered growth on the slopes. The rock slopes appear stable with minor amounts of small talus. | The rock slopes appear stable; but intermittent sloughing into the channel may occur on the downstream soil slopes in wet seasons. |

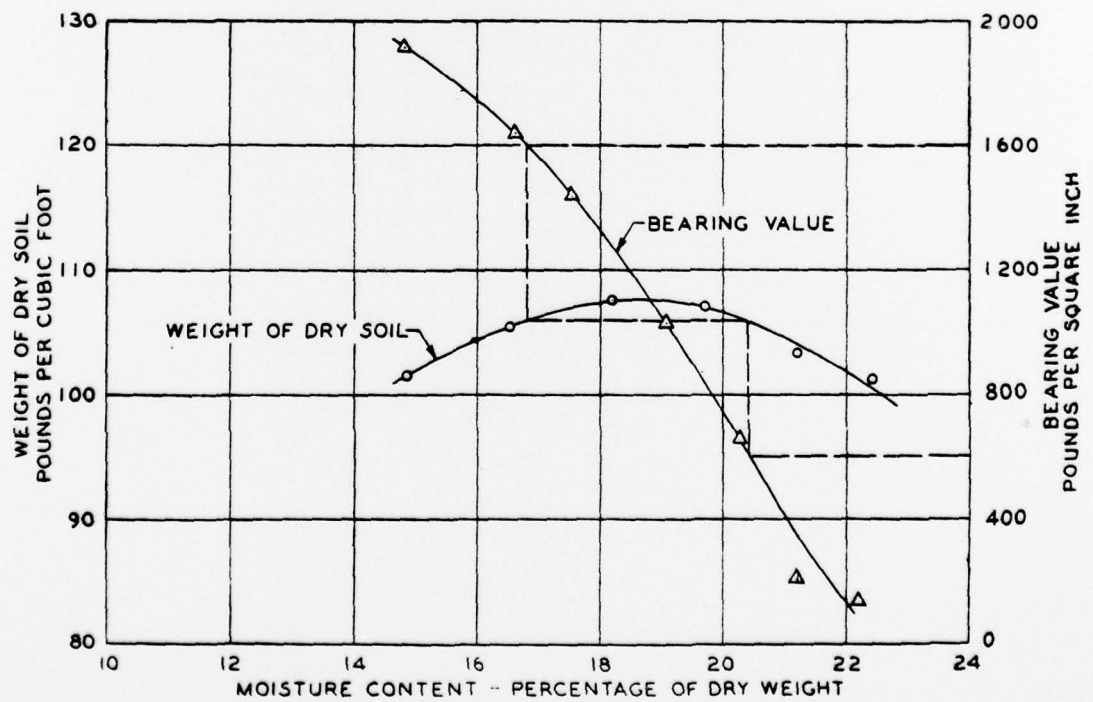
Fig. 2 - Curves obtained from compaction test data

One of the curves resulting from the test, shown in figure 2, serves to illustrate the significance of the compaction data. The weight of dry soil-moisture content curve discloses that for this soil a moisture content of about 19 per cent is required if maximum compaction is to be obtained. The corresponding bearing value is about 1,100 pounds per square inch.

If, at the specified compaction, the bearing value of this particular soil is indicated by the plasticity needle to be higher than 1,100 pounds, the increase can be considered as only temporary if the fill is to be unprotected from water after construction. Thus, a bearing value of 1,600 pounds per square inch indicates a moisture content of slightly less than 17 per cent. This corresponds to a dry weight of about 106 pounds per cubic foot. At this density the soil can take up moisture to a maximum of slightly more than 20 per cent which, in turn, corresponds to a bearing value of but 600 pounds per square inch.
