Name Of Dam: BEAVER CREEK DAM

Location: MARTINSVILLE, VIRGINIA

# PHASE I INSPECTION REPORT

## NATIONAL DAM SAFETY PROGRAM

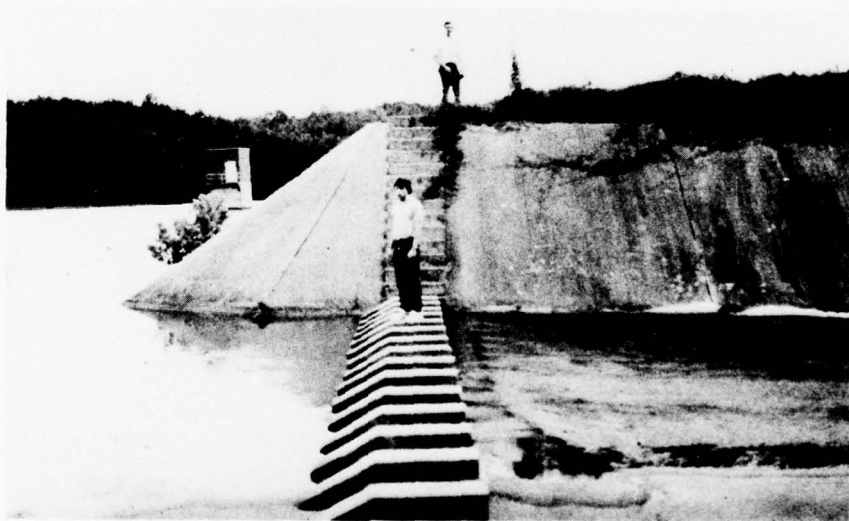
The spillway appeared to be in good condition. There were no cracks in the concrete and the construction joints had recently been sealed with a bituminous material.

BEAVER CREEK DAM - SPILLWAY CREST

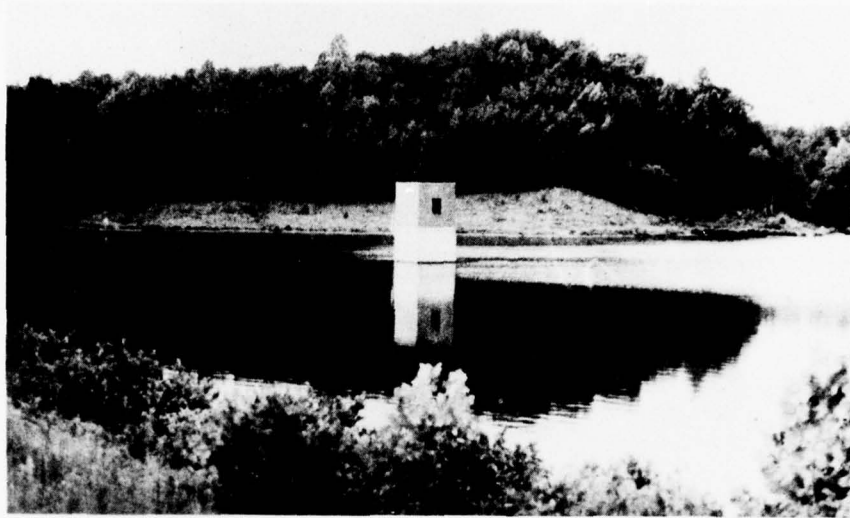
BEAVER CREEK DAM GATE TOWER

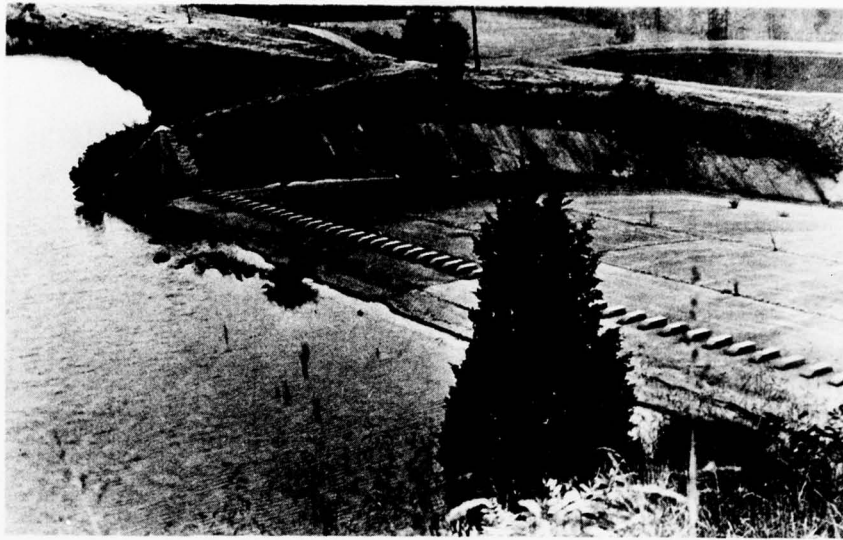
VIEW OF EMBANKMENT AND SPILLWAY FROM RIGHT ABUTMENT

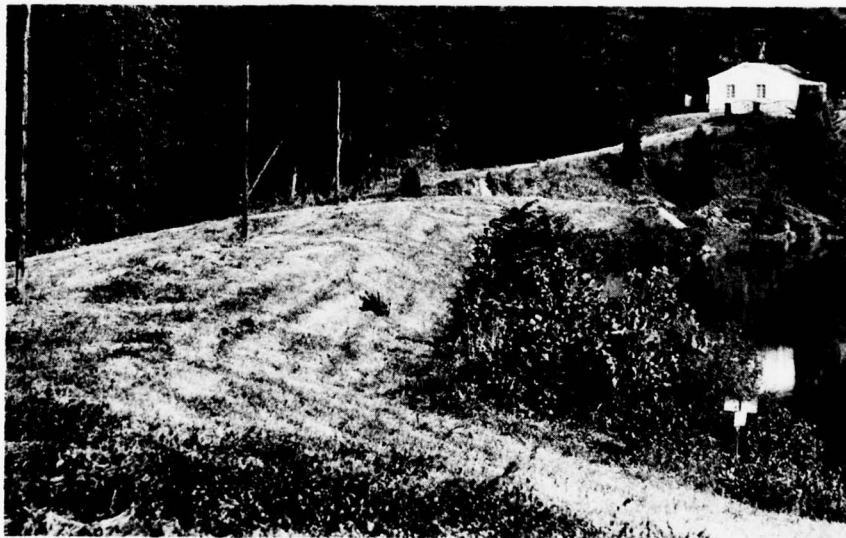
UPSTREAM FACE OF EMBANKMENT FROM LEFT ABUTMENT
