LOWER WARWICK RESERVOIR DAM  
ORANGE COUNTY NEW YORK  
INVENTORY NO. 59

PHASE I INSPECTION REPORT  
NATIONAL DAM SAFETY PROGRAM

Prepared by: NEW YORK DISTRICT CORPS OF ENGINEERS  
Date: SEPTEMBER 1978

PHASE I INSPECTION REPORT  
NATIONAL DAM INSPECTION PROGRAM  
LOWER WARWICK RESERVOIR DAM I.D. NO. 59

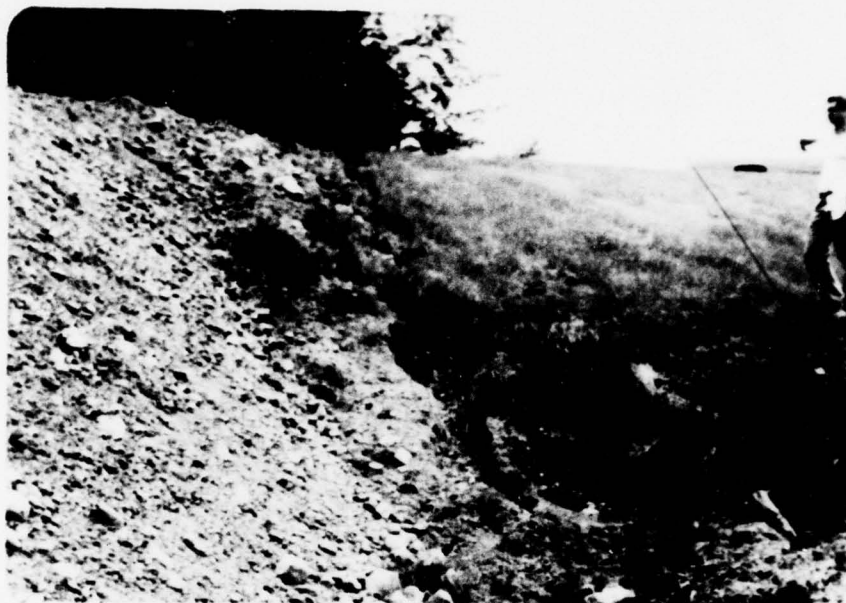
EROSION ON DOWNSTREAM EMBANKMENT SLOPE

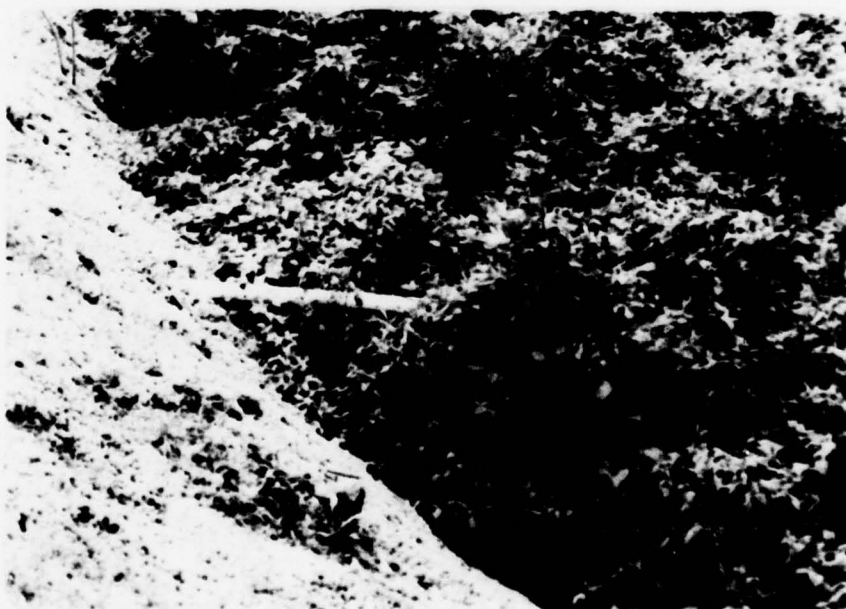
OUTLET PIPE FOR TOE DRAINAGE

d. Post Construction Changes. Repairs on the western portion of the downstream embankment slope were completed in the spring of 1978. The recently placed toe drainage facility is not passing water, indicative that the impervious blanket placed on the upstream slope in this area is functioning as anticipated.

3. Toe drainage facility should be inspected and flow noted at frequent intervals.

4. The toe drainage facilities should be inspected and flow noted at weekly intervals.

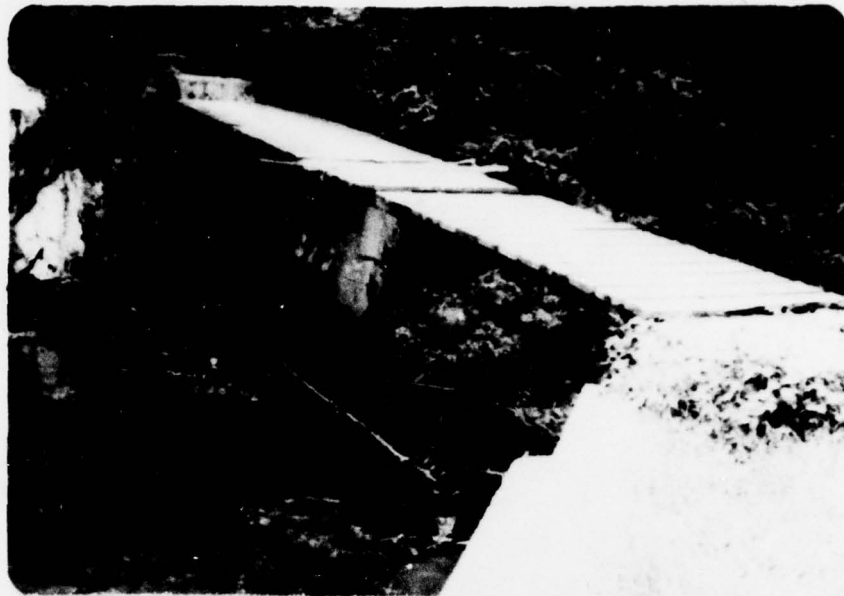
OVERVIEW OF SPILLWAY

d. Spillway. The spillway, located at the west abutment is a concrete gravity section 25 feet in width. Two to three inches of water was flowing over the spillway at the time of inspection. The concrete appeared to be in good condition with minor surface scaling. There is no evidence of structural cracking. The spillway is cut into bedrock and the west abutment contact is in rock. No evidence of distress was evident.
