KAUFFMAN DAM  
NDS ID NO. PA-00691  
DER ID NO. 54-54

SCHUYLKILL COUNTY MUNICIPAL AUTHORITY

PHASE I INSPECTION REPORT  
NATIONAL DAM INSPECTION PROGRAM

AUGUST 1978

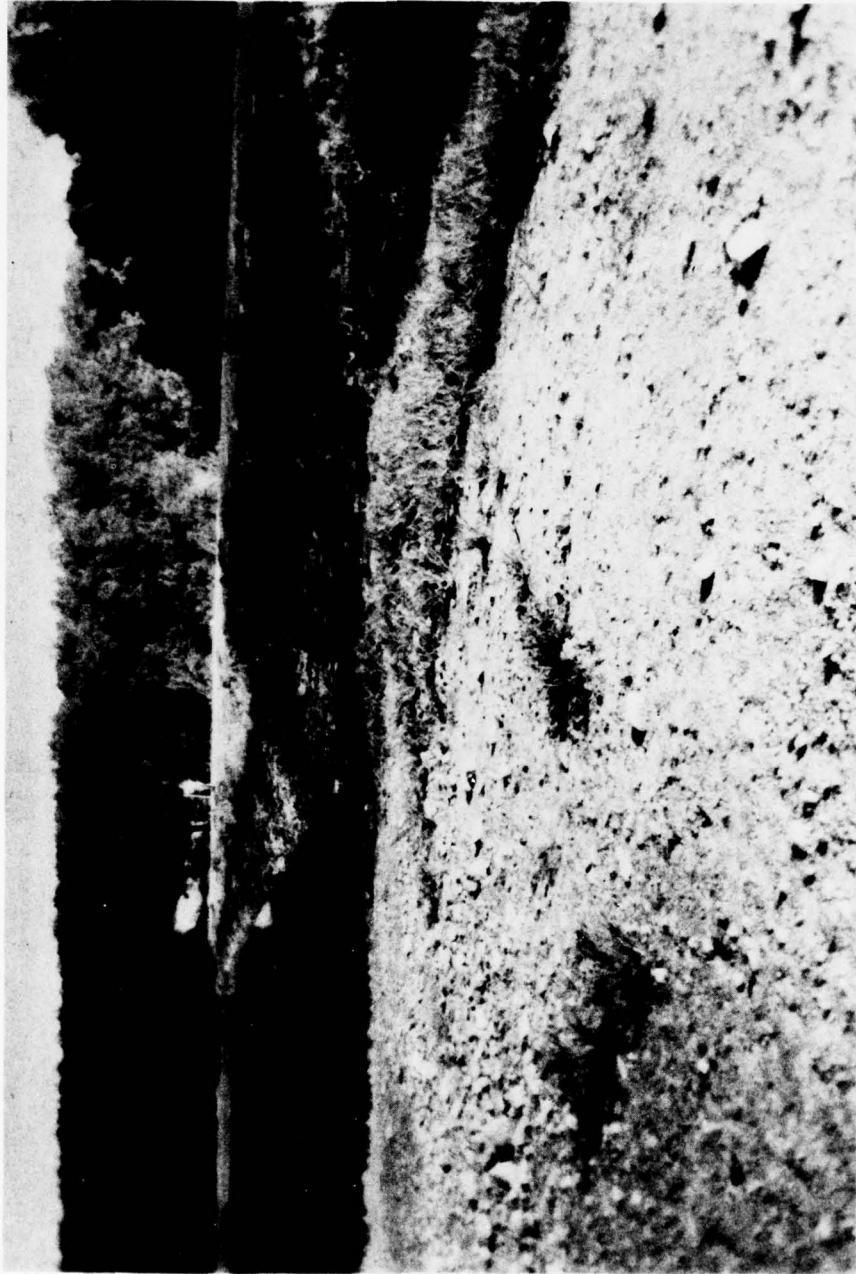
Upstream Slope of Embankment from Spillway Approach Channel.

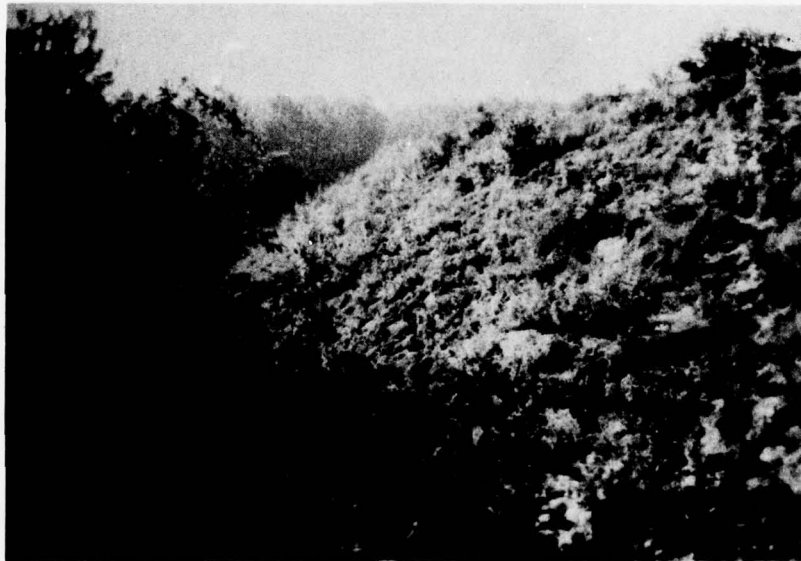
B. Downstream Slope of Embankment from Left Abutment.

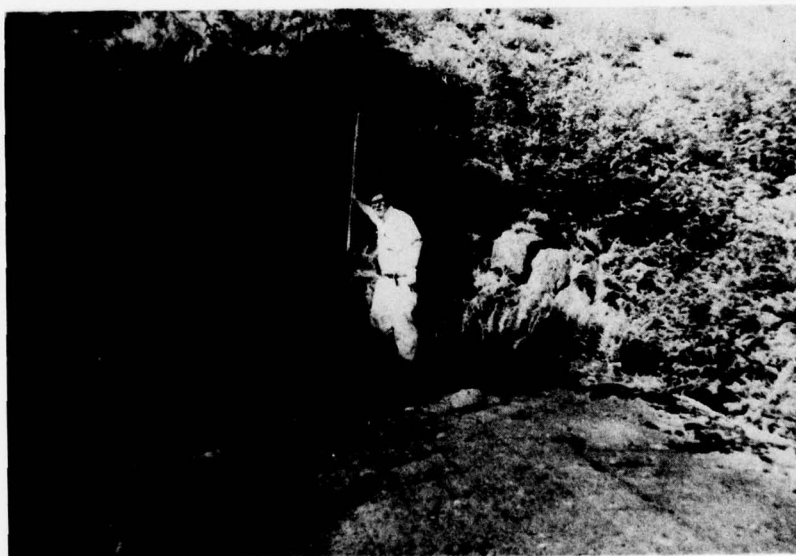
Near the highest section of the embankment, bulges were observed near the downstream toe (Photograph D). The bulges are typically 5 feet wide, 15 feet long, and they are about 1.3 feet high, measured normal to the slope.

The bulges on the downstream slope were first noted in 1924 during an inspection by the Pottsville Water Company, then the Owner. The inspection report notes that the bulges were "re-laid". The bulges were not mentioned in the next eight inspection reports. A letter, dated September 1941, from the Commonwealth to the Owner noted bulges and suggested establishing survey monuments to monitor movement. The next inspection in 1942 noted that the suggestion had not been carried out. A letter, dated September 1945, from the Commonwealth to the Owner again suggested the monitoring of the bulges. The Owner responded, in the same month, and stated that the bulges had been monitored for a year and no movement had been observed. The bulges were not noted in the 1962 and 1971 inspections by the Commonwealth. In July 1972, after Tropical Storm Agnes, the dam was inspected by the Soil Conservation Service in company with representatives of the Pennsylvania Department of Environmental Resources and the Corps of Engineers. The inspection report states that the downstream slope of the embankment was LV on LH and bulged. The inspection report recommends immediate placement of compacted rockfill on the downstream slope "for stability purposes".

seepage near the downstream toe were observed during the visual inspection. The bulges have apparently stabilized. The seepage is from a known source and flows under the embankment through a pipe. The downstream LV on 1.5H slope of the embankment is considerably steeper than current standard practice would allow. However, the concrete core wall is apparently functioning as designed, judging by the controlled seepage observed downstream of the dam. As such, it is felt that the embankment has an adequate margin of safety. Any changes in the bulges or the seepage should be cause for concern.

D. Bulge of Riprap Immediately Above Valve House.

(5) Establish survey monuments on the embankment, especially near the bulges. Monitor the embankment at frequent intervals. If changes are noted, an evaluation of the embankment stability should be made.

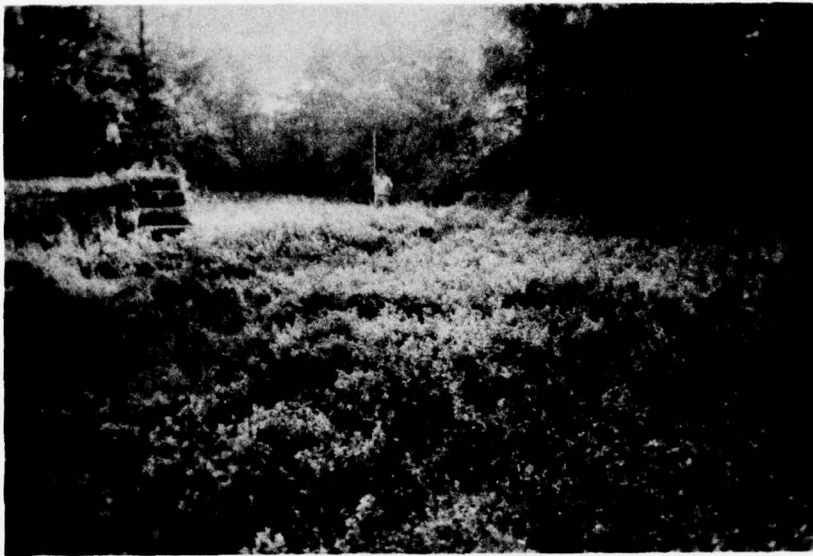
c. Appurtenant Structures. No deficiencies were observed at the spillway weir or at the masonry wall to the left of the weir. As determined by a survey performed for this inspection, the approach channel is 0.1 to 0.7 foot above spillway crest elevation. Both the approach channel and the channel downstream of the weir are generally covered with thick brush that is about 2 feet high (Photographs E and F).

E. Spillway Approach Channel —  
Looking Downstream.

(2) Grade the spillway approach channel to provide adequate approach conditions.

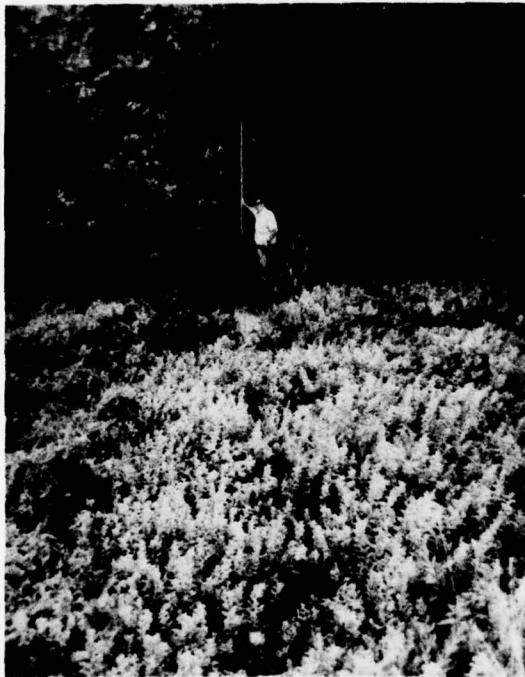
c. Visual Observations. Some visual observations relevant to hydraulics are presented in Paragraph 5.1a.(3). On the day of the inspection, brush was observed in the channels upstream and downstream of the spillway weir. This would reduce the spillway discharge capacity. A survey performed for this inspection revealed that the approach channel was from 0.1 to 0.7 foot higher than the spillway crest. Although this would have only minor effects on peak spillway discharge capacity, it would have significant effect on low head spillway discharge capacity.

F. Brush on Masonry Spillway  
Weir — Flow from Right to Left.

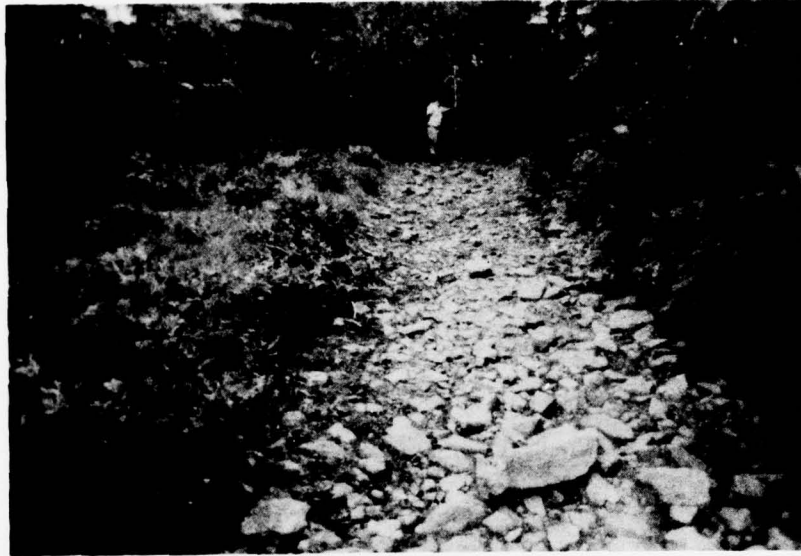
A concrete sill with a notch is located 84 feet downstream of the spillway weir (Photograph G). The channel downstream of the sill is quite narrow with heavily wooded overbanks (Photograph H). About 50 feet downstream of the sill, the channel extends down the natural hillside. The channel in this reach appears to have been eroded by the spillway flows. Beyond the toe of the hillside at the Kauffman Run overbank, the spillway channel is poorly defined. Many large piles of debris were observed (Photograph I).

G. Spillway Outlet Channel —  
Looking Downstream Towards Concrete Weir.

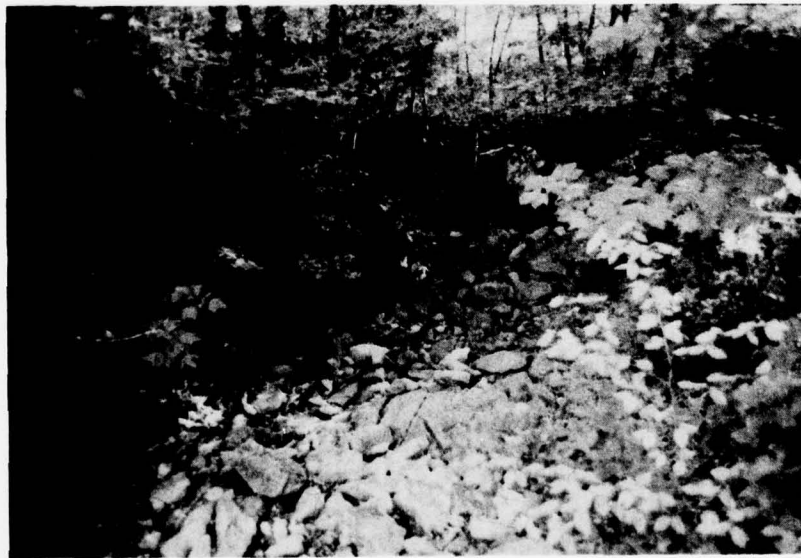
H. Spillway Outlet Channel Below Concrete Weir —  
Looking Downstream.
