PLAIN NINE DAM

NDI I.D. NO: 520

PHASE I INSPECTION REPORT

Plain Nine Dam (NDI 520), Susquehanna  
River Basin, Blair Gap Run, Blair County,  
Pennsylvania. Phase I Inspection Report.

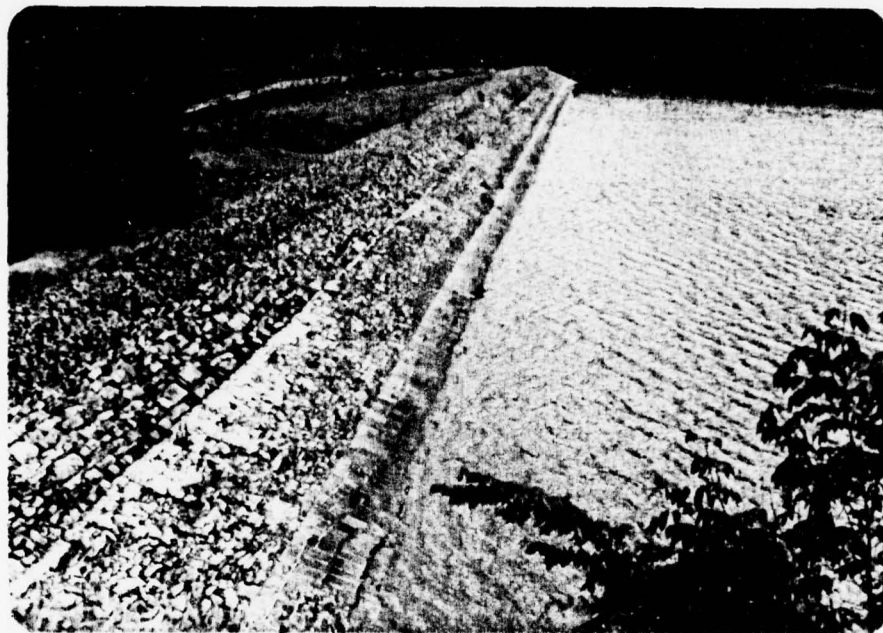
Upstream Face

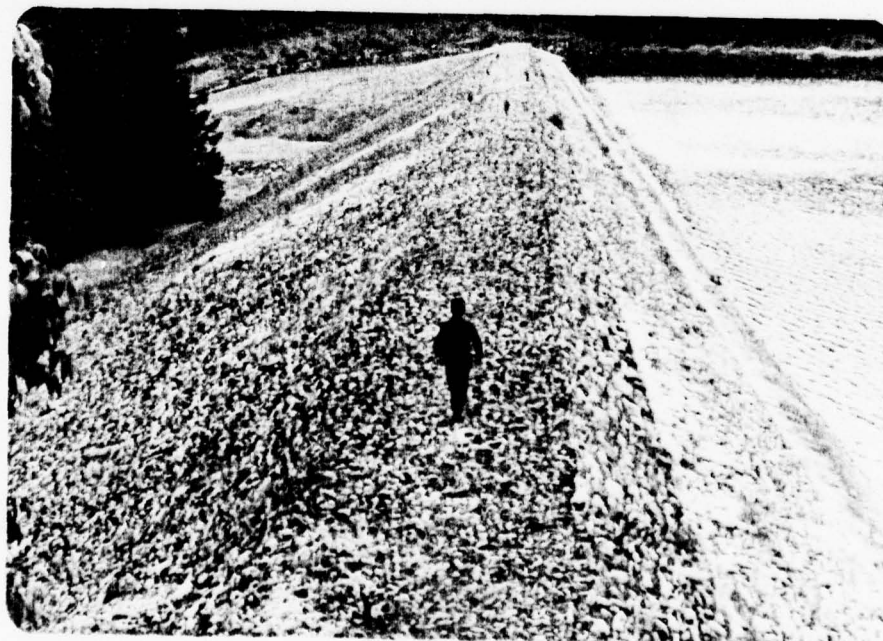
Downstream Face

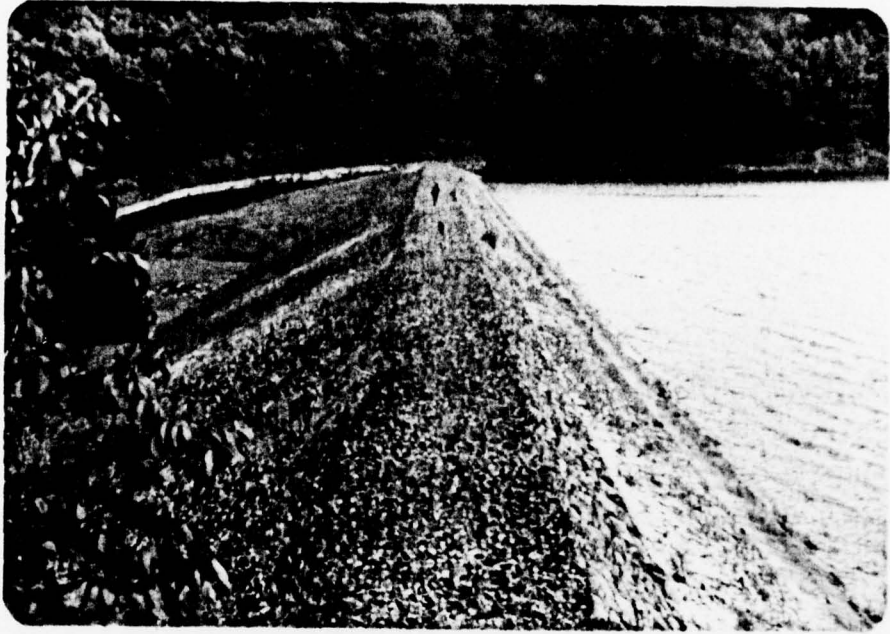
Photograph No. 1  
Crest (looking south).

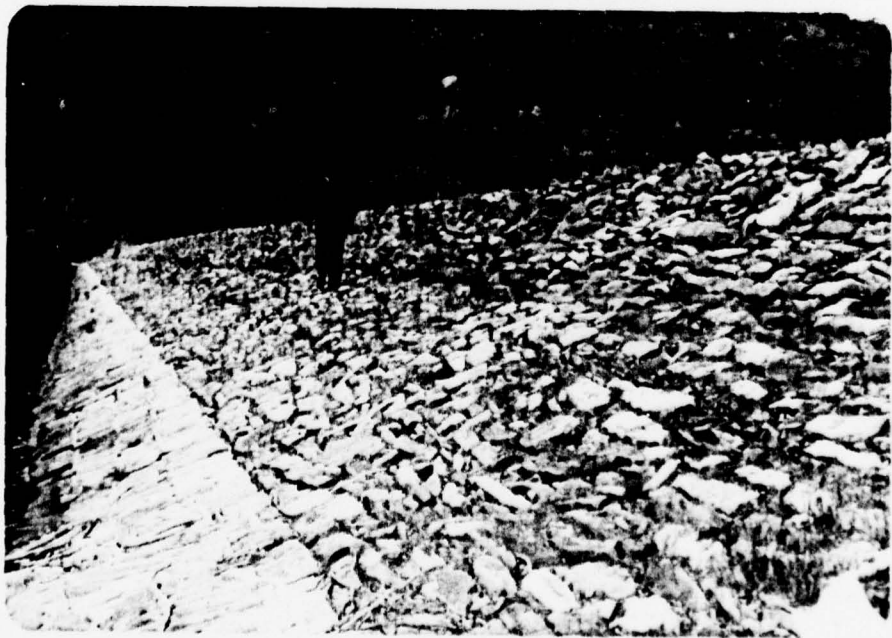
Photograph No. 2  
Upstream face.

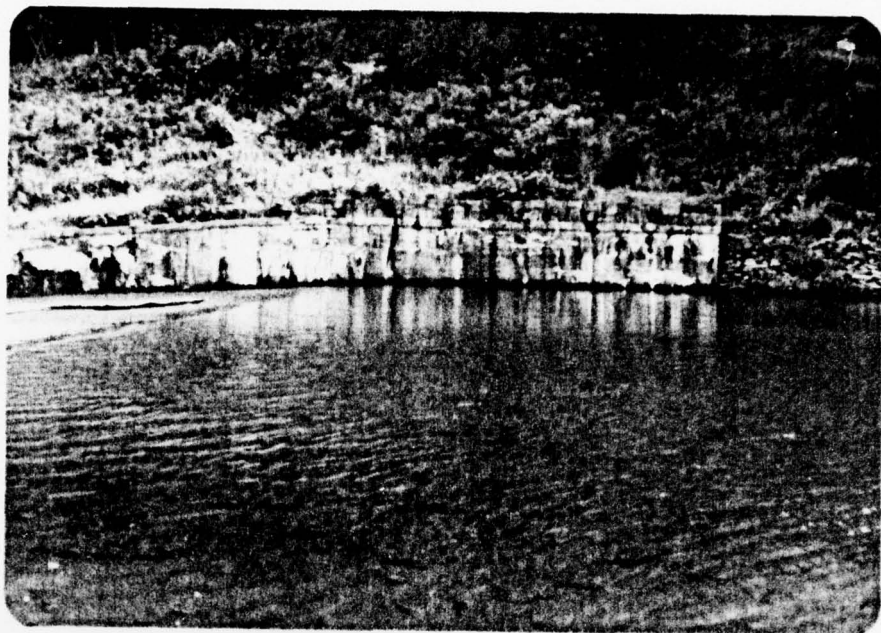
Photograph No. 3  
Spillway crest.

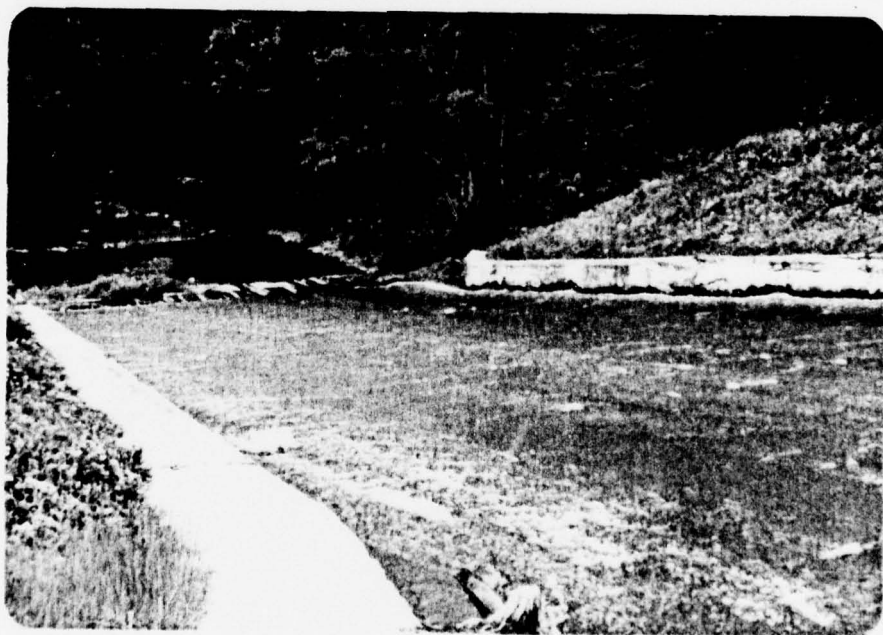
Minor seepage along the walls of the spillway channel and spalling on the channel walls were observed. The condition of the timber energy dissipator was considered to be fair.

Photograph No. 4  
Spillway chute and plunge pool.

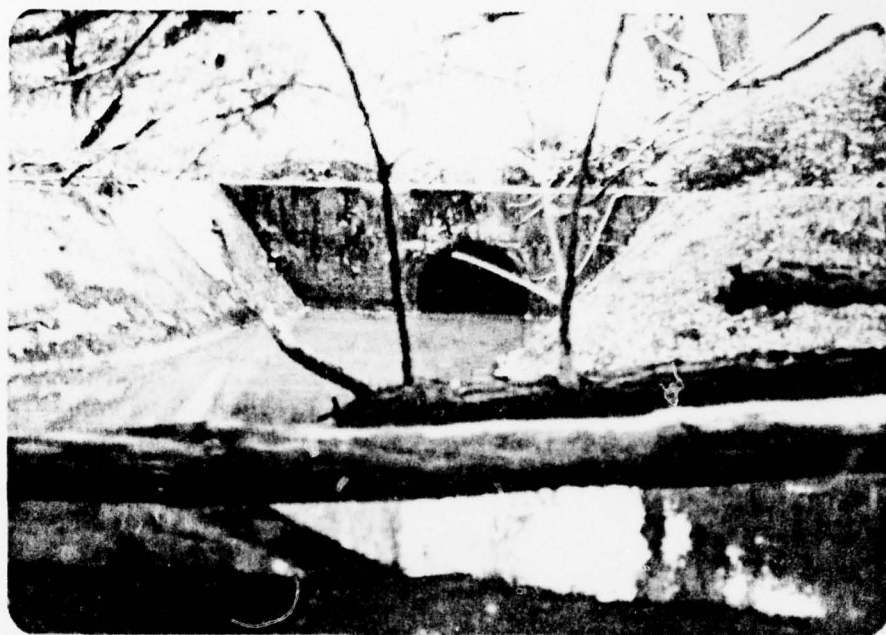
4.3 Maintenance of Operating Facilities. The water company declined to operate the blow-off valve to demonstrate its functional condition without compensation for operation and for any damages that would result due to this operation. Therefore, the operational condition of the blow-off pipe could not be assessed.

Photograph No. 5  
"Blow-off" pipe outlet.

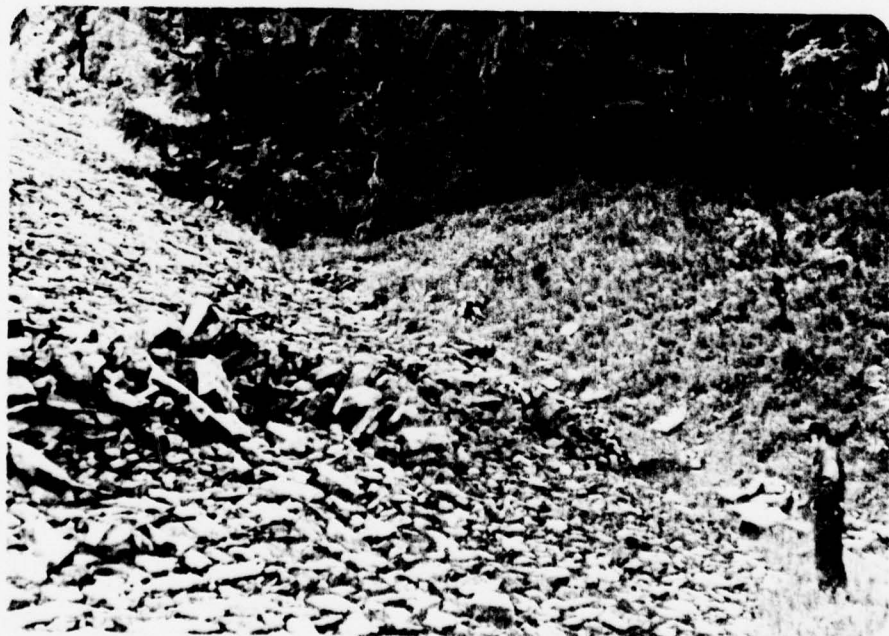
1. Two swampy areas were observed at the toe area of the dam; one located to the right of the center of the embankment adjacent to the toe and another near the left abutment about 120 feet from the toe. Only minor seepage (one to two gpm) was associated with these wet areas.
2. One of the wet areas near the left abutment contained acid mine drainage precipitate (yellow boy). However, the extent of precipitate accumulation is not considered to be significant.
3. Numerous bulges in the riprap on the downstream slope located near the toe of the dam were observed. The appearance of these bulges suggests that they are a result of buckling of the riprap layer as it moves downslope over the fill material.

3.2 Evaluation. In general, the condition of the dam is considered to be good. Minor seepages and wet areas located below the toe of the dam are not considered to have a significant effect on the stability of the dam at this time. The bulges on the downstream slopes appear to be a result of surficial sliding of riprap. No indications were found that these bulges are related to deep-seated slides in the downstream slope.

Photograph No. 6  
Typical bulges in downstream face riprap.

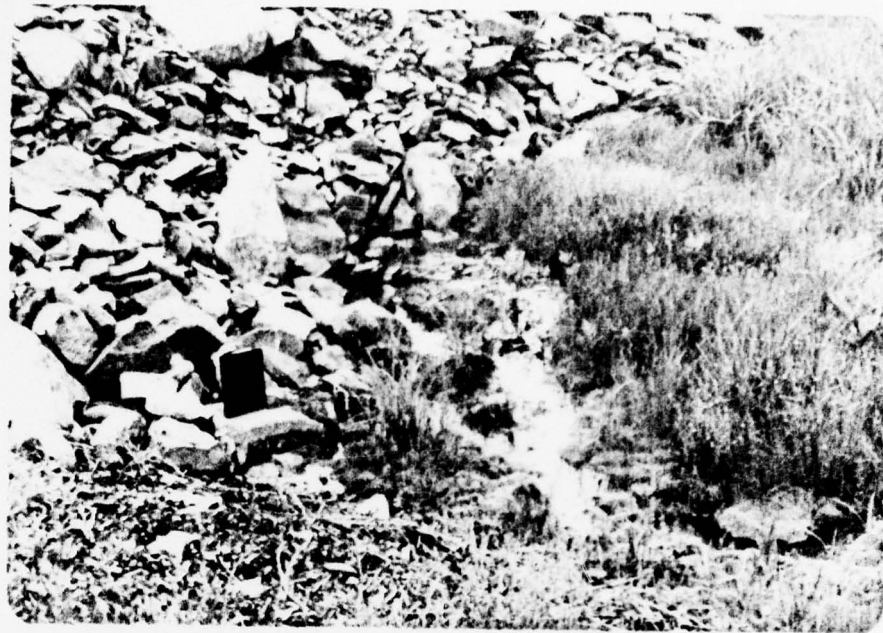
Photograph No. 7  
Seepage at toe.

4. It is recommended that the owner monitor and record seepage quantities regularly and observe the turbidity of the seeps. The condition of swampy areas in the vicinity of the toe should also be periodically observed. If the conditions worsen, remedial measures should be taken.
5. It is recommended that the owner should provide around-the-clock surveillance during unusually heavy runoff and develop a formal warning system to alert the downstream residents in the event of an emergency.
6. It is recommended that the owner be advised that the dam and appurtenant structures should be inspected regularly and adequately maintained.

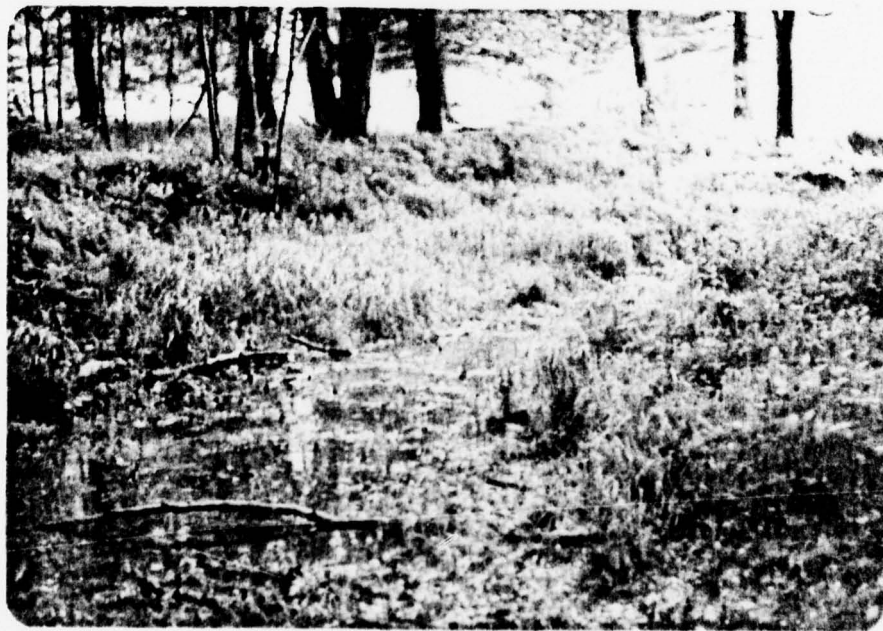
Photograph No. 8  
Seepage at toe (note yellow boy).

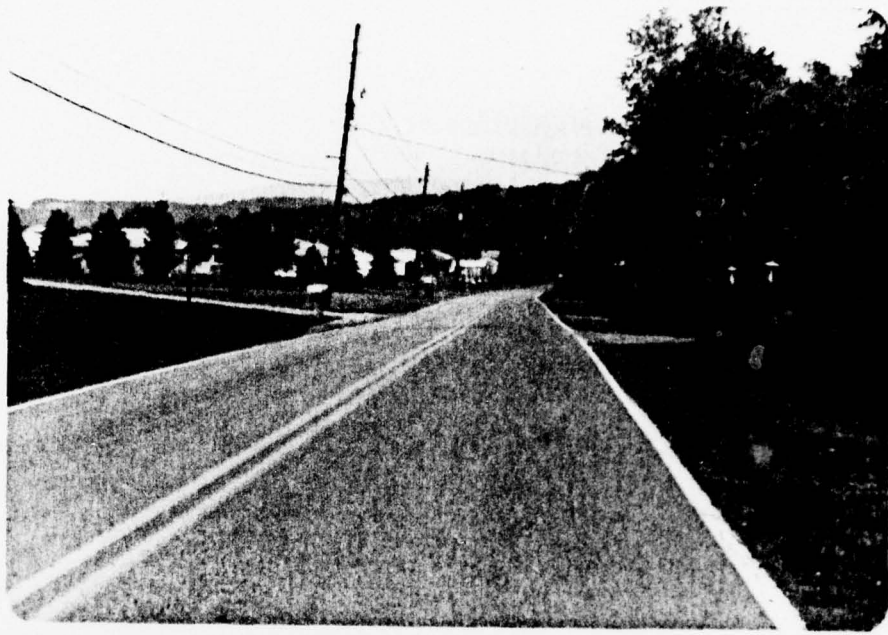
Photograph No. 9

Typical flood plain, two miles downstream.  
(Stream off the photograph on the right is  
approximately 10 feet below road level.)

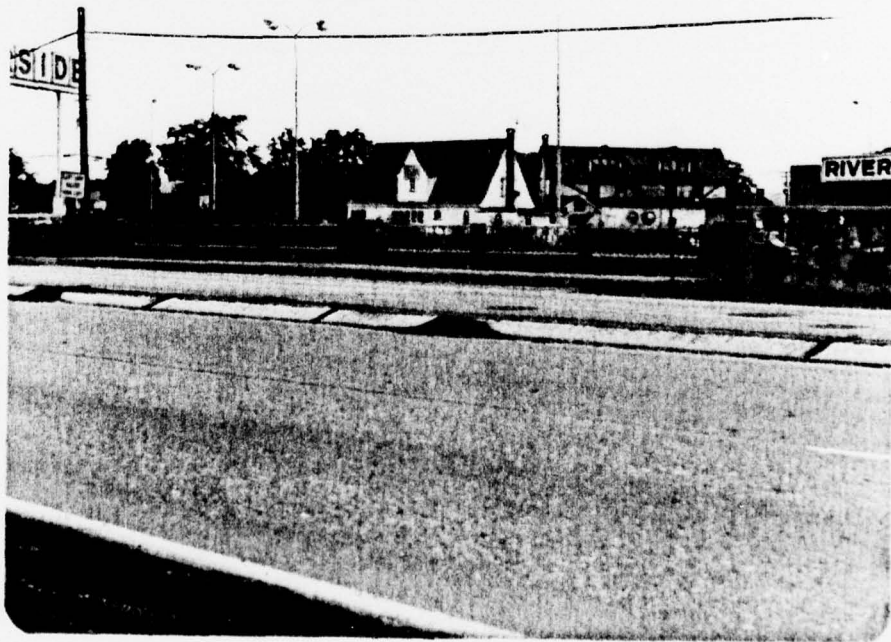
Photograph No. 10

Bridge on Blair Gap Run at Duncansville.  
(Route 220, 4 miles downstream.)
