PARKER POND  
NDI NO. MD 00085

PHASE I INSPECTION REPORT  
NATIONAL DAM INSPECTION PROGRAM

DEPARTMENT OF THE ARMY  
Baltimore District, Corps of Engineers  
Baltimore, Maryland 21203

Prepared By: Maryland Water Resources Administration  
AUGUST 1978

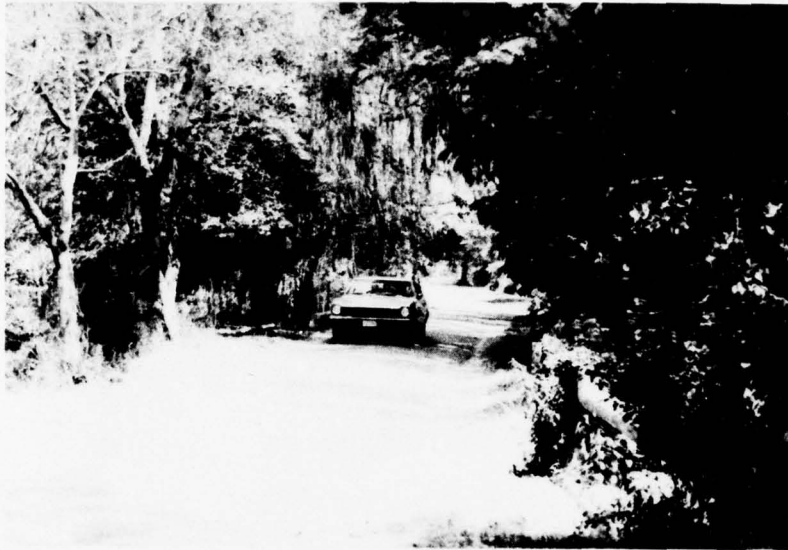
Top of dam  
east view

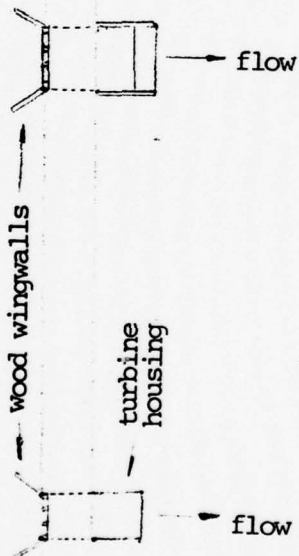
Top view Parker Pond 00085

unplanned overflow  
area along paved  
road

stream channels converge  
1/8 mile downstream

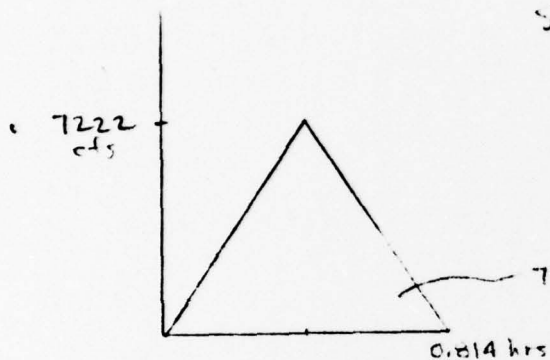
Assumed failure hydrograph

$$Y = 0.64 Y_0 = 0.64 \times 10 = 6.4 \text{ FT}$$

$$S_c = 24 V_b / Q_{max} = 24 \times 245 / 7222 = 0.814 \text{ hrs.}$$

∴ Beaglin Park will not overflow when it is at its O.H.W.  
and superimpose on top its assumed  
failure hydrograph from Parker Pond.
