LAKE PAHAGACO DAM

PHASE I INSPECTION REPORT

NATIONAL DAM INSPECTION PROGRAM.

Name of Dam: LAKE PAHAGACO DAM
State and State No. PENNSYLVANIA - 67-484
County Located: YORK
Stream: FIRST FORK BUNCH CREEK, SUSQUEHANNA
Date of Inspection: June 20, 1978

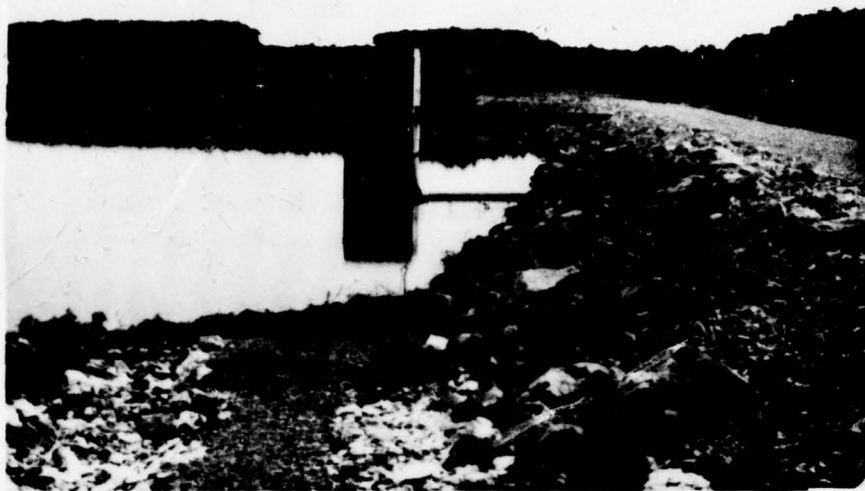
OVERVIEW
UPSTREAM
SLOPE

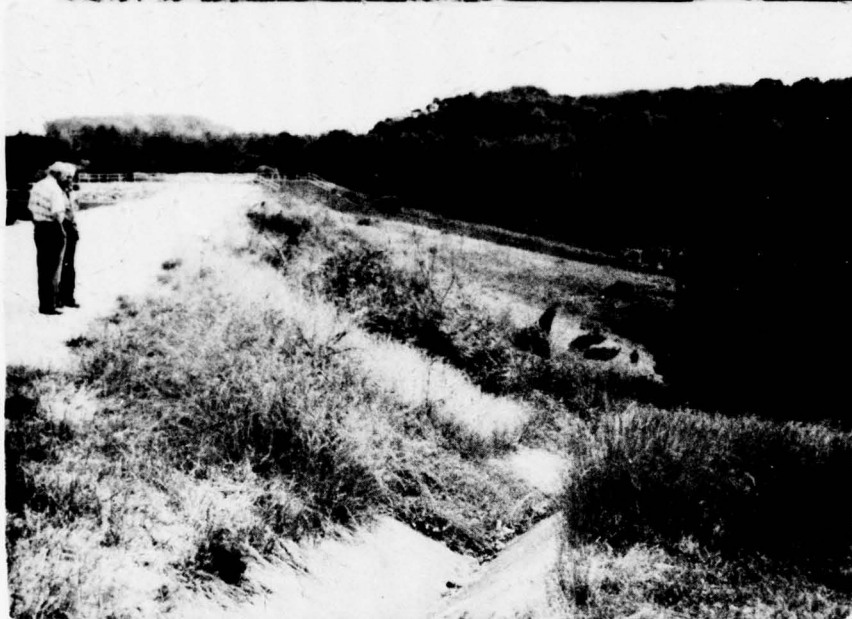
There are no visual indications of settlement or sloughing of the embankment slopes. There is, however, a sizable area of the downstream slope which was found to be wet during this inspection (June 20, 1978). The heavy growth on this slope makes it difficult to define the limits of this condition. Considerable records have been kept regarding leakage at the outlet structure and from the toe of the slope, up to 1978. Reference to slope seepage, however, has not been found in any of the available information. Removal of the growth on the downstream slope and further examination and study of this condition is recommended. The wet area on the downstream slope is of concern.

The inspection of the dam revealed a wet condition high on the downstream slope indicating seepage across the area. The heavy growth of weeds on the downstream slope makes it difficult to define the limits of this condition. Additional investigations to establish the source of this wet condition as well as its extent should be initiated by the owner.

Tall grass and brush on downstream slope made it difficult to observe slope condition. Wet areas were detected by carefully walking and pressing firmly onto the slope with one's foot.

DOWNSTREAM
EMBANKMENT

1. The the source and effect of seepage on the downstream slope be thoroughly investigated by the owner's consultant.
2. That the seepage from the toe and around the conduit be continued to be monitored on a monthly basis and be evaluated along with the slope seepage condition.
3. That the six foot weir across the outlet channel be reconstructed and monitored as part of the overall seepage investigation.

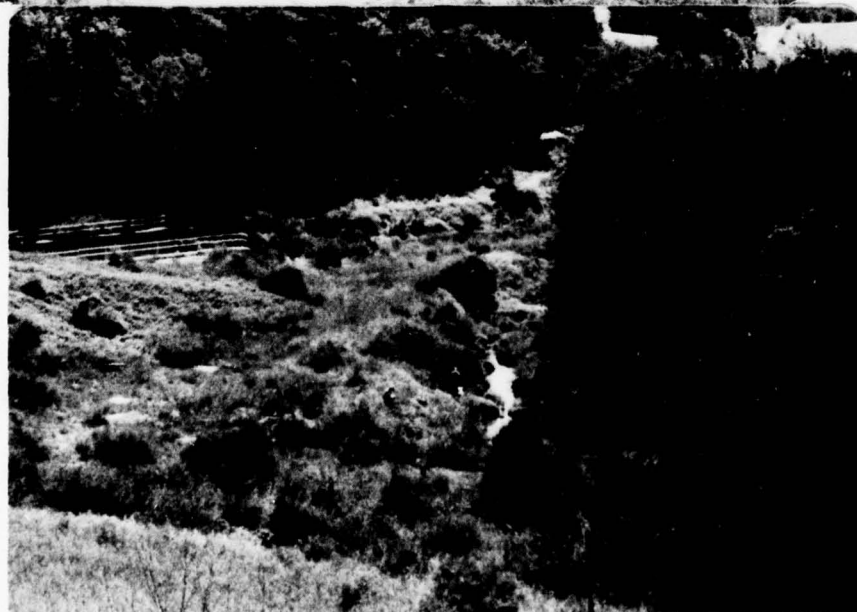
The intake structure, also founded on rock, is a concrete housing containing the outlet control gates and valve. It is accessible from a footbridge connected to the embankment. General condition is very good. A 48-inch diameter discharge pipe leads to the outlet structure which is a concrete impact basin type. The outlet is about 325 feet downstream from the intake control tower. The condition of the outlet facilities is also good.

SPILLWAY &
CONDUIT
OUTLET

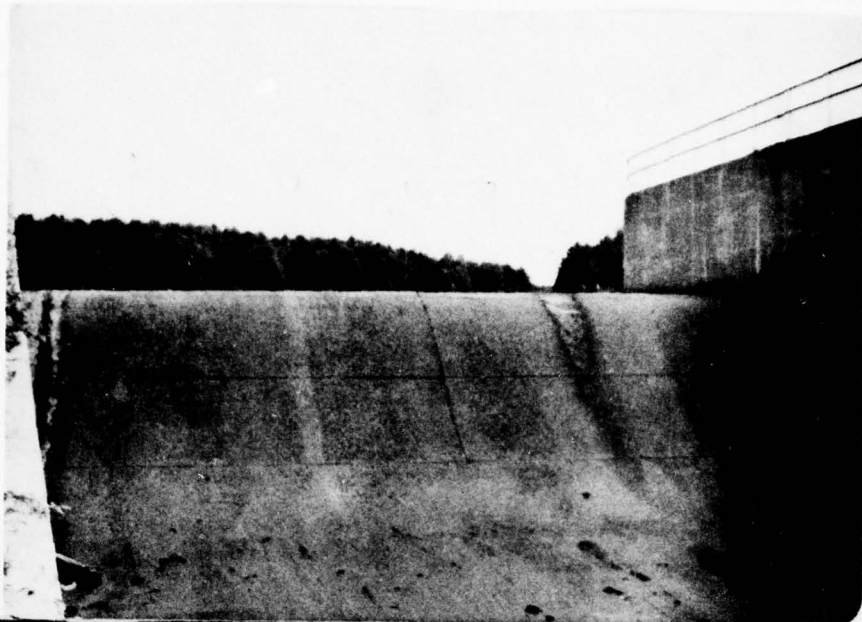
The spillway is a concrete ogee type and is founded on rock with a concrete curtain wall on the upstream face extending 6 feet into the rock. The crest is 50 feet in length between abutment walls. The walls extend 10 feet above the crest. The wasteway channel tapers and leads to the stilling basin 400 feet downstream. All features of the spillway are in good condition.

SPILLWAY
WEIR

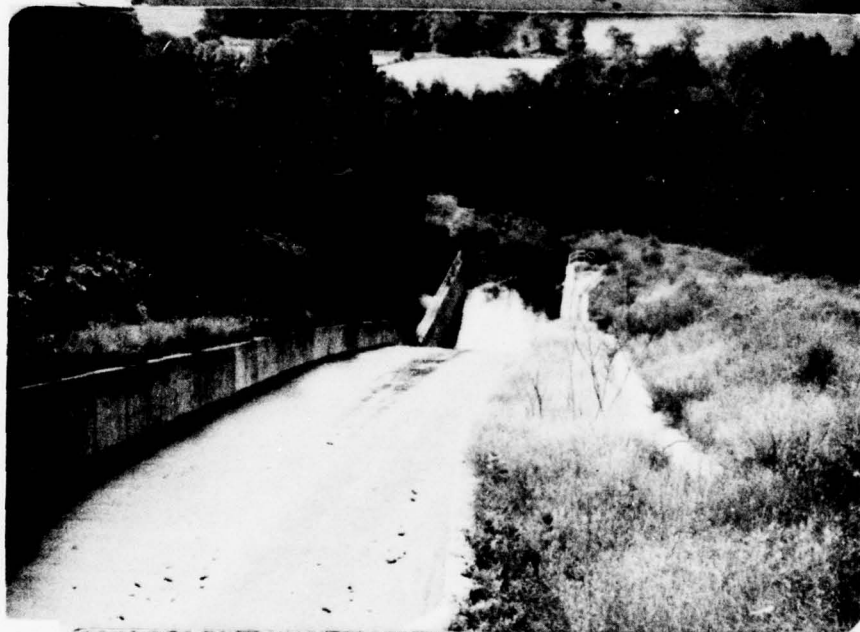
The spillway is in excellent condition as are the walls and slab of the spillway channel and the stilling basin.

SPILLWAY
CHUTE

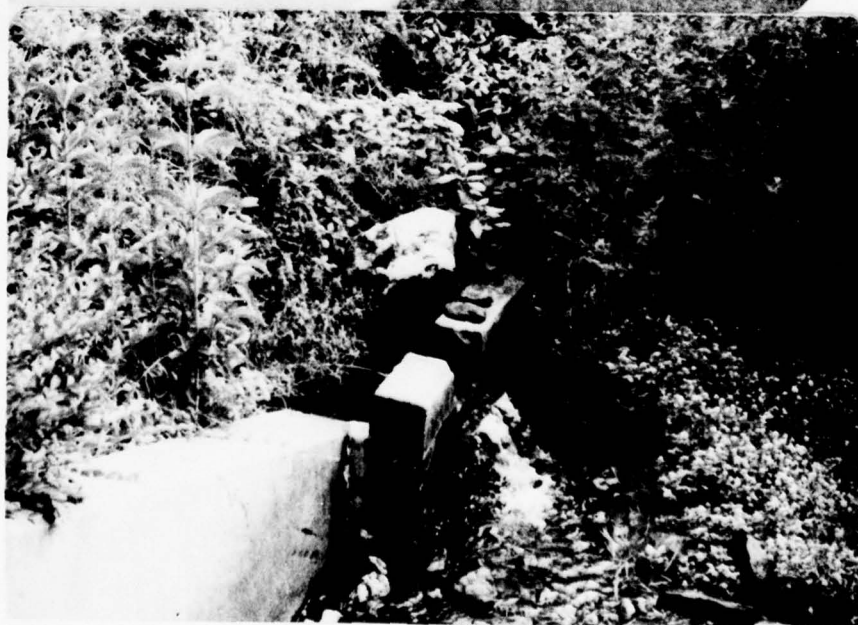
Three concrete weirs are located in the area of the outlet structure. Another deteriorated wooden weir is located across the outlet channel. It is not operable.

CONDUIT
WEIR
