TWO LICK CREEK DAM

NDI No. Pa. - 285

PHASE I INSPECTION REPORT
NATIONAL DAM INSPECTION PROGRAM.

Two Lick Creek Dam
Pennsylvania
Indiana County
Two Lick Creek Dam
11 August 1978

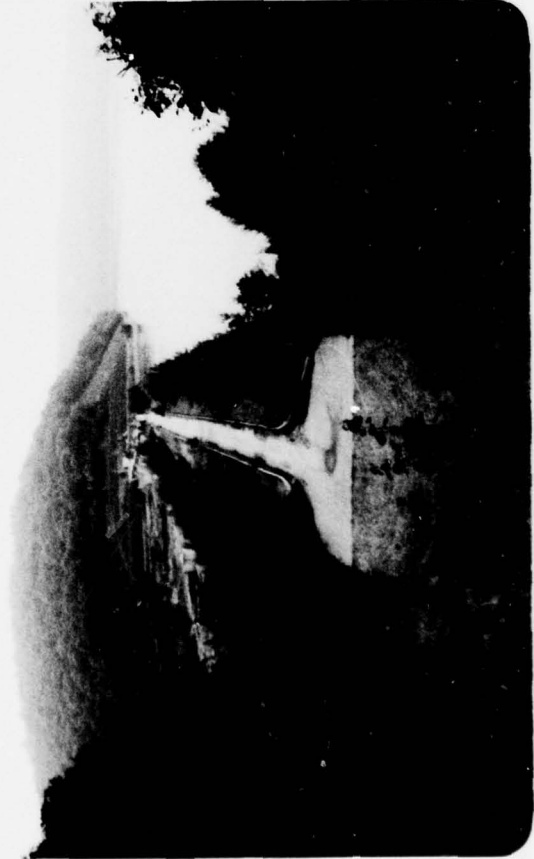
PHOTOGRAPH 3 View of the crest of Two Lick Creek Dam taken from the left abutment.

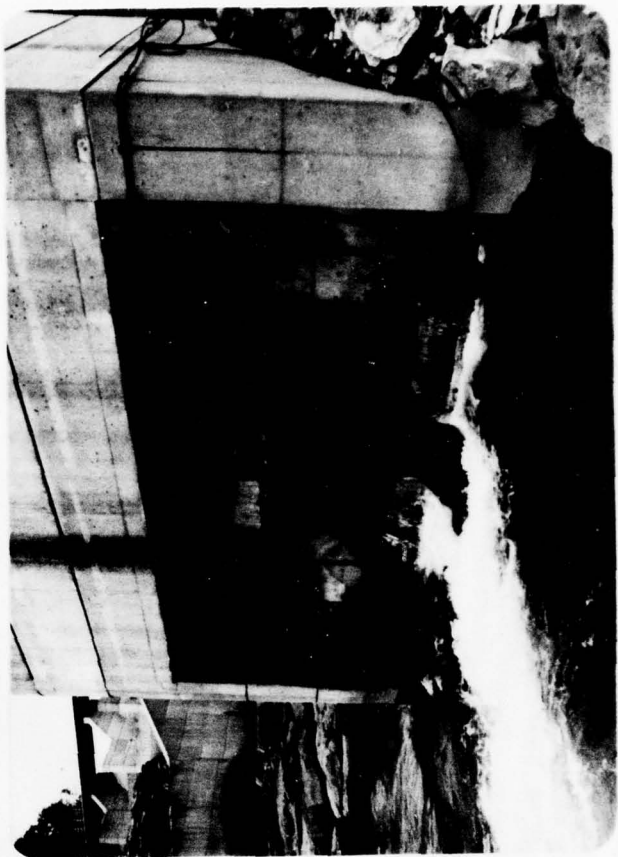
PHOTOGRAPH 8 View of the outlet end of the discharge tunnel at the Two Lick Creek facility.

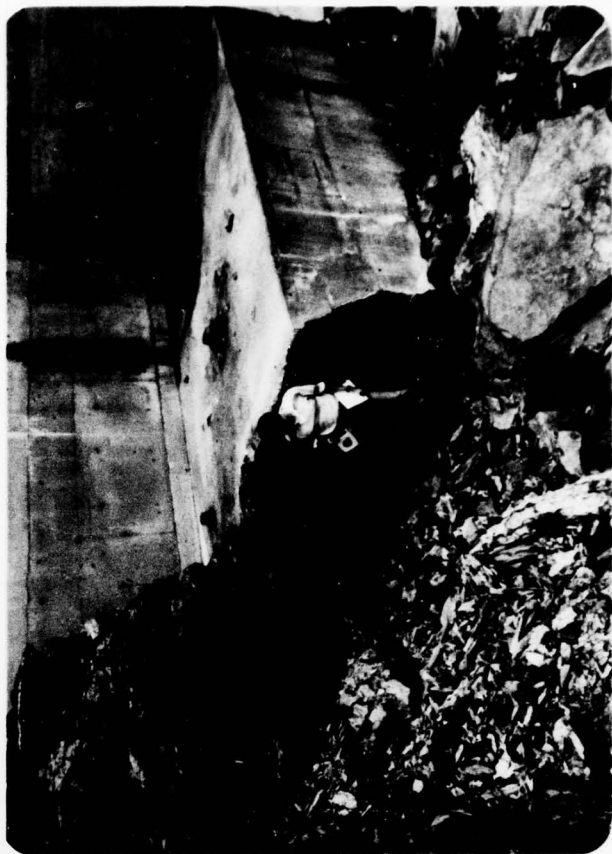
The portion of the downstream channel which is not in good condition is that area immediately beyond the emergency spillway (Bays 1, 2, and 3). Significant erosional damage occurred as a result of the July 1977, flood (see Photographs 11 and 12, Appendix D). The area, nevertheless, appears sound in spite of the damage. All concrete sections of the embankment remained intact.

Bays 1, 2, and 3 have no well defined discharge channels and merely discharge flow onto the right abutment hillside. The rains which caused the Johnstown Flood of 1977 caused Bays 1, 2, and 3 to discharge. The result was extensive damage to the area immediately beyond the spillway bays. Much of the rock was stripped away by the flood waters.

PHOTOGRAPH 12 View of erosion damage at the intersection of the emergency spillway and the rock abutment. A coal seam was eroded out in this area.

d. The owner implement remedial measures to repair damage to the right abutment (emergency spillway outlet).

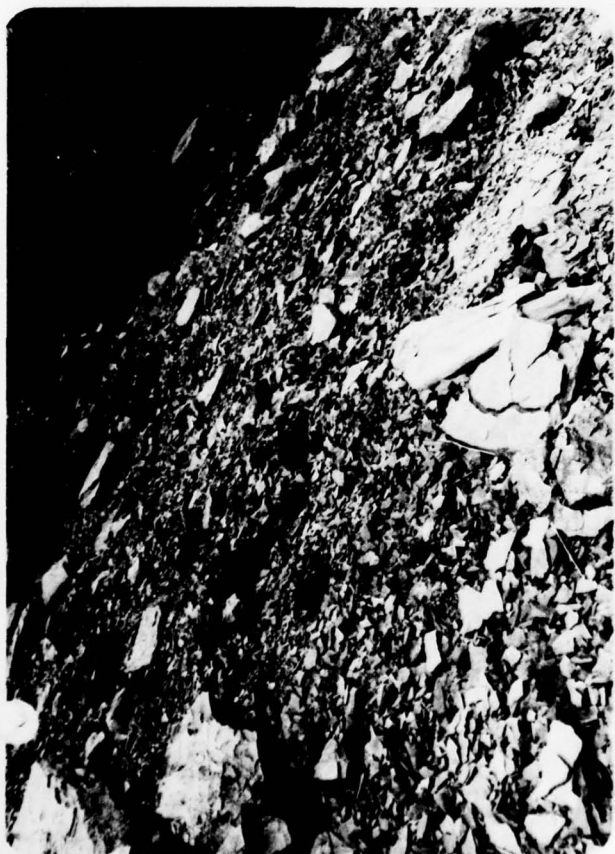
PHOTOGRAPH 9 Close-up view of materials comprising the downstream face of the earth section of Two Lick Creek Dam.

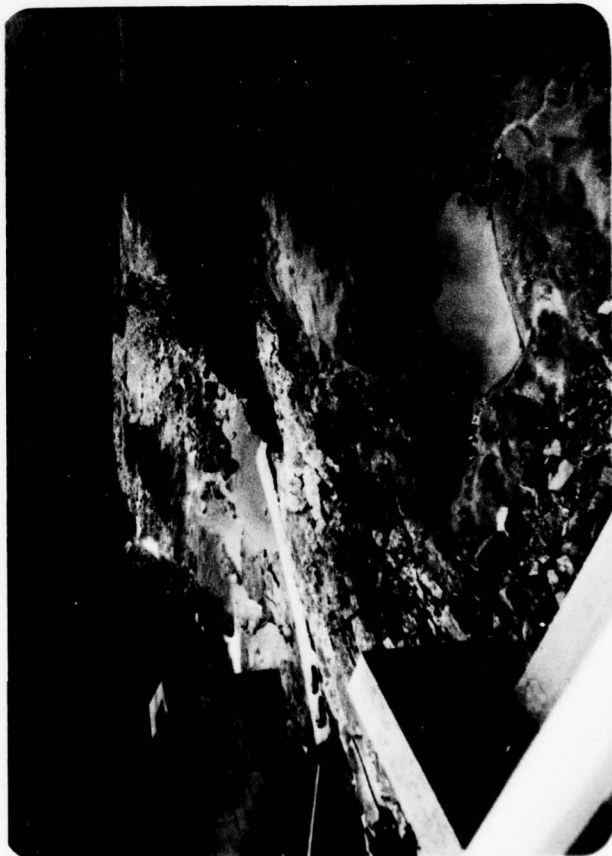
PHOTOGRAPH 11 View of erosion in the rock channel at the outlet of the emergency spillway (foreground). The pool of water and earth dike mentioned in the previous photograph can be seen in the left background. Note the character of the valley just downstream of the dam.
