HUNTSVILLE DAM

NDS ID NO. PA-00553

PHASE I INSPECTION REPORT

NATIONAL DAM INSPECTION PROGRAM

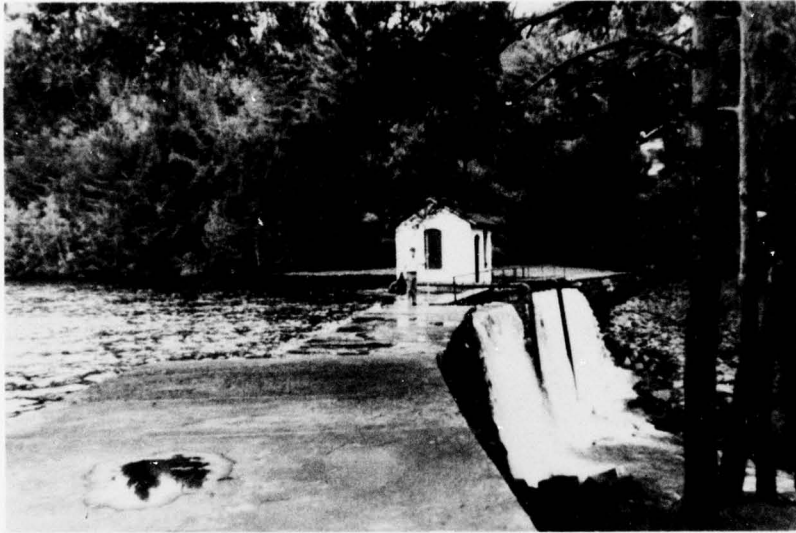
(4) Vertical variations of +2 inches were noted for the capstones across the lengths of the various sections. One capstone on the crest of the right auxiliary spillway section was broken (Photograph E). It was also observed that the capstones on the crest of the right auxiliary spillway overhung the downstream face by a larger amount than those on the left auxiliary spillway. The caretaker said that the stones have been displaced laterally by ice forces. Mortar was missing from some of the joints between the capstones. Views of the top of the structure are shown on Photographs A, B, C, and E.

(1) It was noted that the operating floor of the gatehouse is situated at the same elevation as the crest of the auxiliary spillway (Photographs A and B). Consequently, if the reservoir level were at top of dam, the operating floor would be submerged to a depth of 2 feet.

A. Top of Dam and Auxiliary and Main Spillways. Access to Gatehouse is Plank Footbridge Over Main Spillway.

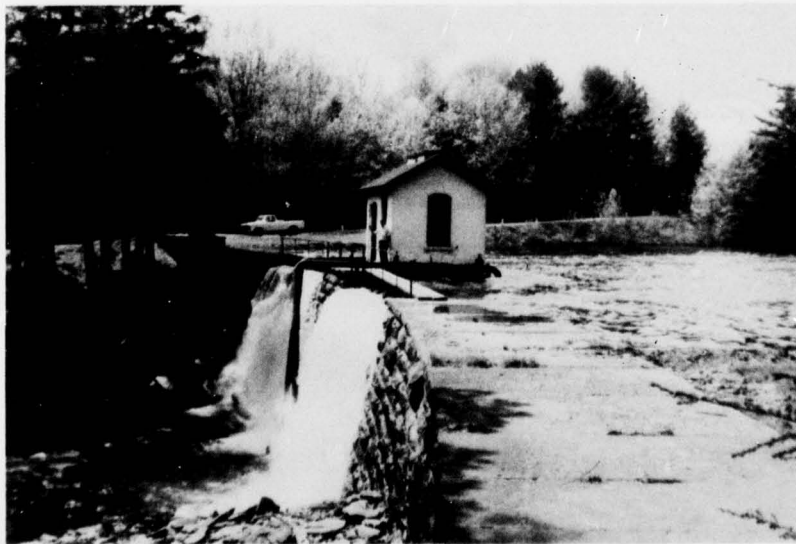
(3) It was observed that the roadway adjacent to the right abutment is about 2 feet lower than the top of the dam, and a 30-foot long ridge of ground at the same elevation as top of dam prevents overflow around the right end of the dam. If the dam were overtopped, the overflow around the right end of the dam would go onto the roadway and travel along it for some distance downstream from the dam. A view of the right abutment area is shown on Photograph B.

B. Downstream Face of Dam. Looking Toward Right Abutment.

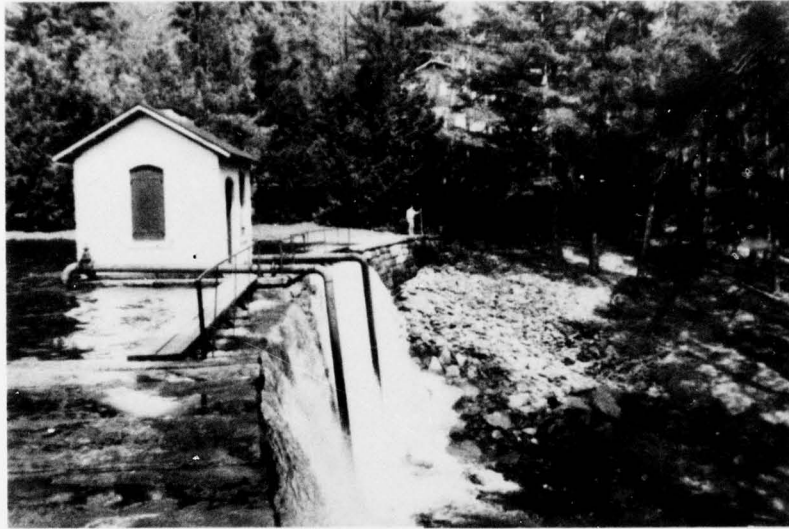
C. Downstream Face of Dam,  
Left Abutment and Riprap at  
Downstream Toe of Left Auxiliary Spillway.

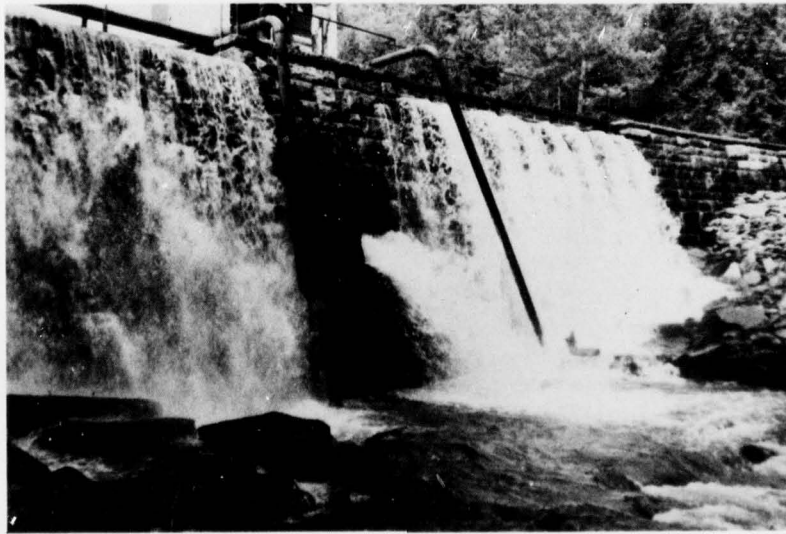
D. Upper Outlet Conduit During Operation.  
Leakage from Dam Visible Above Conduit.

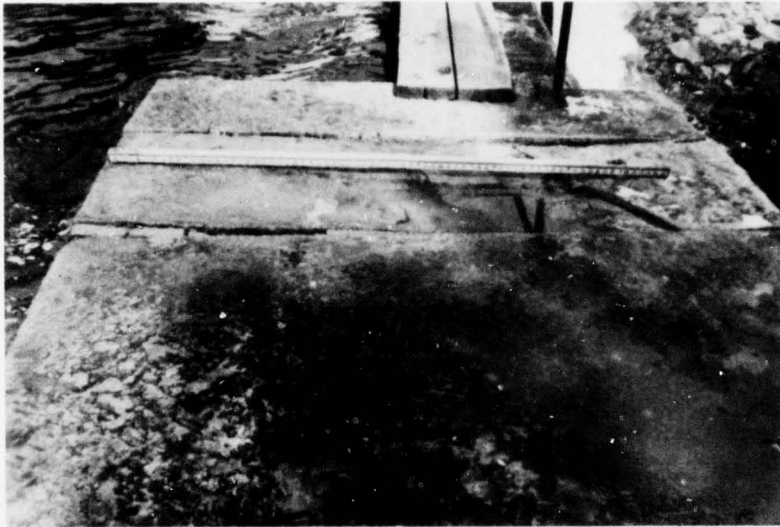
(3) The vertical irregularities of the capstones on the structure have little consequence. The lateral displacement apparently caused by ice forces indicates that the stones are not properly secured to the underlying structure. These capstones are primarily for appearance sake, and even if they were completely displaced it is doubtful that the underlying structure would be affected.

E. Broken Capstone and Missing Mortar  
at End of Right Auxiliary Spillway

- (1) Monitor condition of mortar in joints and amount of seepage from downstream face and make repairs when necessary.
- (2) Make repairs to capstones on crest of structure.
- (3) Excavate high area in approach channel of left auxiliary spillway.

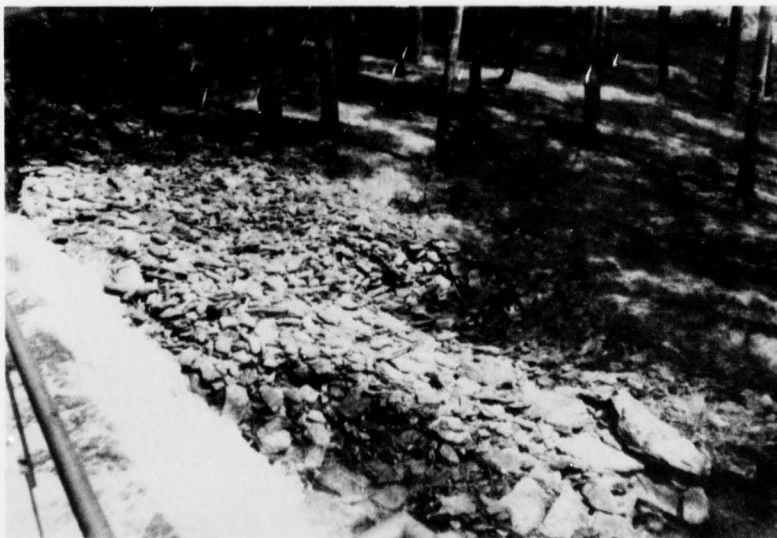
F. Sandstone Riprap Below Left Auxiliary Spillway

(4) Repair area at toe of left auxiliary spillway where riprap is displaced. Some larger stone should be provided.

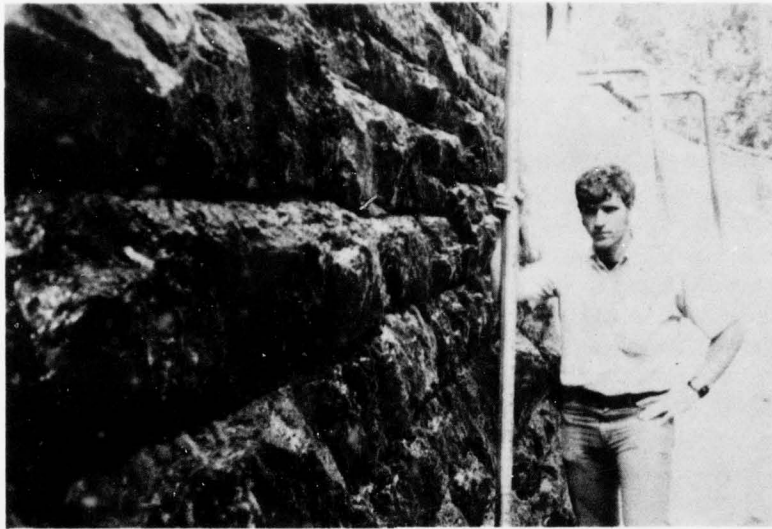
(2) The mortar in the joints on the downstream face of the structure was generally cracked and loose or missing altogether (Photograph G). Seepage was observed over most of the downstream face, and it ranged from drips to concentrated flows of up to 5 gpm. The largest single leak was located near the top of the raised center section between the two sections of the main spillway (Photograph D). This leak was estimated to be about 25 gpm. It should be noted that too much flow was going over the main spillway sections to determine the condition of the downstream face in those reaches. The amount of flow also made it impossible to inspect the toe of the main spillway for undermining. The leakage from the downstream face entered either the natural stream channel or the slope protection adjacent to it. No apparent damage to other features has resulted from the seepage. The caretaker said that the dam was routed and the joints on the downstream face were repointed in 1962. He said that the leakage at that time was considerably greater than that observed during this inspection and that the repair work stopped almost all of the leakage.

(1) The condition of the mortar in the joints on the downstream face of the structure and the leakage therefrom did not appear to have progressed to the extent that the integrity of the structure is in question. However, the condition is undesirable and will worsen in time.

G. Loose and Missing Mortar at Masonry Joints  
on Downstream Face of Right Auxiliary Spillway

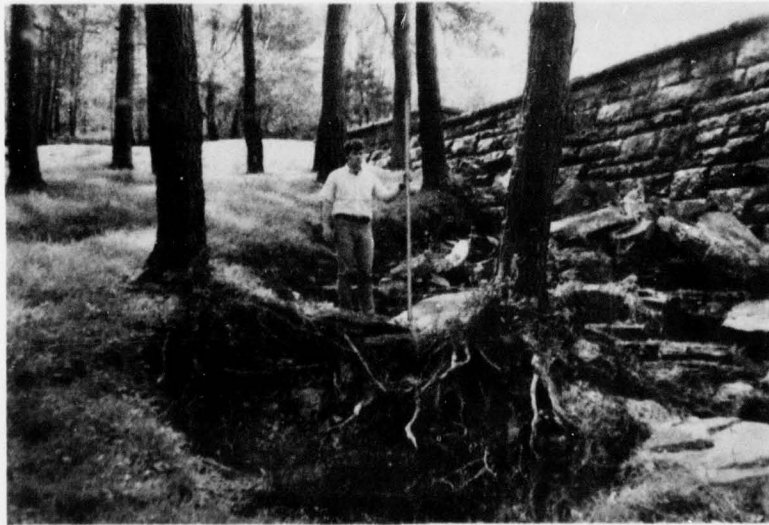
H. Eroded Area Downstream from  
Right Auxiliary Spillway

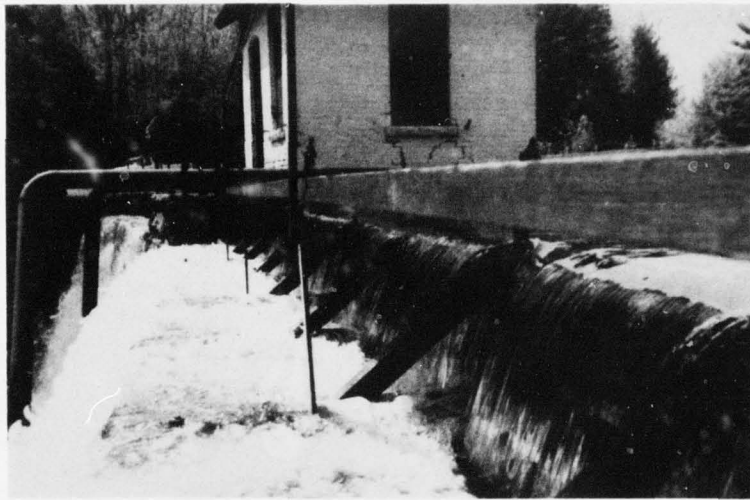
3 x 3 x 1/4 steel angles that are bolted to the main spillway crest, and additional support was obtained by bolting them to the three bridge supports, which are, in turn, bolted to the main spillway crest. The angles supporting the flashboards on the left main spillway section are slightly smaller, but seven of them were used instead of four as used on the right side. The flashboards on the left main spillway section are also bolted to three bridge supports (Photograph I). The caretaker said that the flashboards were not designed to fail and that they are kept in place throughout the year. He said that the flashboards were not removed and did not fail during the June 1972 Flood, which caused a depth of water over the flashboards of about 1.8 feet.

(6) The effect of the flashboards on the main spillway crest is reduced spillway capacity. Flashboards are normally designed to fail when the pool rises to a certain level above the top of the flashboards. It is also normal operating procedure to remove the flashboards during the winter and spring months when the threat of a flood is generally the greatest.

I. Flashboards on Main Spillway

- (1) Remove flashboards from main spillway crest.
- (2) Develop a detailed emergency operation and warning system for Huntsville Dam.
- (3) Repair slide gate on lower outlet conduit.
- (4) Perform additional in depth studies of hydrology and hydraulics to more accurately ascertain the required spillway capacity for Huntsville Dam and the nature and extent of remedial measures required to make the spillway hydraulically and structurally adequate to pass the PMF.

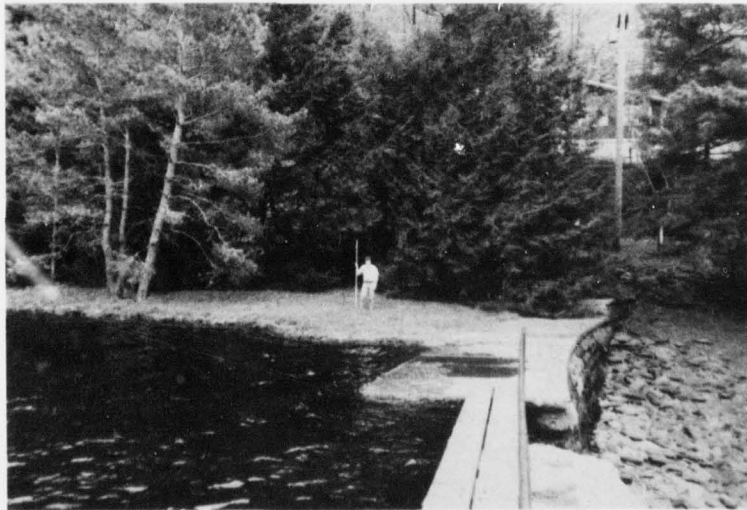
J. Left Auxiliary Spillway Approach Area
