BUTLER STORAGE RESERVOIR DAM
WARREN COUNTY, NEW YORK

PHASE I INSPECTION REPORT
NATIONAL DAM SAFETY PROGRAM

Prepared by
CONVERSE WARD DAVIS DIXON
CONSULTING ENGINEERS
91 ROSELAND AVENUE, P.O. BOX 91
CALDWELL, NEW JERSEY 07006

For
DEPARTMENT OF THE ARMY
NEW YORK DISTRICT, CORPS OF ENGINEERS
26 FEDERAL PLAZA
NEW YORK, NEW YORK 10007

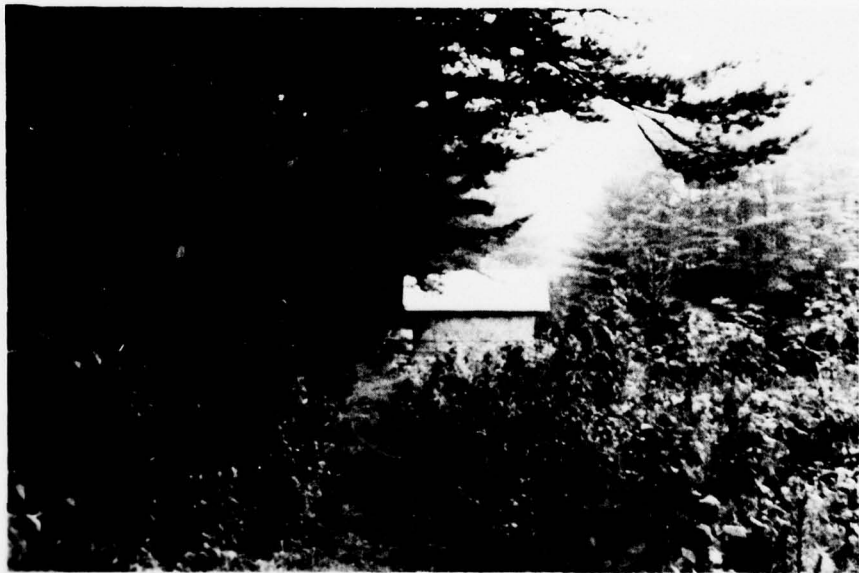
As is obvious from Figures 1 and 2, the downstream slope of the dam is heavily wooded, and supports a stand of red pine trees. The roots of these trees can be seen extending transversely across the surface of the roadway on the crest in Figure 2. Also shown in Figure 2 is the beginning of some brush and tree growth on the upstream slope. We were informed by GFWD personnel that vegetation on the upstream face was trimmed annually, although trees more than 10 feet tall were noted on the upstream face at the left abutment (Refer to Overview Photo).

FIGURE 2 ACCESS ROAD ON CREST OF DAM

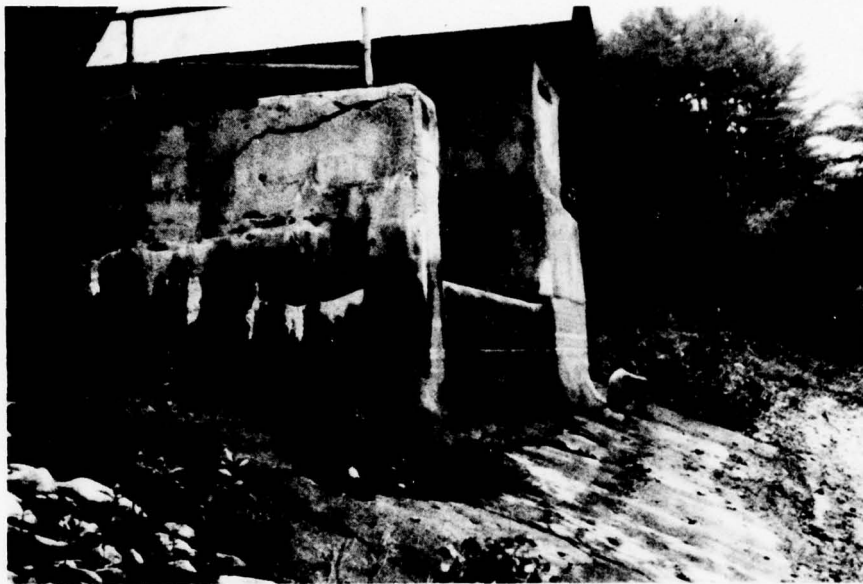
i) There is moderate spalling and cracking of the apron, with vegetation beginning to grow in the spalls and cracks (Fig. 4, Appendix D).

iii) The spillway itself appears to be in generally good condition with only minor cracking and scaling of the left pier (Fig. 4, Appendix D).

FIGURE 4 OVERFLOW SPILLWAY AND GATE HOUSE

1) The junction between the spillway/gate house superstructure and the concrete apron on the upstream slope should be repaired.

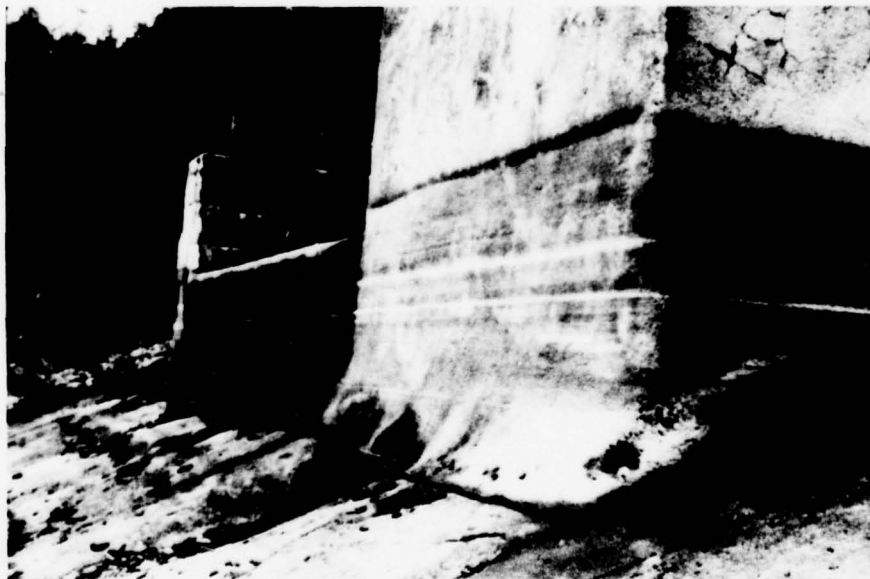
ii) The junction between the apron and the spillway/gate house superstructure is cracked with portions of previously applied gunite breaking off (Fig. 5, Appendix D).

FIGURE 5 OVERFLOW SPILLWAY

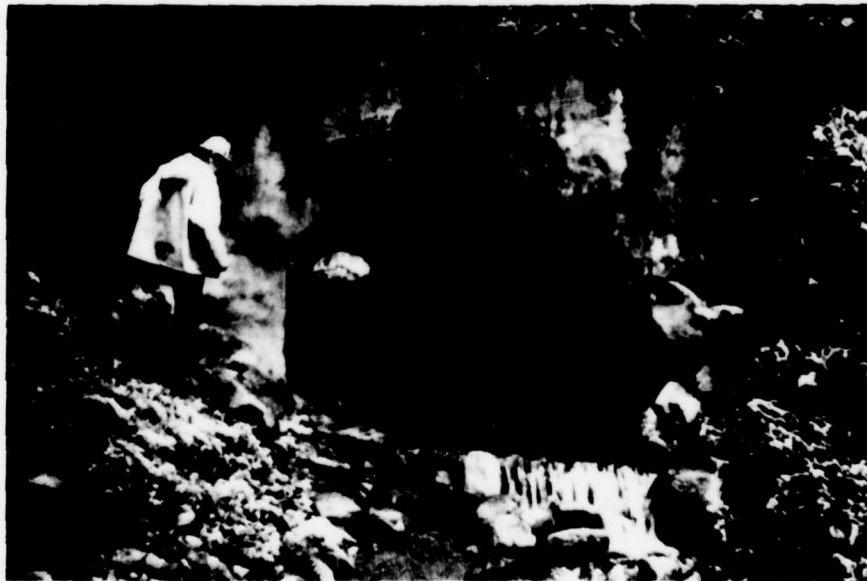
FIGURE 9 EXIT PORTAL OF OUTLET TUNNEL

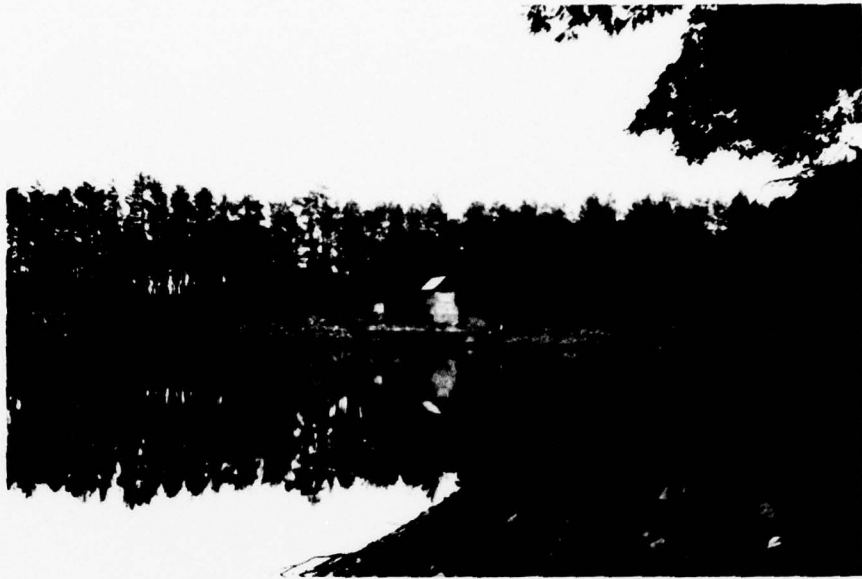
The reservoir area is heavily wooded. Slopes along the banks are approximately 3 vertical to 4 horizontal up to the high water mark (Fig. 10, Appendix D). They then increase to about 1 vertical to 1 horizontal and there is evidence of creep at the tree line (Fig. 11, Appendix D). Based on our field observations and examination of stereo pairs of air photos, there is no evidence of sloughing or sliding failures of the slopes or indications of significant siltation of the reservoir.

FIGURE 10 SLOPES ALONG RIGHT SHORELINE
