PUTNAM LAKE DAM

PUTNAM COUNTY, NEW YORK

INVENTORY NO. N.Y. 90

**PHASE I INSPECTION REPORT
NATIONAL DAM SAFETY PROGRAM**

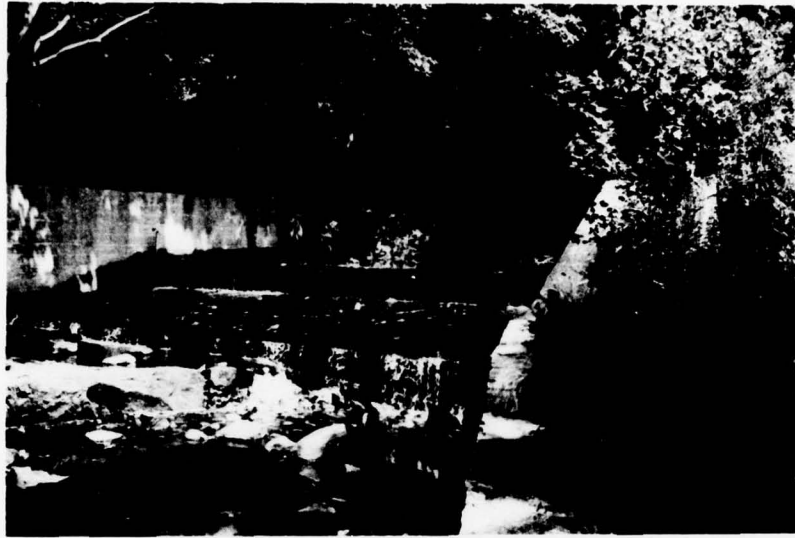
The spillway is in satisfactory condition. Two cracks in the east wall have been repaired. There were four sockets in the crest of the concrete spillway and anchor bolts on the side walls where supports for flashboards may have been located at one time. A pipe extending about two feet above the spillway crest was located in one socket on the west end. There was no other evidence of flashboards being used.

SPILLWAY AND APRON
(Looking West)

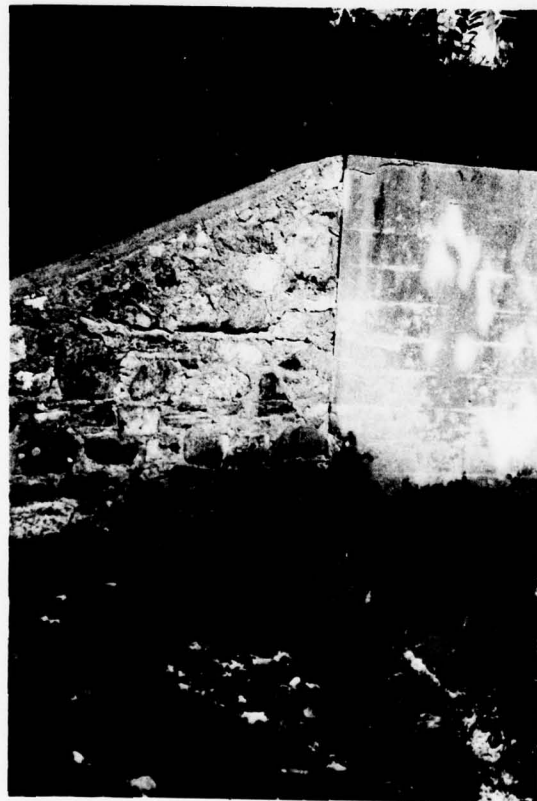
SPILLWAY CHANNEL WALL-SPILLWAY WALL
(Looking West)

(6) Condition Around SPILLWAY
WEST - SATISFACTORY ; WALL EXTENDS INTO EMBANKMENT
EAST - SOME EROSION IMMEDIATELY BEHIND CONC. WALL
DEPTH - 1.5' BELOW TOP WALL
