5 Name Of Dam: DAM ON THE HEADWATERS OF SQUALL CREEK
3 Location: PATRICK COUNTY, VIRGINIA
8 Inventory Number: VA 14104

PHASE I INSPECTION REPORT

NATIONAL DAM SAFETY PROGRAM

FEBRUARY 1978

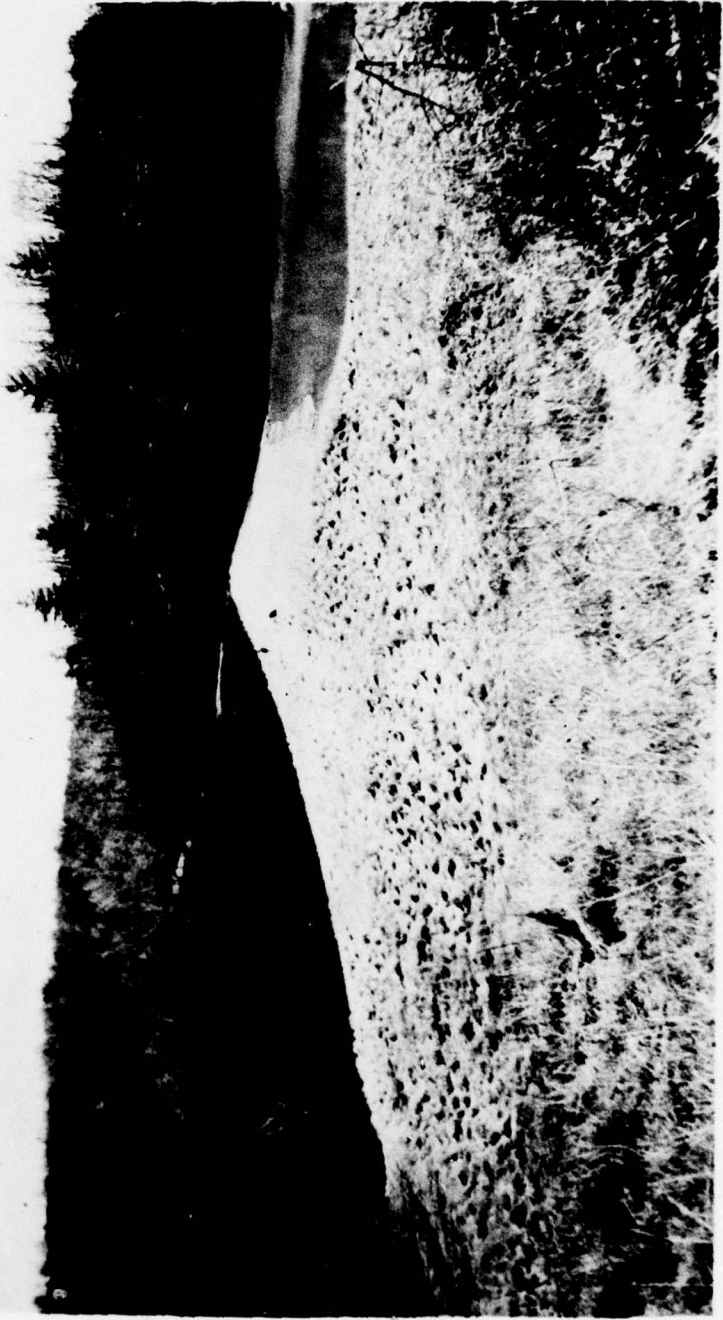
DAM ON THE HEADWATERS OF SQUALL CREEK - OVERVIEW OF DAM FROM LEFT ABUTMENT

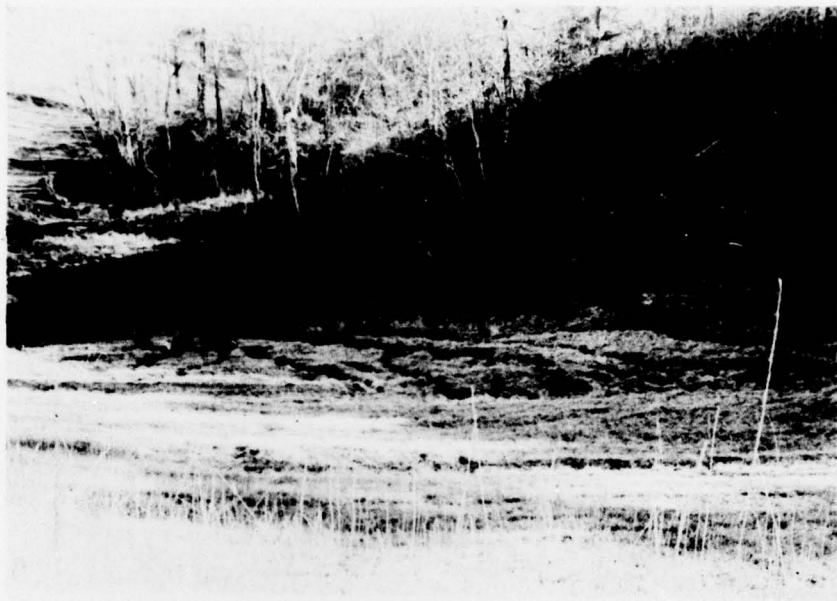
3.1.2.1 Embankment. The earth fill dam was constructed from local residual material which had been weathered from underlying schist or phyllite bedrock. The only sign of distress on the embankment was the severe erosion on the downstream slope. The erosion gullies ranging in depth from 6 inches to 3 feet were more pronounced near the abutment contacts where surface runoff was being channeled from the abutment slopes. Vegetative cover ranged from adequate near the dam crest to nonexistent in the areas of severe erosion. The visible portion of the upstream slope was 4h to 1v.

VIEW LOOKING DOWNSTREAM FROM CREST OF DAM - NOTE EROSION
ON THE DOWNSTREAM SLOPE

7.2 Remedial Measure. The severe erosion problem should be addressed immediately to prevent further slope deterioration. After filling and seeding the existing gullies, measures should be taken to prevent erosion while the vegetative cover is being established. In an effort to prevent further erosion, surface runoff from the adjacent abutments should be redirected away from the embankment slopes.

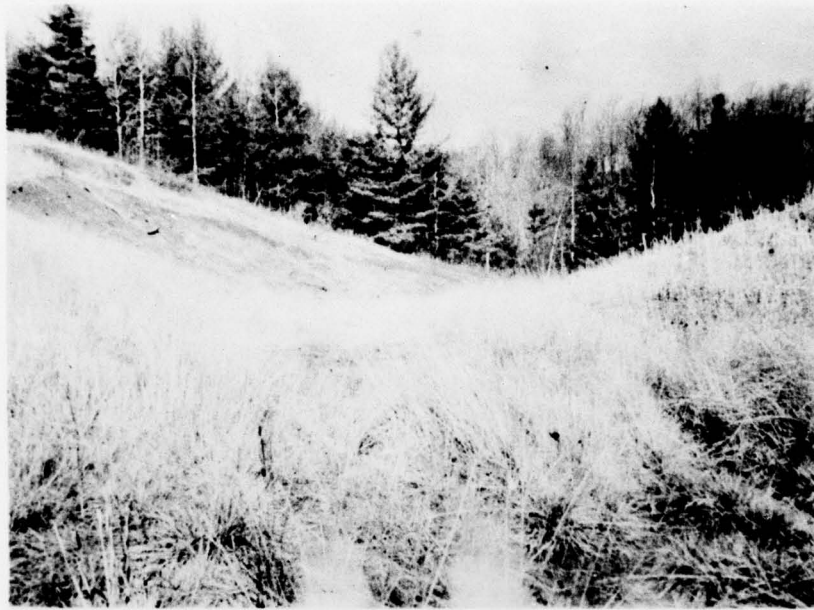
APPROACH CHANNEL There is very little vegetative cover within the spillway channel. Some rock outcrops are present.

VIEW OF SPILLWAY - LOOKING DOWNSTREAM FROM UPSTREAM ENTRANCE

The crest of the spillway is approximately 4 feet below the crest of the dam. It is recommended that a vegetative cover be established in the spillway to minimize erosion.

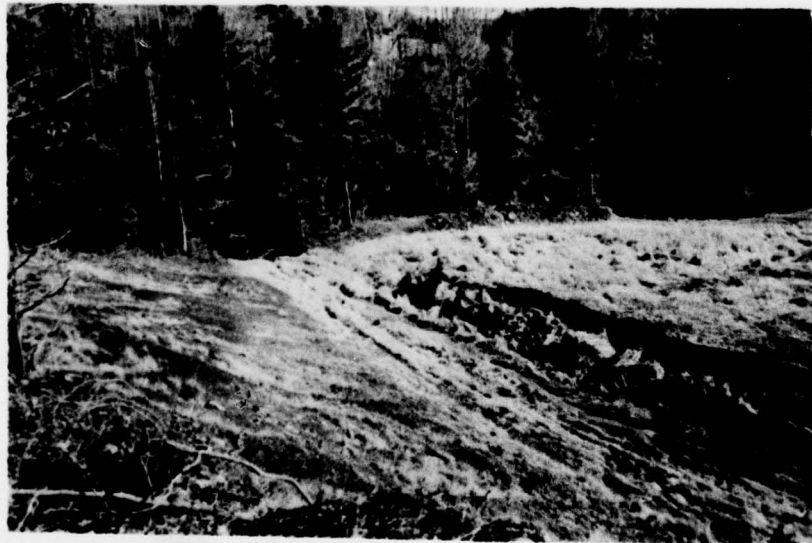
The approach channel is approximately 300' long and drops approximately 5.5' from influent to discharge. The spillway discharges into Squalls Creek down a slope of 1v to 1h.

VIEW OF DOWNSTREAM END OF SPILLWAY LOOKING EAST

The spillway discharges into Squalls Creek proper, thereby, minimizing the effect on the dam. The sides of the channel near the discharge point should be built up to prevent water from spilling over onto the left abutment/embankment contact.
