HUDSON RIVER BASIN
WATERVLIET RESERVOIR DAM
ALBANY COUNTY, NEW YORK
INVENTORY NO. 88

PHASE I INSPECTION REPORT
NATIONAL DAM SAFETY PROGRAM

LOWER HUDSON RIVER BASIN
WATERVLIET DAM
INVENTORY NO. 88
PHASE I INSPECTION REPORT

Name of Dam: WATERVLIET (I.D. NO. 88)
County Located: ALBANY COUNTY
Stream: LOWER HUDSON RIVER
Date of Inspection: 5 - 6 JUNE 1978

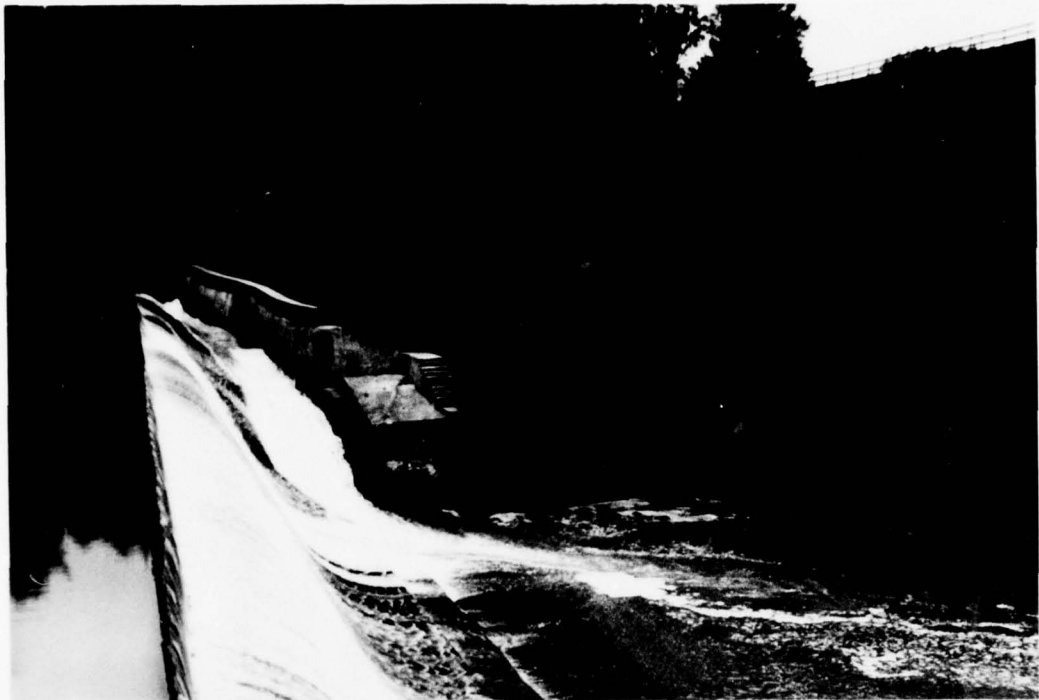
The training wall at the north abutment is in a similar condition with wire mesh exposed from under the eroded gunite layer on the concrete apron in this area.

DOWNSTREAM TRAINING WALL AT NORTH ABUTMENT. NOTE EROSION OF CONCRETE AT BASE OF WALL (SEE NEXT PHOTO), BEDDING PLANES OF SHALE, AND RAILROAD BRIDGE DOWNSTREAM.

b. The concrete training wall and rock erosion at both abutments should be repaired.

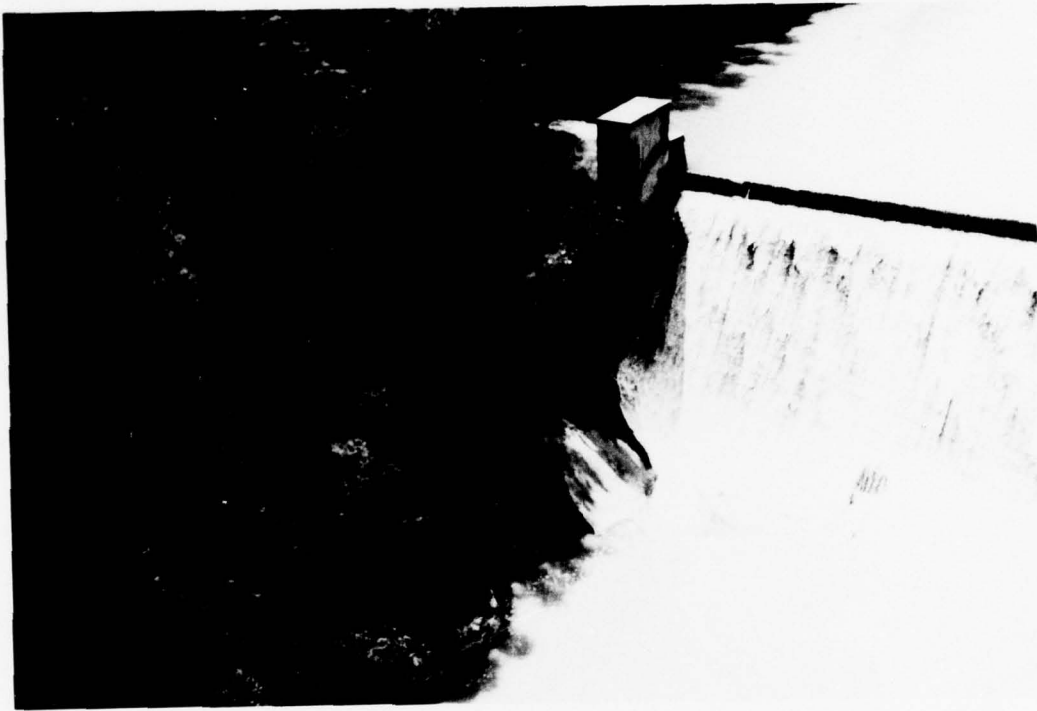
DOWNSTREAM TRAINING WALL AT SOUTH ABUTMENT SHOWING
ENTRANCE TO DAM. NOTE EROSION OF CONCRETE AT BASE OF
WALL (SEE NEXT PHOTO).

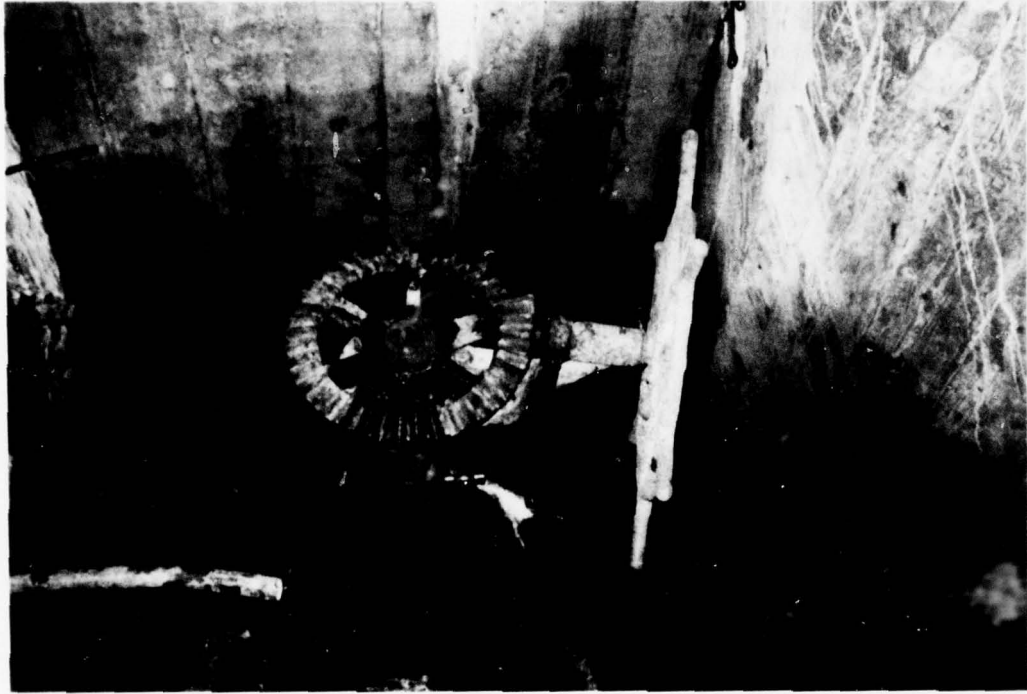
The sluice gate was completely submerged, not allowing for inspection. The gate stand operator was lubricated and appeared to be in operating order, although the gate was difficult to operate. No leakage at the operating stand was observed.

VALVE STEM OPERATOR FOR SLUICE GATE ON LOW
LEVEL OUTLET.

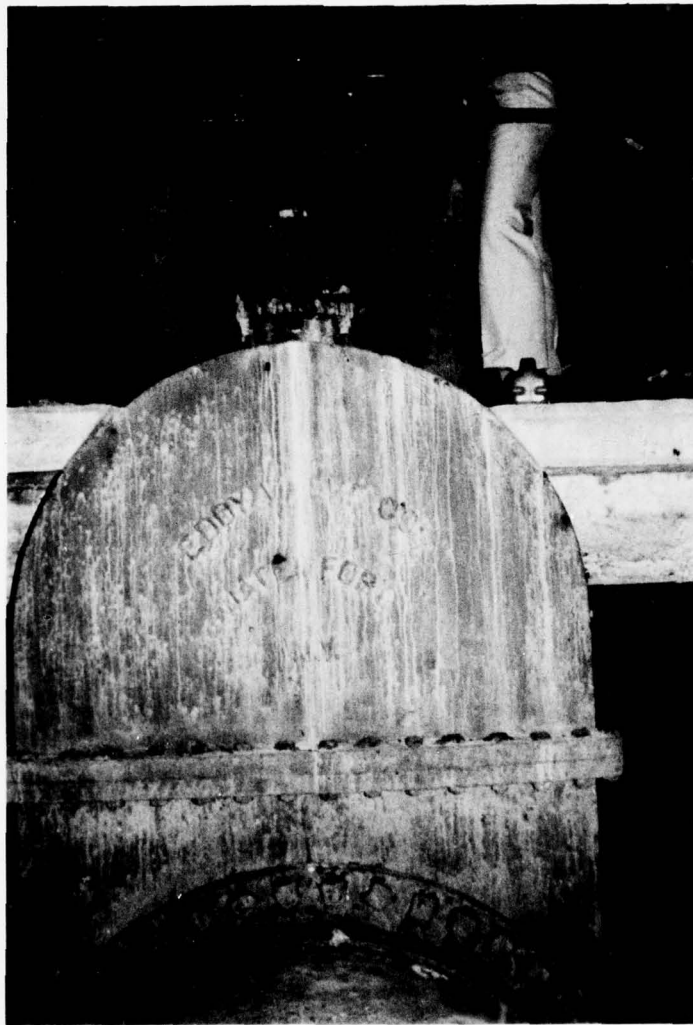
The gate valve appeared to be in good condition. The gear actuator was clean and lubricated and appeared to be completely operable. About 1964, the valve stem was replaced. During the inspection, the packing was slightly damp. Arrangements have reportedly been made to add an electric motor operator to the valve.

48" GATE VALVE ON WATER SUPPLY PENSTOCK FACING DOWNSTREAM

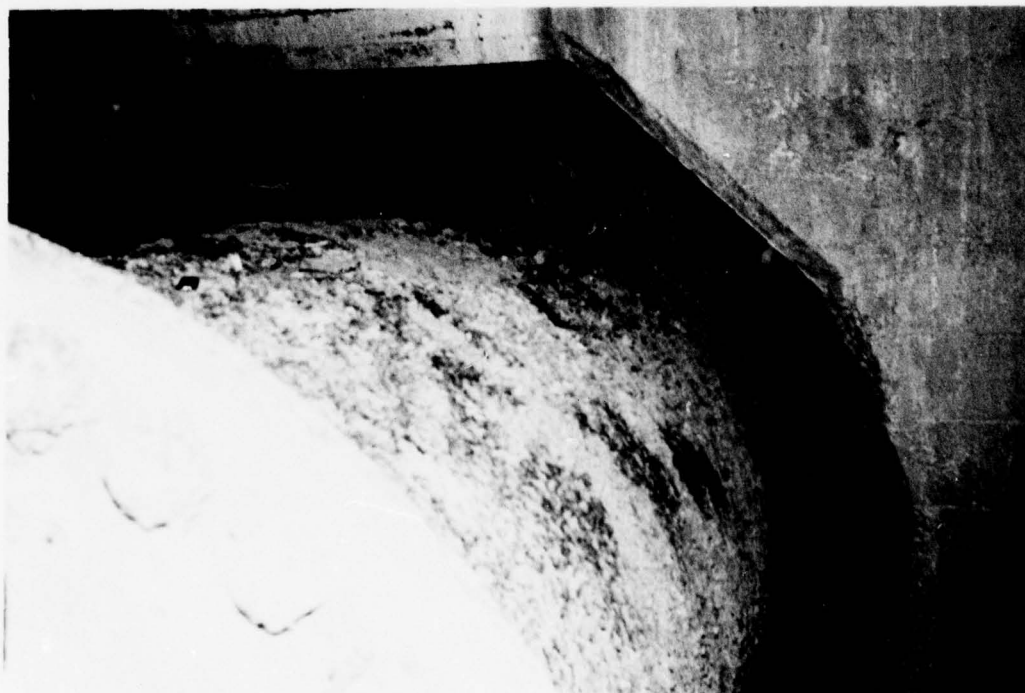
Two 4-foot sections of penstock, adjacent to the cast-iron bends, were observed to have heavy surface corrosion over their entire surface including the flanges. Large amounts of corrosion by-products could be removed from the pipe surface, many of the rivet heads holding the pipe to the flange could be broken from their stems and strips of material could be peeled from the flange, all by hand. Due to the severity of the corrosion,

the depth of the pits from the original surface was indeterminable. Many of the bolts through the flanges were also observed to have severe material losses.

CLOSE-UP OF CORROSION ON PENSTOCK SECTION
PASSING THROUGH BUTTRESS.

The extreme corrosion of the pipe sections is considered to represent an unsafe condition of the dam. The safest course of action would be to completely shut the 48-inch gate valve upstream of the corroded pipe sections until their replacement. However, bearing in mind that the penstock carries the City of Watervliet's only water supply, a recommended alternative procedure would be to close the upstream gate valve so as to substantially reduce the water pressure in the corroded pipe sections and yet provide the water requirements of the city until the replacement is made. If this alternative is elected it is recommended that replacement of the corroded pipe sections be made within 30 calendar days of the date of this report and that surveillance and warning systems be put into effect until replacement has been made.

e. After the testing and replacement of the required penstock sections, all exposed metal surfaces should be cleaned, primed with a rust inhibitor, and painted with an appropriate coating.

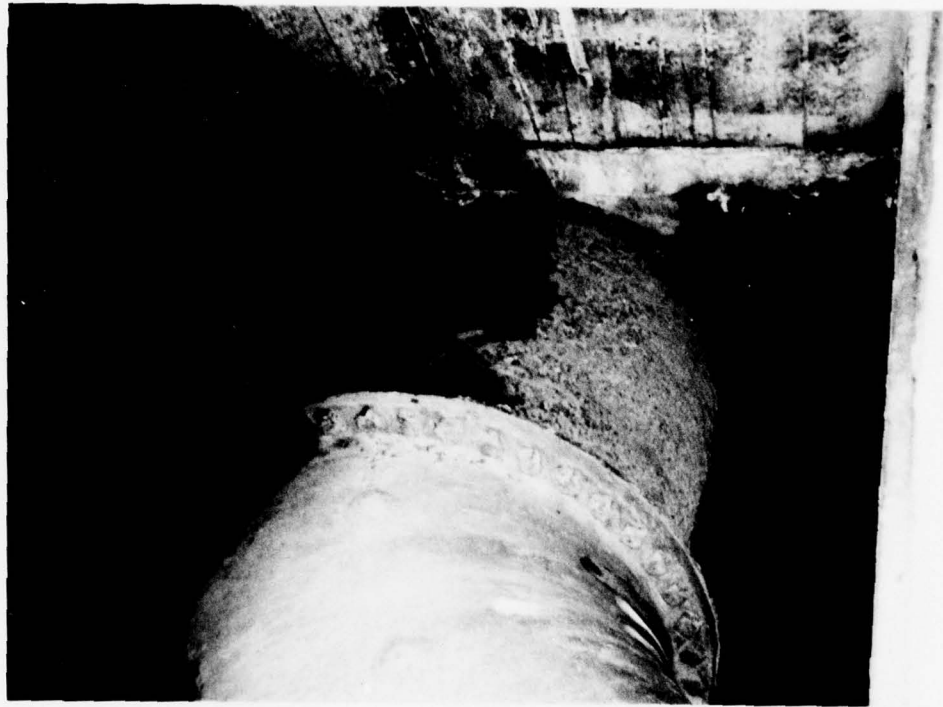
The severe corrosion on fabricated penstock sections within the dam is considered to be a hazardous condition. Sudden rupture of the pipe could cause severe hydraulic impact loading on the downstream face of the dam, the buttress and the buttress foundation.

PENSTOCK SECTION THROUGH DOWNSTREAM FACE OF DAM.
ROUGH EDGE ALONG RIGHT SIDE OF PENSTOCK INDICATES
EXTENT OF CORROSION.

It is recommended that the remaining penstock sections and fittings within the dam be tested by non-destructive methods, such as ultrasonic testing, to determine their soundness.
