**LAKE KANAWAUKE DAM**  
ROCKLAND COUNTY, NEW YORK

NY 58  
**PHASE I INSPECTION REPORT**  
**NATIONAL DAM SAFETY PROGRAM**

Prepared by  
JOSEPH S. WARD & ASSOCIATES  
CONSULTING ENGINEERS  
91 ROSELAND AVENUE, P.O. BOX 91  
CALDWELL, NEW JERSEY 07006

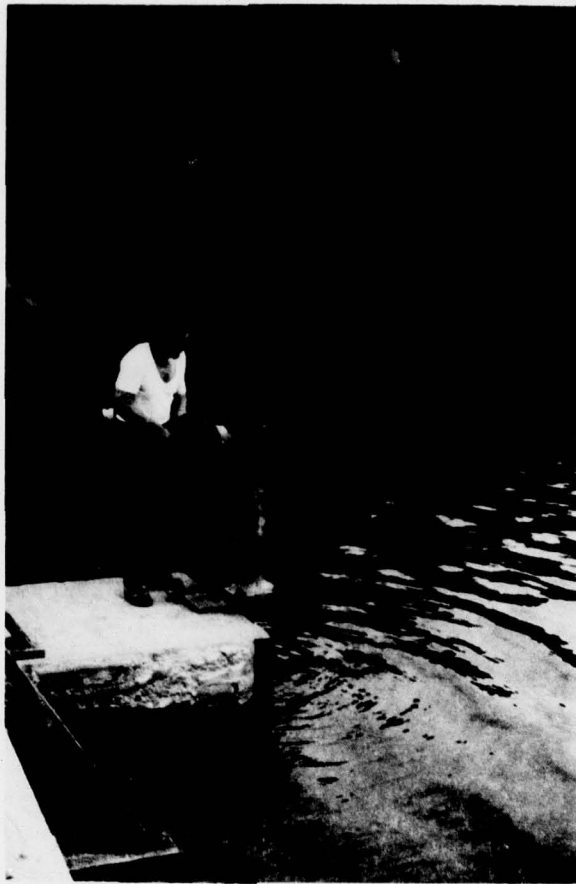
2) The sluice gate controls were operated (Fig. 1, Appendix D) and were observed to function satisfactorily. The gate itself could not be inspected since it was totally submerged. The outlet tunnel was inspected at its exit point and was found to be severely scaled and cracked (Fig. 3, Appendix D).

FIGURE 1 SLUICE GATE CONTROLS

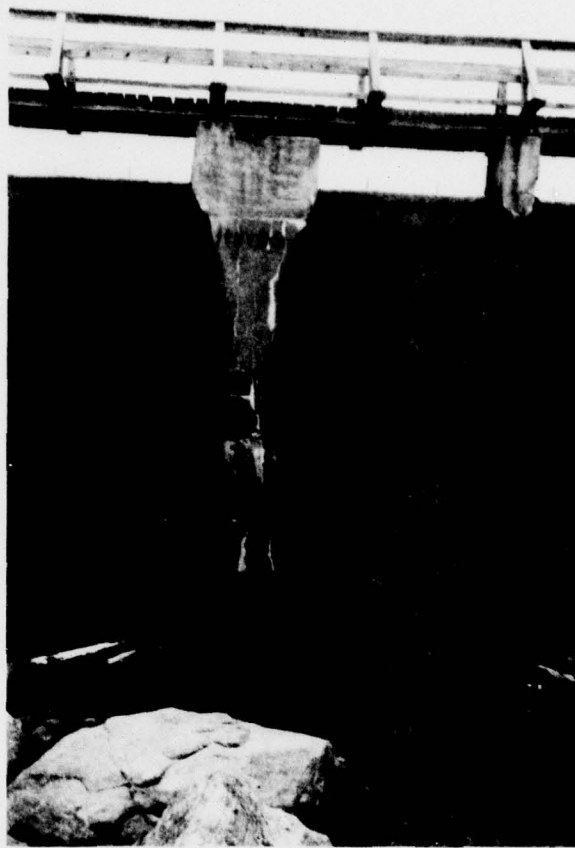
1) A number of spalls in the gunite cover of the downstream face (Fig. 3, Appendix D). These ranged from large to small, mostly in the center portion of the structure. The exposed wire fabric was badly rusted. In some instances the spalling had occurred at joints, and the copper baffle was clearly visible. The fact that there is evidence of patches indicates that this spalling has been a recurring problem for some time.

3) Evidence of severe to very severe scaling of the piers and control gate platform (Figs. 3 and 4, Appendix D). Close examination of one of the spalls in the gunite revealed that there was also some slight scaling of the original dam structure in that area.

FIGURE 3      CRACKING AND SPALLING NEAR EXIT PORTAL OF SLUICE TUNNEL

1. The gunite cover and wire mesh should be removed and replaced with a special concrete cover to protect the structural concrete from water erosion or spalling under frost. Until this is done the public should be prohibited from access to the downstream face because of the danger of slabs of gunite dislodging.

2. Deterioration of concrete on spillway piers, the outlet culvert and the gate control platform should be repaired. Reinforcing bars should be tested for degree of corrosion and existing cross section checked with design requirements prior to any concrete patching work.

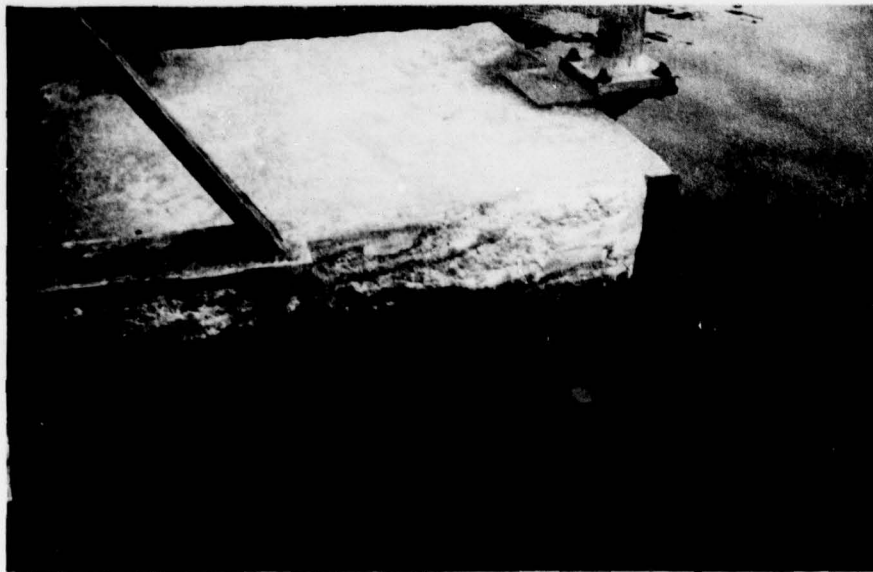
FIGURE 4      SCALING OF CONTROL GATE PLATFORM

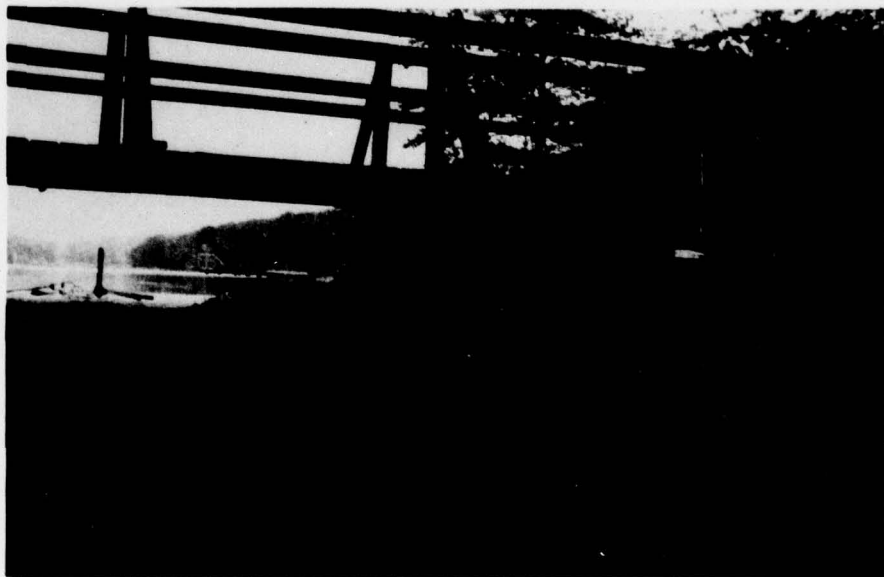
4) A water supply pipeline extends across the dam just below the wooden walkway (Fig. 6, Appendix D). The pipeline appears to be in good condition, with no evidence of leakage observed.

FIGURE 6 LEFT ABUTMENT (DOWNSTREAM)

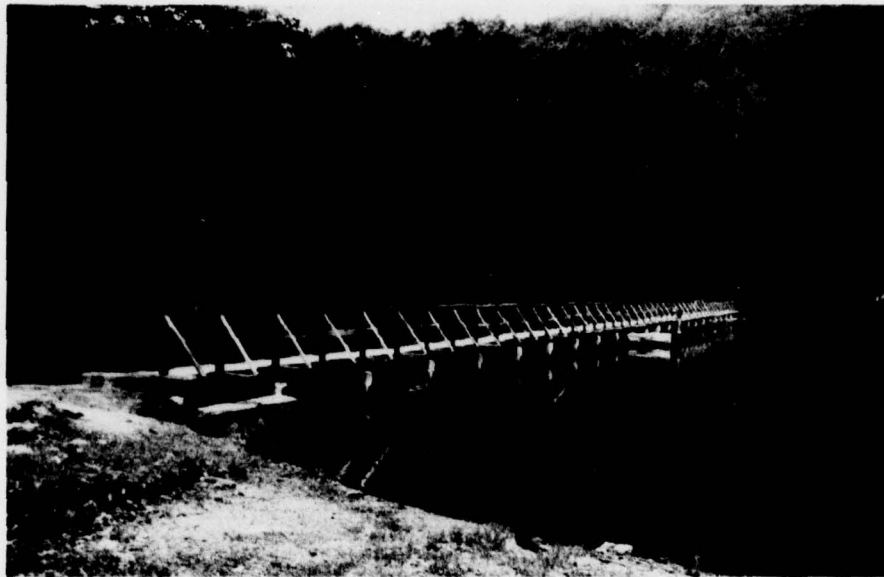
3) The wooden bridge that extends along the top of the dam appears to be in good condition (Fig. 7, Appendix D). Since this bridge provides access to the sluice gate controls, it is essential that it be well maintained.

FIGURE 7 UPSTREAM VIEW OF LAKE KANAWAUKE DAM SHOWING WOODEN WALKWAY, GATE CONTROL PLATFORM AND LEFT ABUTMENT

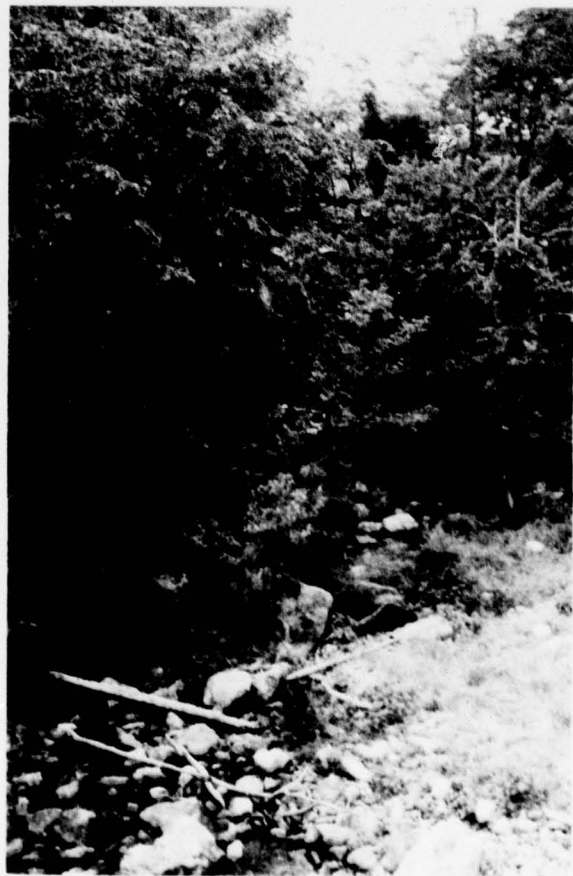
The downstream channel is about 30 to 40 feet wide with side slopes approximately the same as along the reservoir (Fig. 10, Appendix D). Numerous large boulders were observed in the channel out to about 30 feet from the toe of the dam. There is also a considerable amount of debris at the toe (Fig. 11, Appendix D). These serve as an apron and energy dissipator. A few large trees are in the channel and on the slopes farther downstream. The channel slopes appear generally stable, although some minor local slide scars were noted in the vicinity in air photos. About 500 feet downstream there is a large, boulder-covered detention basin (Fig. 12, Appendix D). This basin is used to store water and act as a flood control pond for Sebago Beach (Fig. 13, Appendix D) that lies downstream immediately beyond a two-lane paved road.

FIGURE 10 DOWNSTREAM CHANNEL

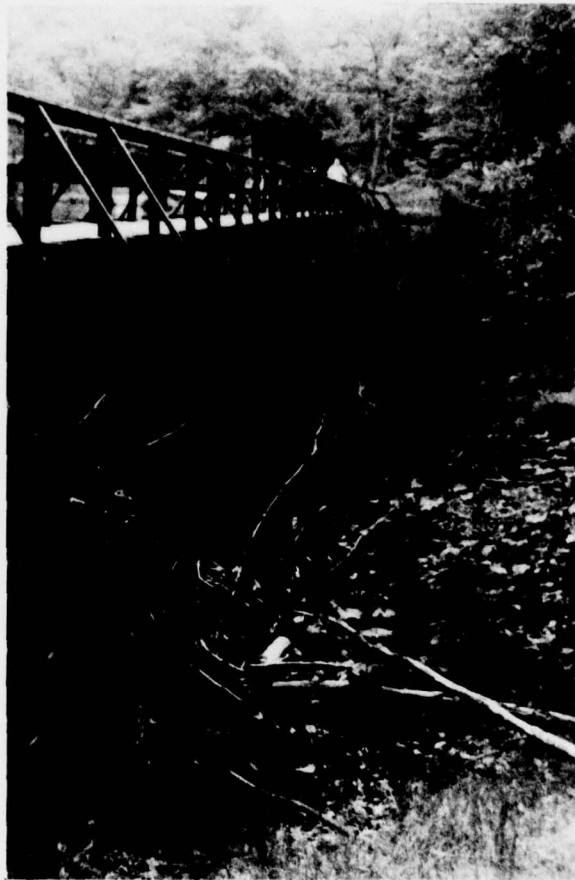
FIGURE 11 DEBRIS AT TOE OF DAM

4) Large pieces of debris immediately downstream and any debris collecting on the spillway should be removed, and the area kept clear of such debris in the future.

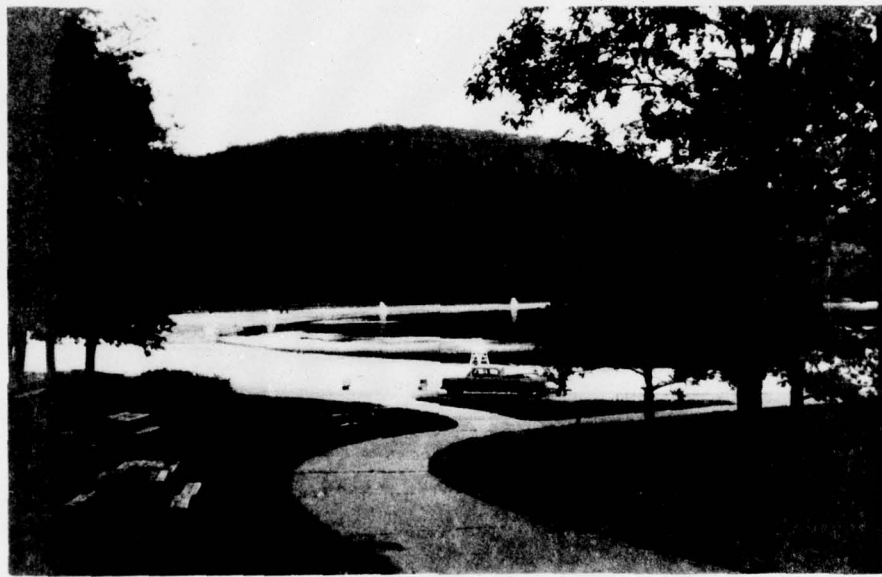
FIGURE 13 SEBAGO BEACH DOWNSTREAM FROM LAKE KANAWAUKE DAM
