FISHING CREEK DAM

INVENTORY NUMBER NDS MD. 16

PHASE I INSPECTION REPORT

by  
BERGER ASSOCIATES, INC  
CONSULTING ENGINEERS  
HARRISBURG, PA

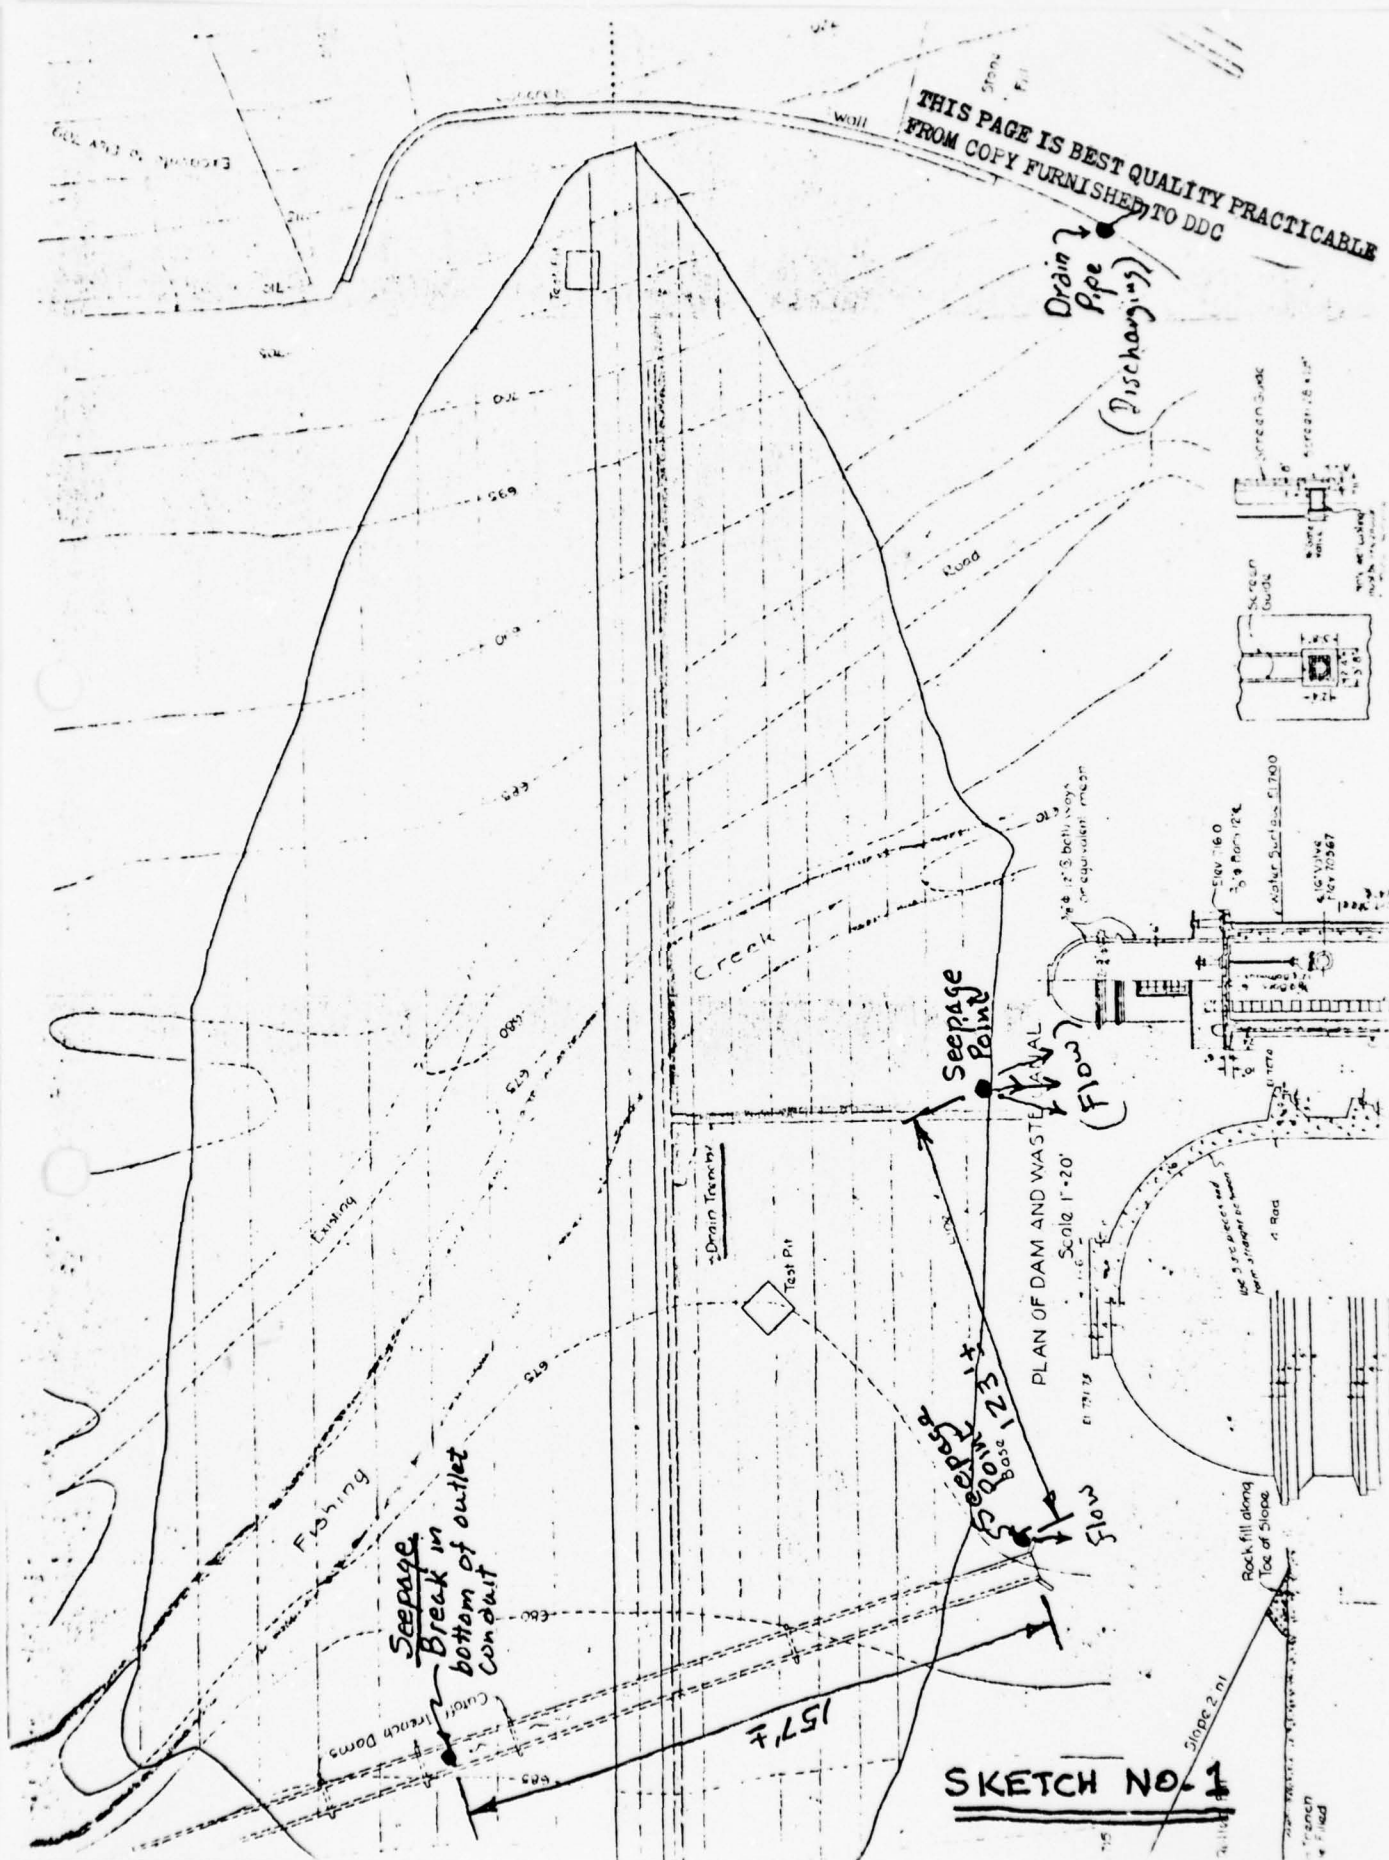
**SKETCH NO. 1**

Several seepage locations were observed during this inspection.

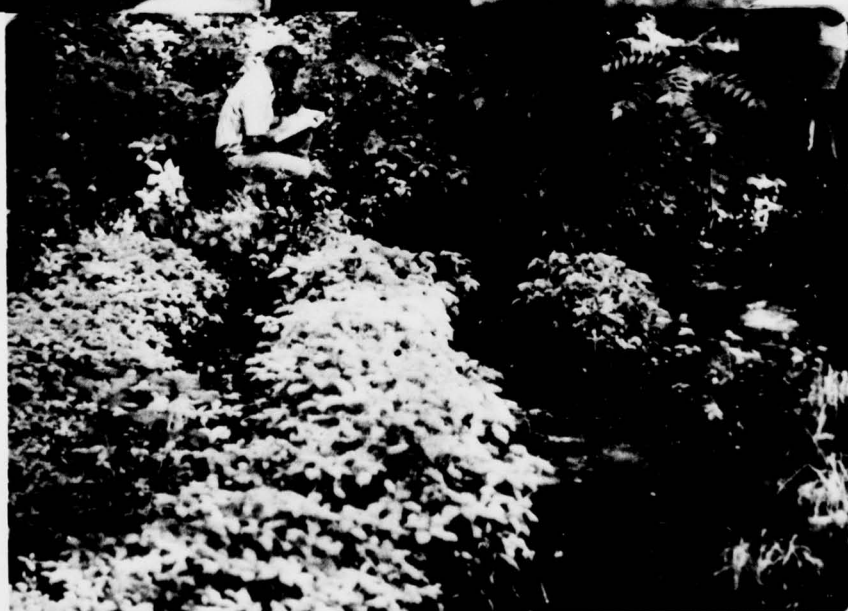
'LEAKAGE' AT  
TOE OF DAM

Seepage was observed at the downstream toe of the embankment at a point approximately 123 feet left of the outlet structure. The water discharging from this location is clear and cold and is estimated to be about 20 gpm (not measured). The material from which the water is flowing appears to be the rockfill as indicated on the plans. This discharge is flowing onto a flat area directly downstream from the toe of the embankment creating a wet marshy condition. The discharge meanders slowly overland creating other surface pondings at random until it finds its way to the stream channel.

1. The steady flow seepage at the toe of the embankment is about 123 feet left of the outlet structure. Reference to the design plan Plate No. VI, Appendix D, shows a stone filled drain ditch located at the base of the embankment just downstream from the concrete cutoff wall. This trench extends nearly the entire length of the embankment. An outlet trench, perpendicular to the drain trench extends downstream from the longitudinal trench to the rockfill at the toe of the embankment. The seepage point noted during this inspection nearly coincides with the discharge point of the perpendicular drain trench on the plan. It is felt that this seepage is coming from the drain trench and is concentrated at this point. This condition is of some concern and remedial action should be taken.

Since the dam has a concrete core wall extending from the rock foundation up through the embankment to its surface and above, the likelihood of seepage through the dam is small. It is considered more feasible that the water is flowing through the foundation and under the wall and then upon rising is intercepted by the drain trench and ultimately discharged at the toe of the embankment.

3. The apparent break in the foundation drain from the toe of the embankment to the spillway channel should be located and repaired.
4. The cracks in the spillway outlet channel should be repaired to prevent undermining of these units during high flows.

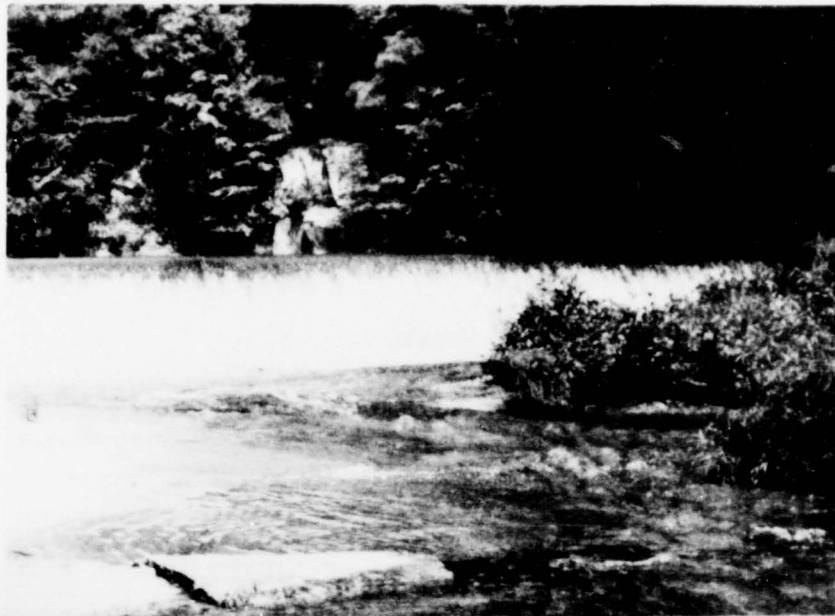
SPILLWAY WEIR

The existing spillway is a concrete ogee section 70 feet in length. Aside from some deterioration of the concrete surface, this structure appears to be in sound physical condition. There were no signs of major distress. The concrete apron below the ogee section leading to the discharge channel has numerous cracks of sufficient size to allow growth of weeds and brush. The spillway channel is excavated in natural rock. The discharge from the spillway cascades over the exposed rock to the outlet channel below. There is no stilling basin.

The physical appearance of the spillway is good, although there is some deterioration of the surface where aggregate is exposed as a result of weathering. The abutments are sound. Its discharge channel has a number of slabs which are cracked and have weeds and brush growing through the openings. The energy dissipation is accomplished by the discharge falling over a rough excavated rock channel. There is no stilling basin.

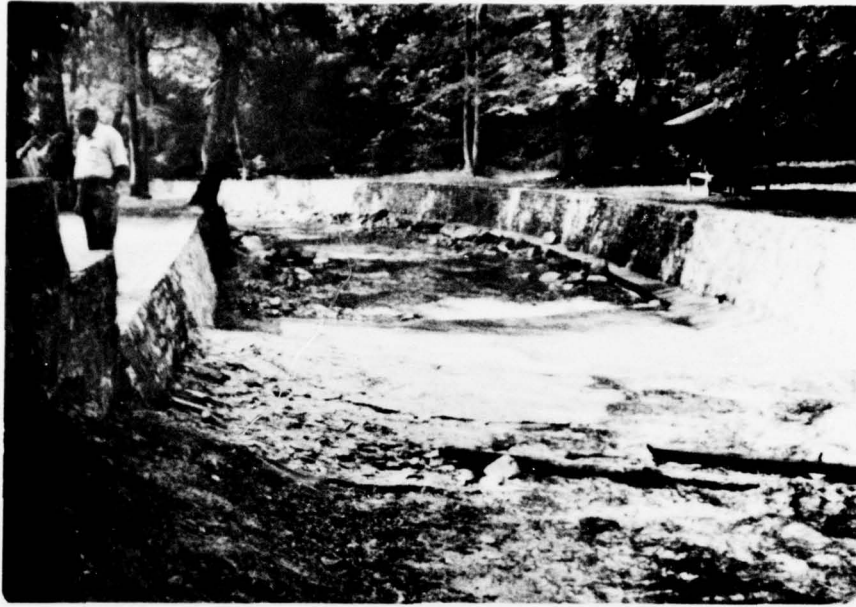
DOWNSTREAM CHANNEL

The downstream channel is natural mountain stream conditions, with stony bottom and trees and brush to the edge of the channel. Summer cottages and some permanent residences are adjacent to the stream and in the flood plain. It is estimated that about 150 residences with a population of 400 to 500 persons are located along the stream. Public camping is permitted adjacent to and downstream from the dam embankment.
