HUNTING CREEK DAM

INVENTORY NUMBER NDS MD-58

PHASE I INSPECTION REPORT

NATIONAL DAM SAFETY PROGRAM

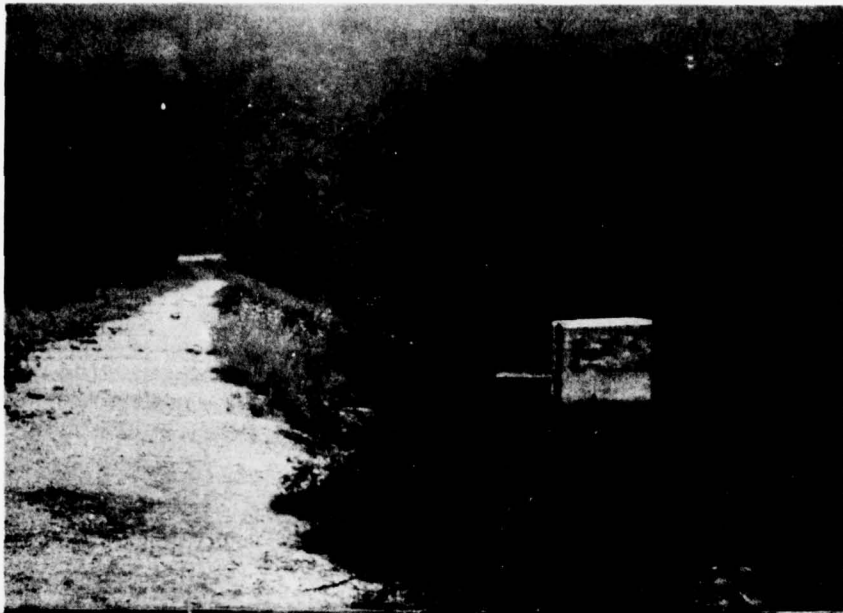
Upstream Slope &  
Control Structure

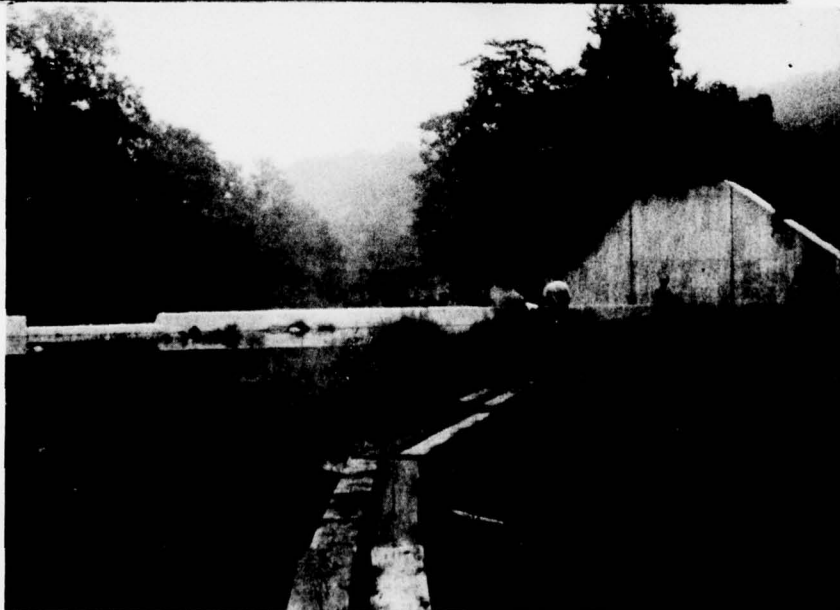
Forebay and  
"Floating" Boom

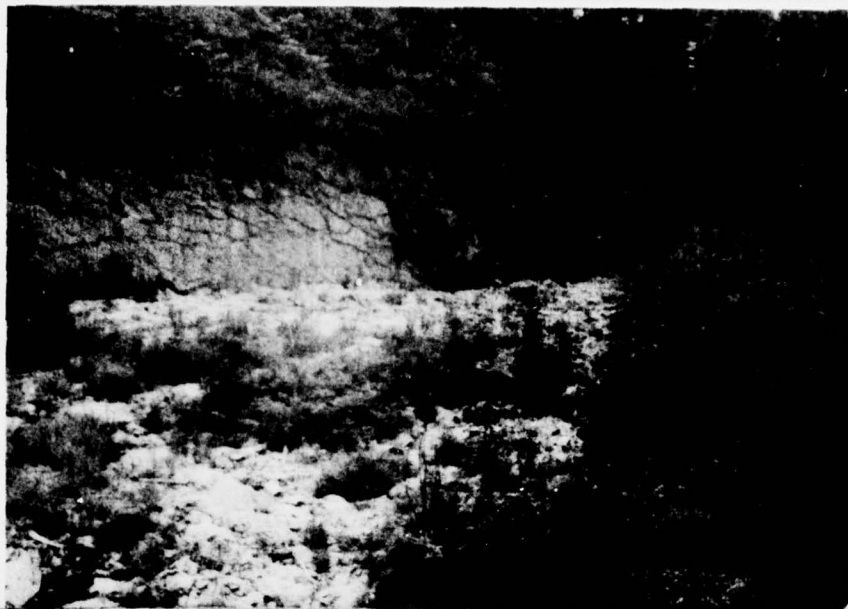
The spillway outlet channel contains some brush and weed growth and should be cleared. Also loose eroded materials should be removed.

Spillway Channel

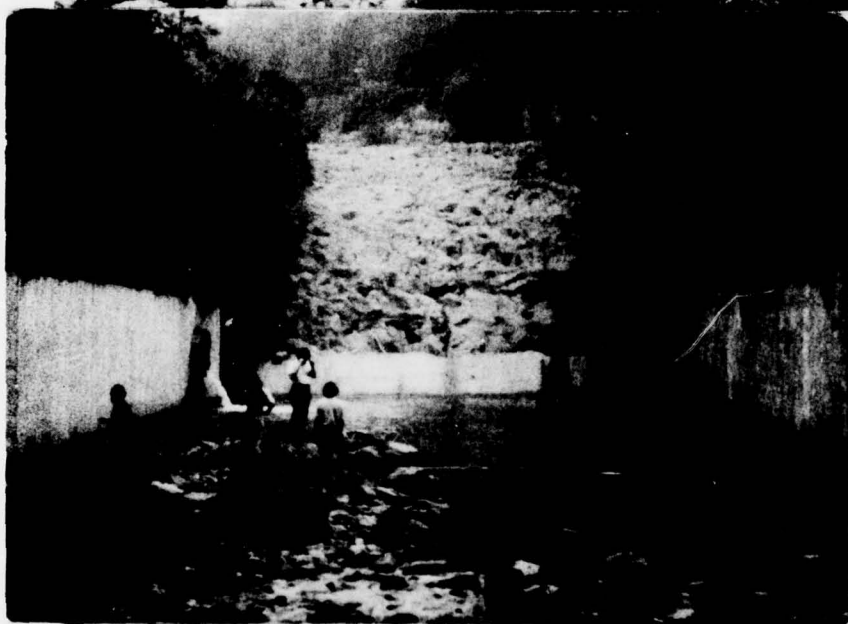
The spillway channel is excavated into natural rock. Its surface is very irregular and provides a natural energy dissipator for the flow. Some brush and weed growth is located in this channel. The stilling basin is a concrete lined basin located at the end of the spillway channel. Erosion of the rough rock surface has partially filled the downstream end of the basin. The concrete walls of the stilling basin appear to be in good condition. Refer to Appendix D, Plate IV.

Spillway Basin &  
Spillway Channel

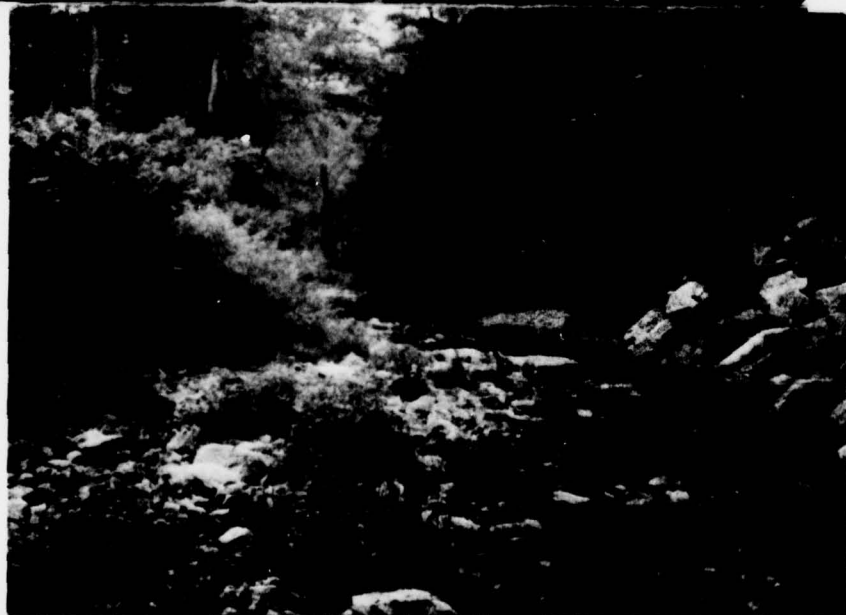
Downstream  
Channel
