LITTLE PINE CREEK DAM

INVENTORY NUMBER NDS PA-351

PHASE I INSPECTION REPORT

by
BERGER ASSOCIATES, INC.
CONSULTING ENGINEERS
HARRISBURG, PA.

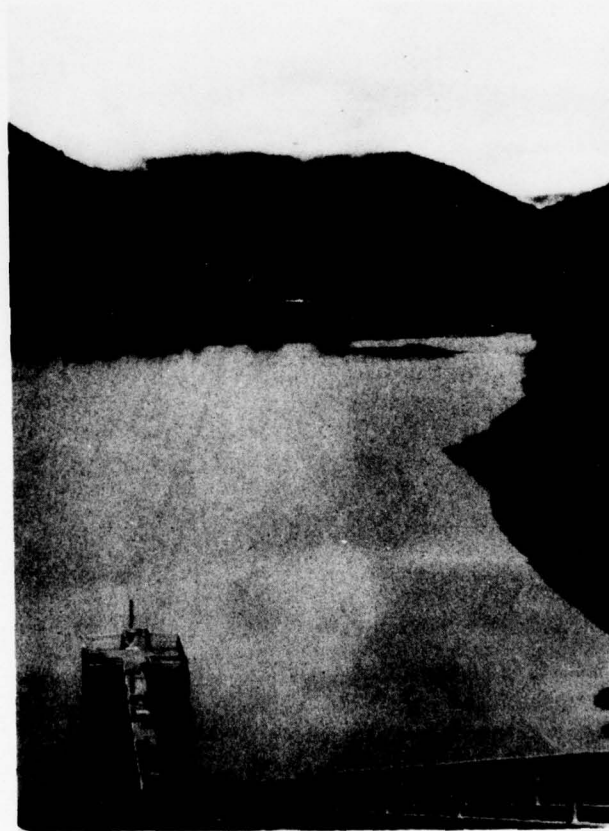
Reservoir & Stairs to Intake Structure

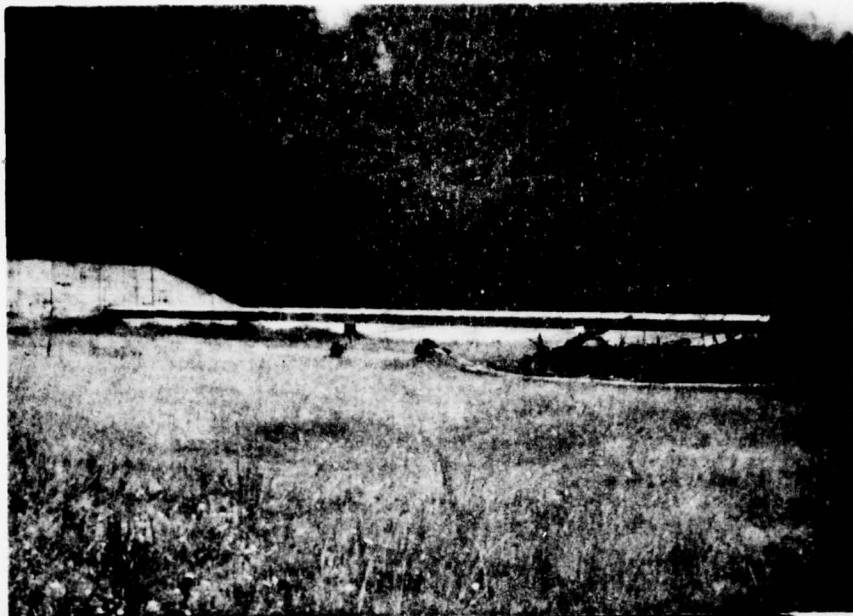
A large forebay area was excavated and is seeded with grass. Some driftwood was piled up in the area, but will be removed. The right side has a curved concrete training wall, the left wall is straight. Some cracking was noticed in the walls, but none of the cracking appeared to affect the structural stability of the walls. Some differential movement at the top of the walls was noticed adjacent to the ogee section. This was caused by variation in support. All the monolithic ogee sections have a vertical crack in the center of the

Forebay

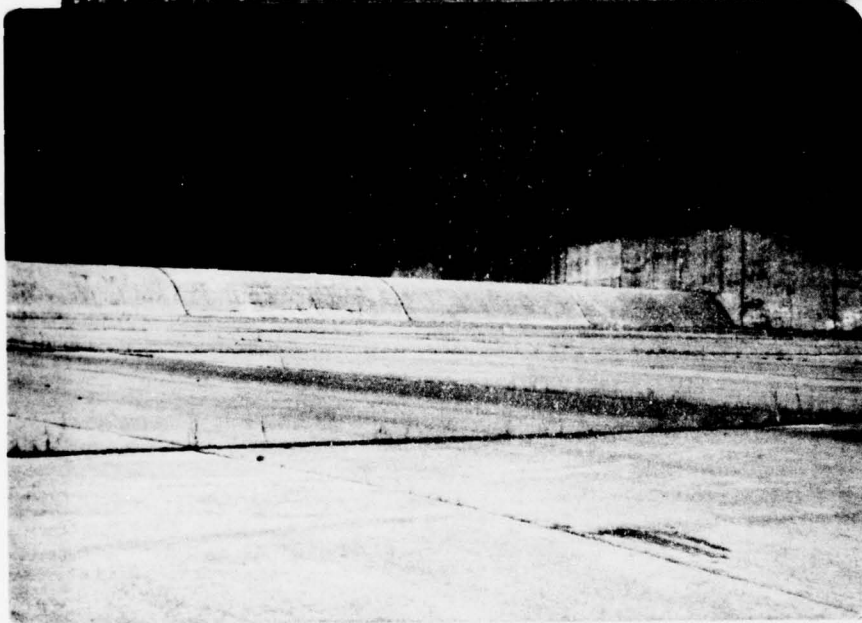
pours, which were approximately 50 feet long. The center section had some horizontal cracking. None of the cracks appear to affect the structural integrity of the structure at the present time. Downstream damage occurred during the tropical storm Agnes (June 1972). The damage has been repaired and riprap has been placed at several locations (Appendix D, Plate VI). A bridge located downstream (Plate VII, Appendix D), was destroyed during that storm and has been replaced several hundred feet further downstream.

Spillway

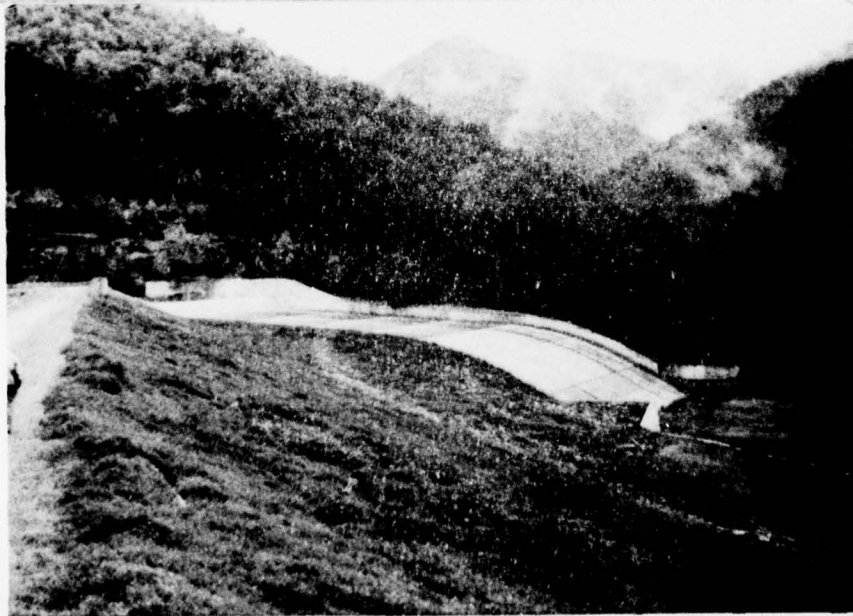
Downstream Slope
& Spillway

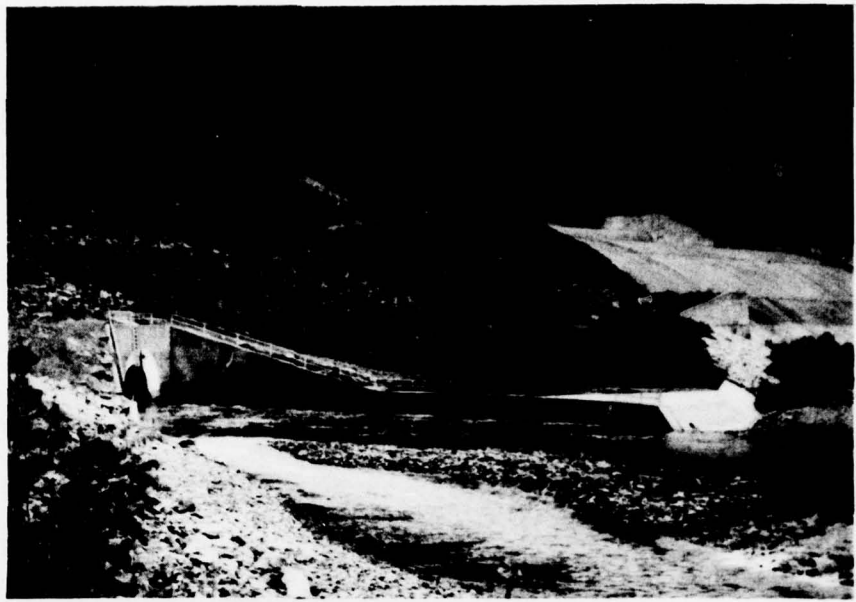
Seepage at left side of outlet below toe of embankment.
Steady flow - clear - park superintendent indicated no change in flow
over long period of time.
This condition on record - appears to come from toe drain or springs.
Estimated 40 gpm± not measured.

Conduit Outlet and Spillway

2. The quantity and turbidity of the seepage exiting at the toe of the dam should be monitored and recorded. Changes in conditions under higher pool level should be noted, to determine if an in-depth study of the seepage condition is required.

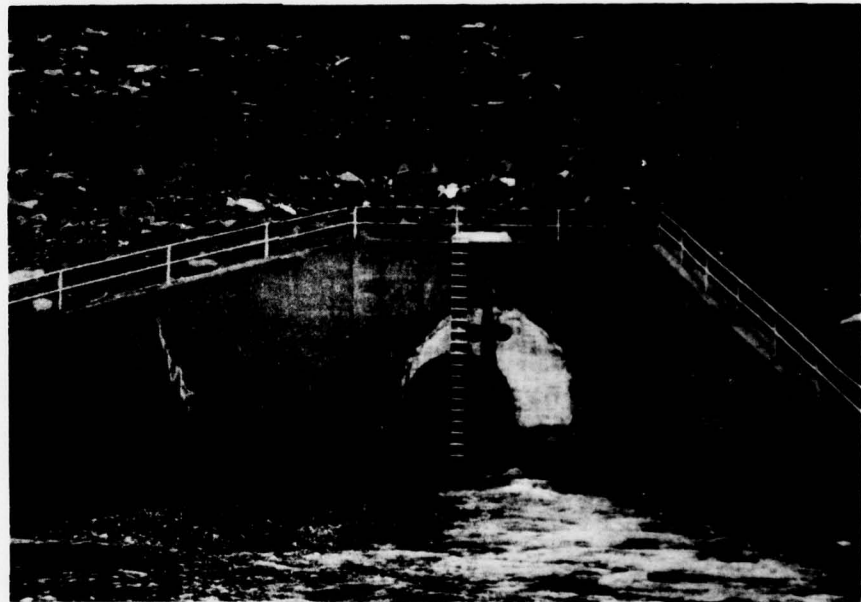
The original construction included a 15 feet diameter concrete conduit which was first used during construction for diversion of stream and is connected directly to the intake structure for pool control after construction was completed. Cavitation during flood flows in 1950 and 1951 caused extensive damage. A new 8.5 foot diameter steel pipe, supported within the original conduit was installed. This steel pipe was damaged during the Agnes storm, but has since been repaired and performs in a satisfactory manner. The damage consisted of slight buckling of the steel plate near the orifice. Improved pipe supports were installed. The discharge through the 5 foot by 5 foot sluice gate runs between the concrete and steel conduit. The steel pipe was inspected and appeared in good condition. A small hole in the top of the pipe was discovered approximately 150 feet upstream from the end of the pipe. The outlet channel was in good condition.

Outlet Steelpipe in Conduit

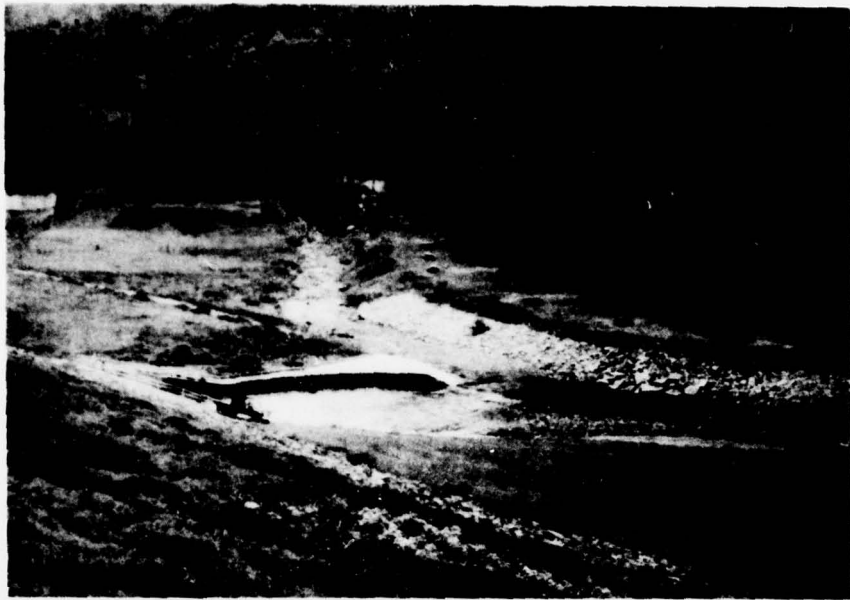
Spillway Discharge Channel

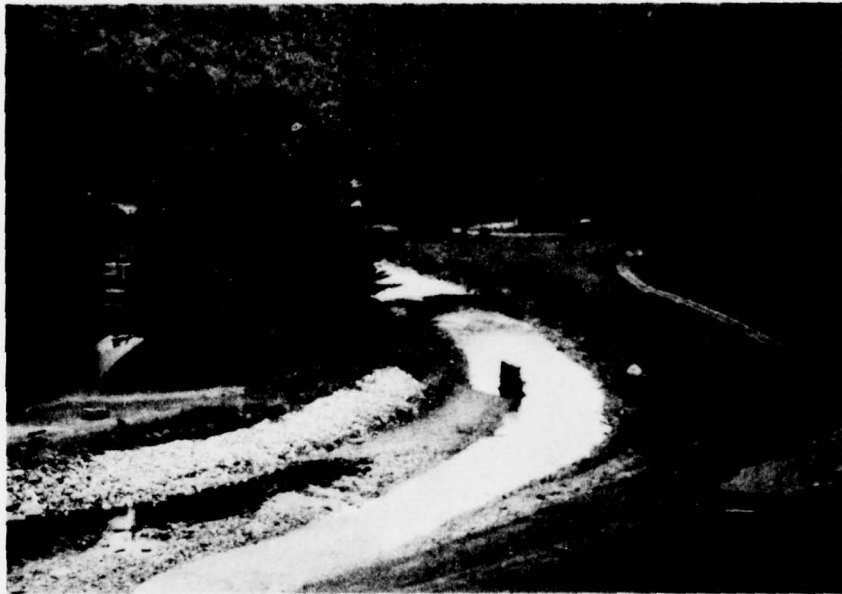
Downstream Channel
