National Dam Inspection Program.
Liberty Dam, Upper Chesapeake Bay
Basin, State of Maryland, Baltimore
and Carroll Counties (NDS-MD-3).
Phase I Inspection Report.

LIBERTY DAM

PHASE I INSPECTION REPORT

Name of Dam: LIBERTY DAM
 State & State Number: MARYLAND - MD-3
 County: BALTIMORE & CARROLL
 Stream: NORTH BRANCH PATAPSCO RIVER
 Date of Inspection: August 1, 1978

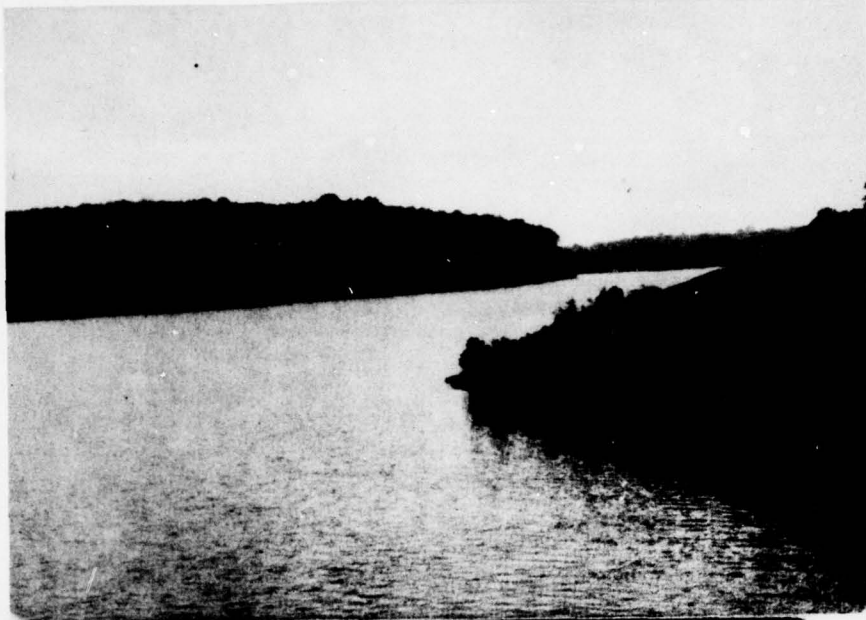
Reservoir

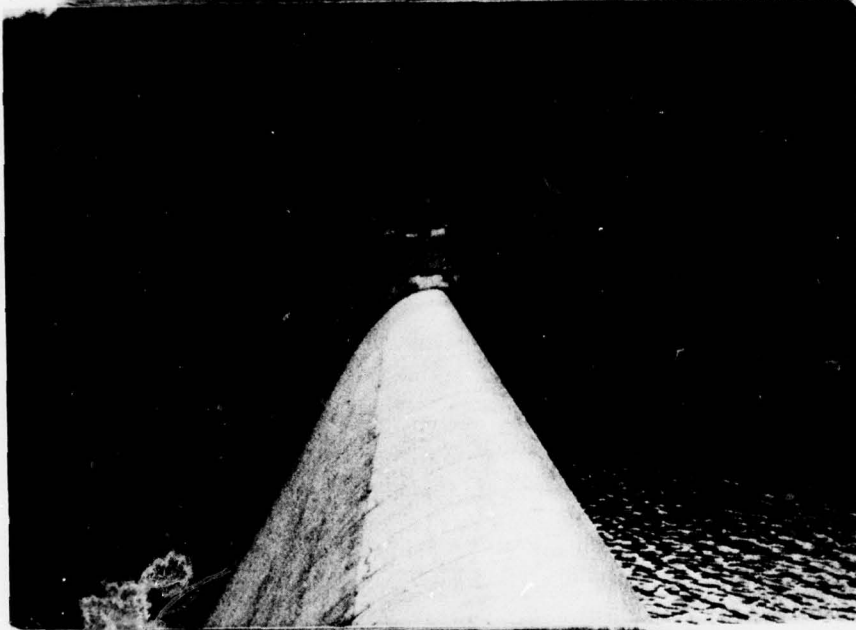
Spillway
Looking West

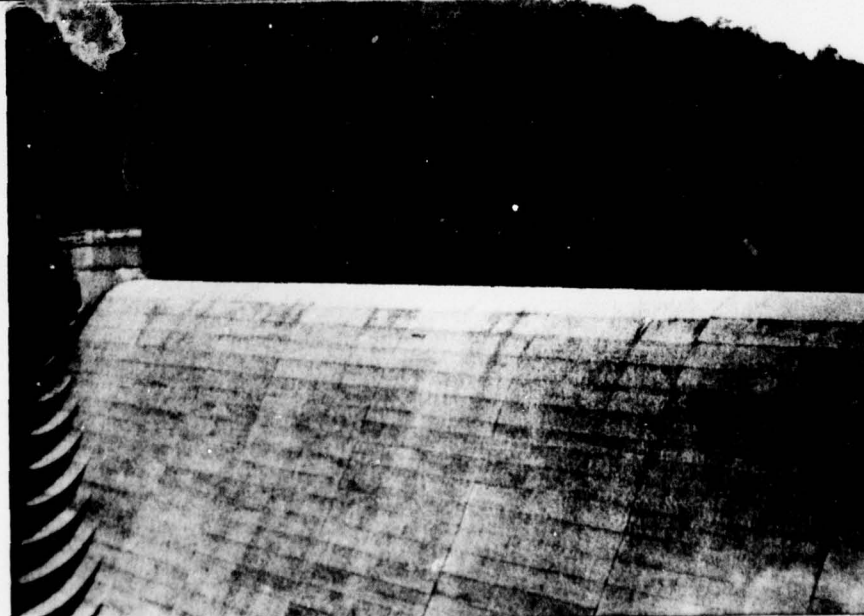
The concrete abutments and spillway appeared to be in excellent condition. The east abutment is open to the public with well maintained access roads. At the time of inspection, the pool level was about 2.5 feet below the spillway crest. An inspection of the concrete surface of the spillway shows some map cracking and some minor weathering of the concrete surface.

The necessary maintenance of a concrete structure is limited until aging causes deterioration. The general appearance is good, although some spalling and cracking of the spillway surface has occurred. The facilities are open to the public and the surrounding area is well maintained. The office and maintenance shop is near the dam site and daily visits to the dam are made.

Spillway Surface

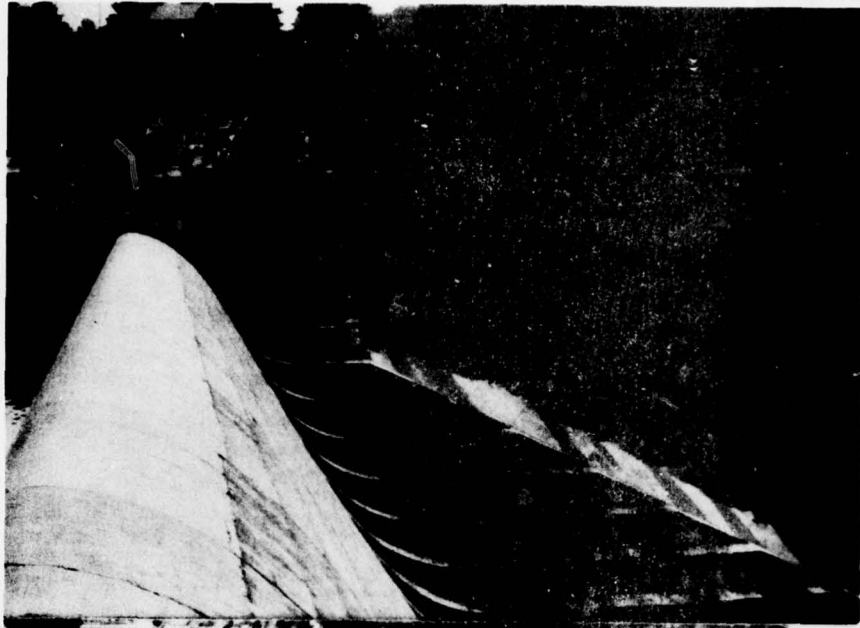
Spillway
Looking East

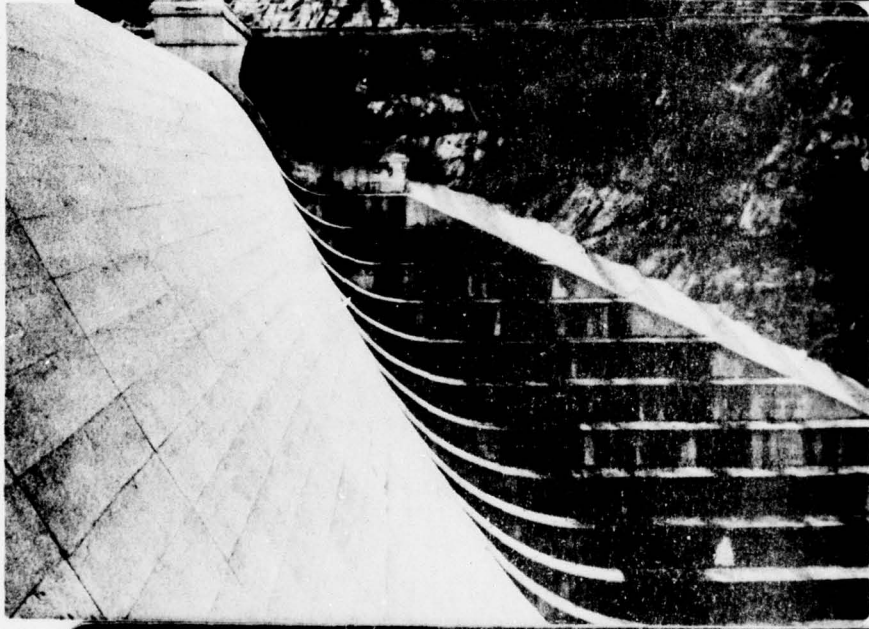
Spillway Surface

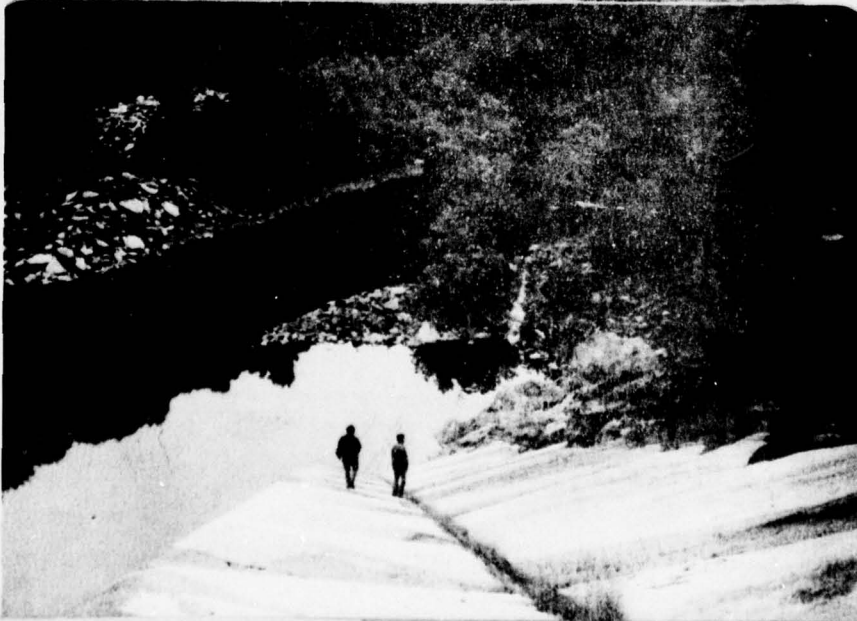
West Spillway Wall
& Downstream Channel

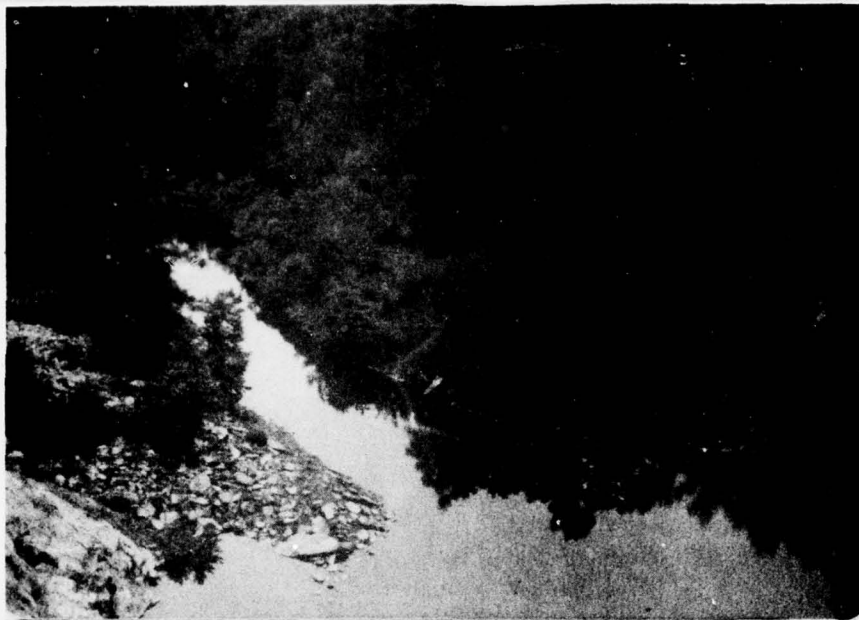
Downstream
Channel

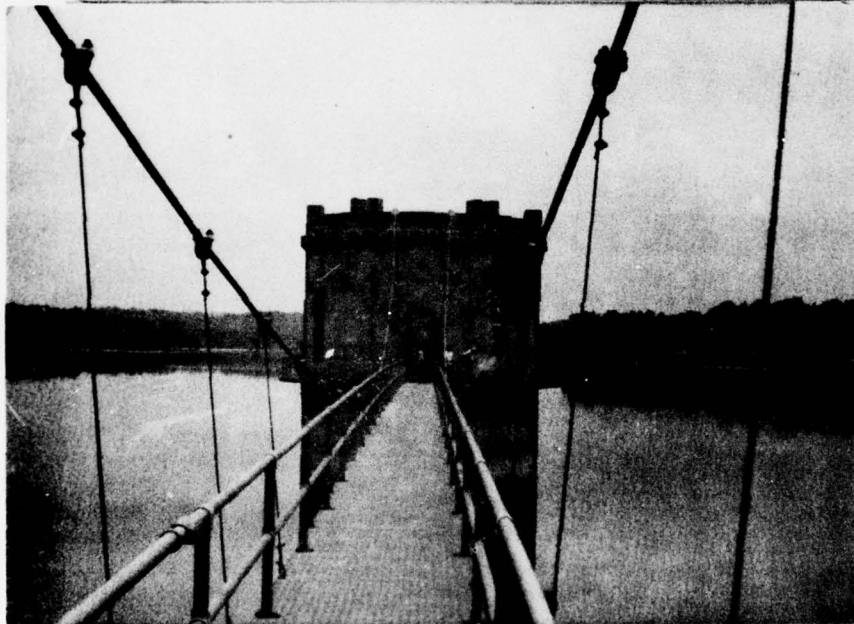
The only operating facilities at the dam are the low flow pipes which have not been opened since 1966. All other operating facilities are located in the intake structure, 1.5 miles upstream. This structure is well maintained and all gates are in excellent condition.

Intake Tower

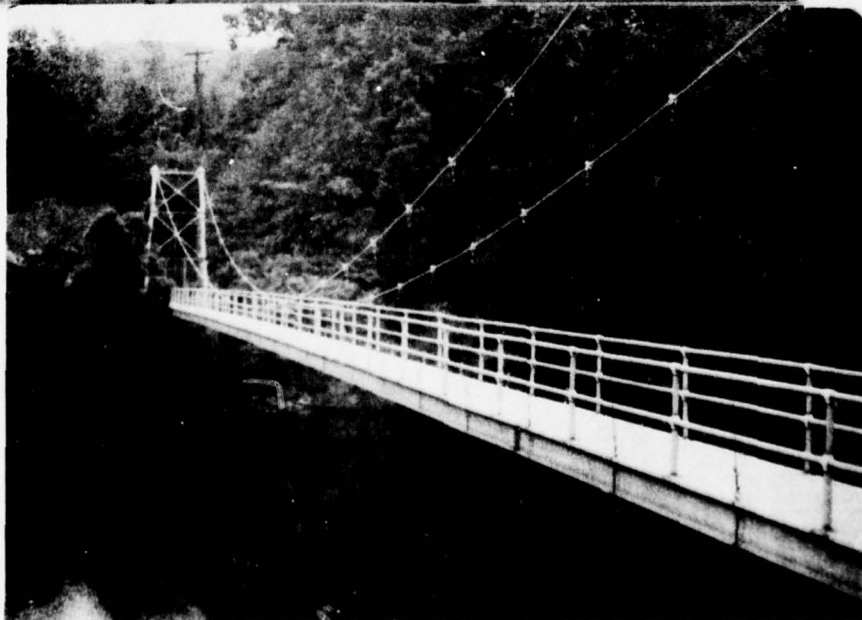
Bridge To
Intake Tower
