**TROUT RUN DAM**

National Dam Safety Program. Trout Run Dam (NDI-Pa.-481), Ohio River Basin, Trout Run, Westmoreland County, Pennsylvania. Phase I Inspection Report.

**PHASE I INSPECTION REPORT  
NATIONAL DAM INSPECTION PROGRAM**

OCTOBER 1978

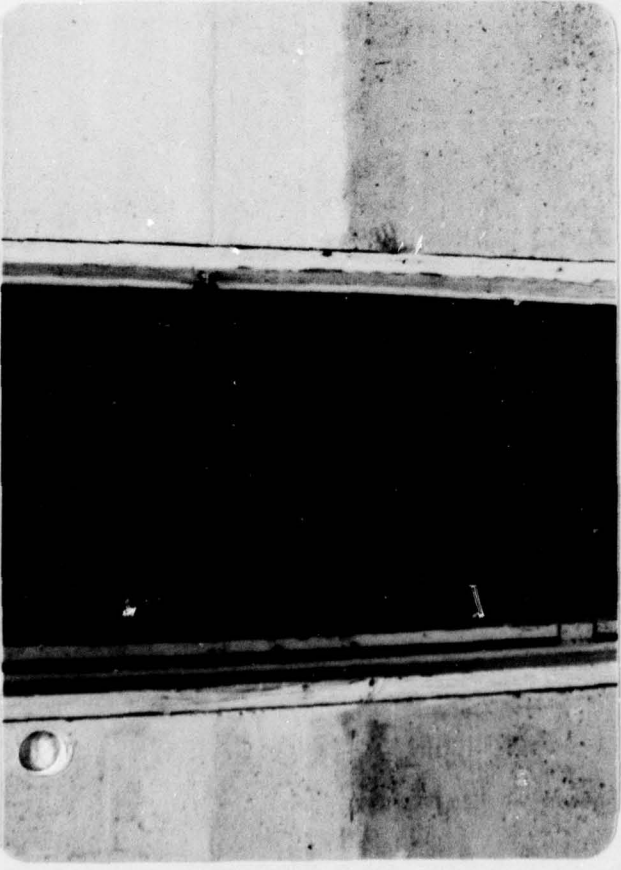
5

**PHOTOGRAPH 5** View of the interior of the gate house.
