**OHIO RIVER BASIN  
WEST PENN RUN, WESTMORELAND COUNTY**

**NDI No. Pa. - 452**

**WEST LEECHBURG RESERVOIR DAM**

**PHASE I INSPECTION REPORT  
NATIONAL DAM INSPECTION PROGRAM**

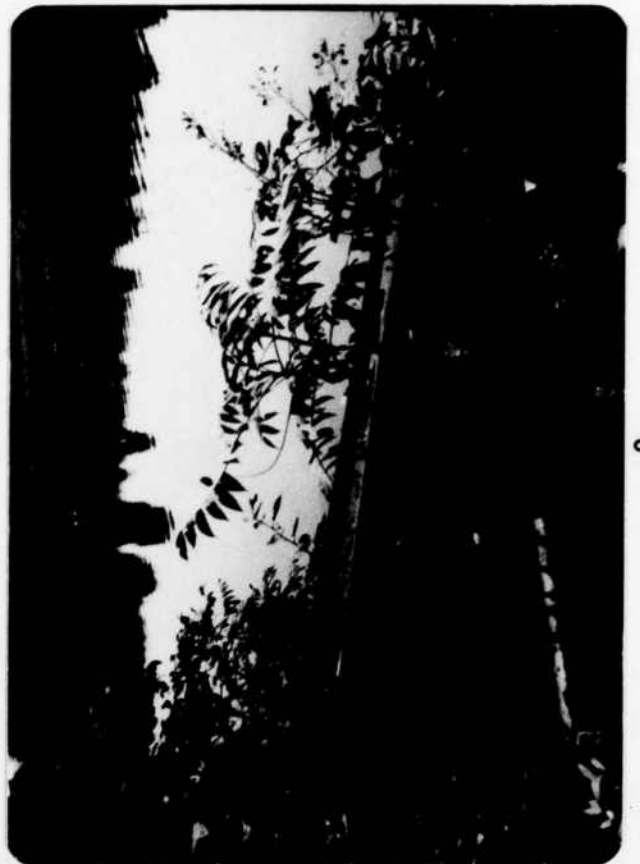
the authority to decant water from five (5) elevations within the reservoir. Reportedly, the gates are corroded open and cannot be closed. Because of this condition, there is no way to regulate flow on the inlet end of the outlet works.

There is no formal maintenance of the operating facilities serving the dam. The intake portals on the riser pipe are corroded and the valves on the blow-off pipe are no longer opened periodically.

The low level intake located at the base of the upstream embankment toe was submerged during the inspection and could not be observed. Four additional intakes are located along a conduit which ascends the reservoir slope along the left shoreline approximately 175 feet upstream of the embankment and can be observed as it juts out from below pool level. All intakes are reportedly open and inoperable. The visible portion of the conduit is corroded.

PHOTOGRAPH 8 Closeup view of the intake system located upstream of the spillway. The valve stem on the outside of the pipe is connected to a gate on the blow-off line.

c. Modify or repair the outlet system so as to provide a method for controlling discharge at the inlet end of the 24-inch diameter outlet pipe.

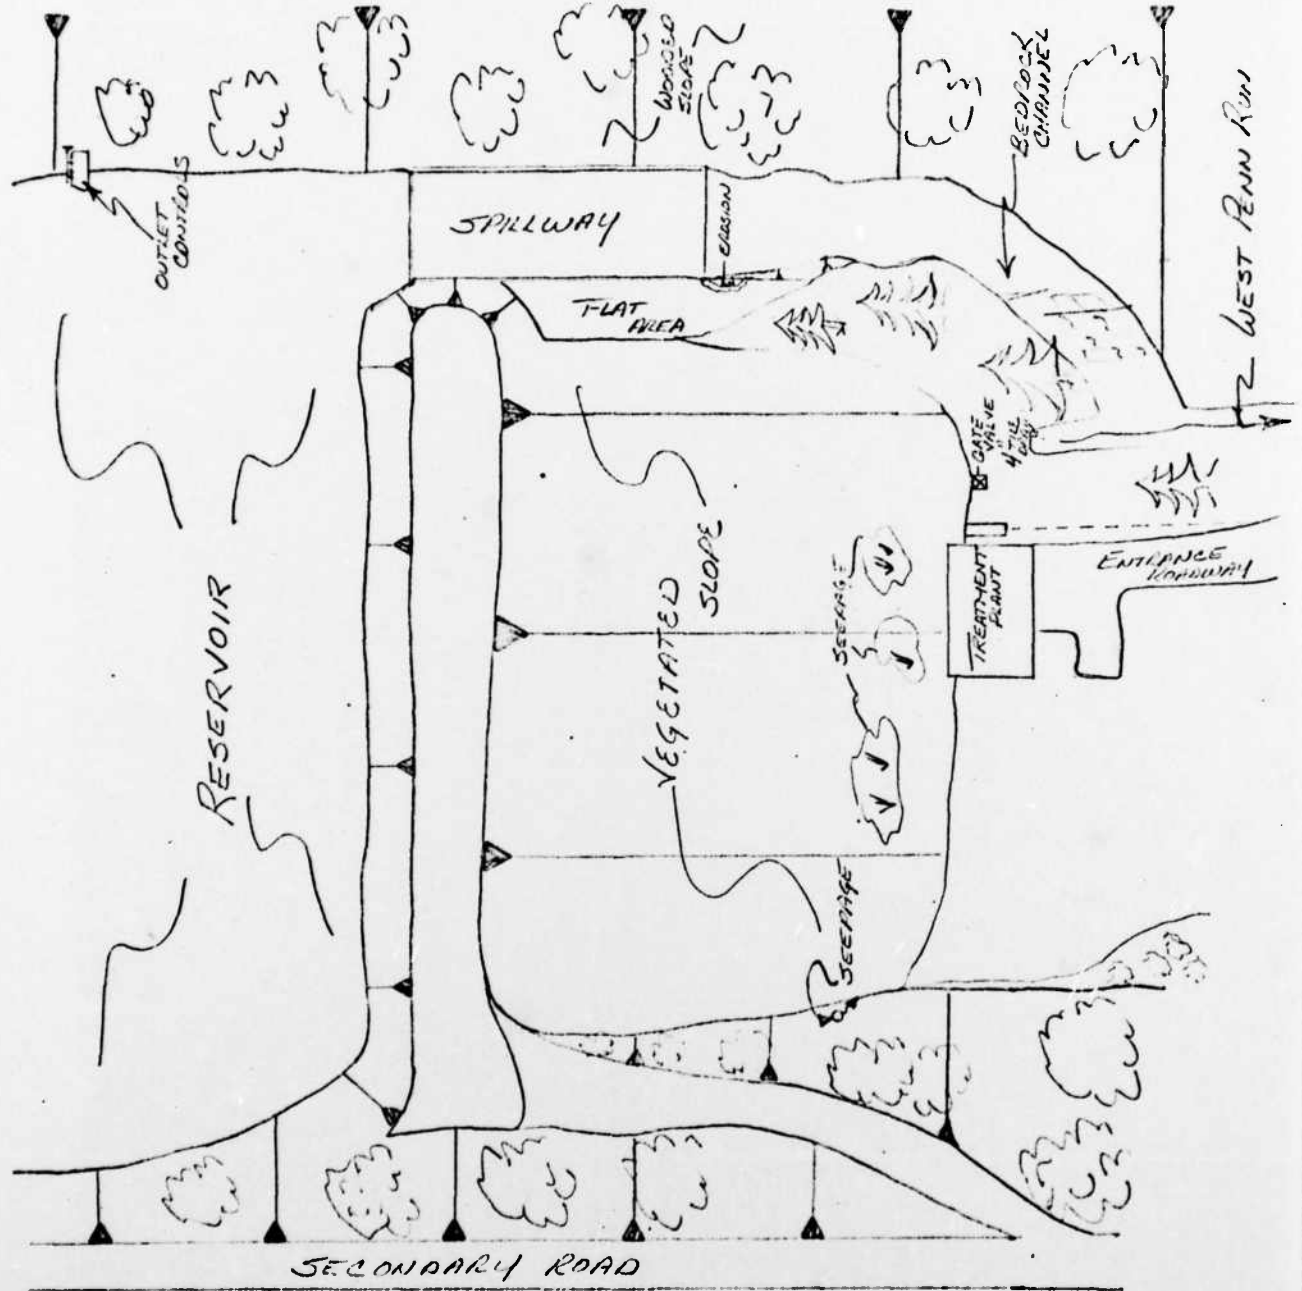
FIGURE 1

Seepage noted above the toe of the dam behind the treatment plant. Flow could not be measured; however, a large area (see sketch in Appendix F) was saturated. Seepage was also observed emanating from the right abutment hillside downstream of the dam and from a tile drain in the stream channel to the left of the treatment plant.

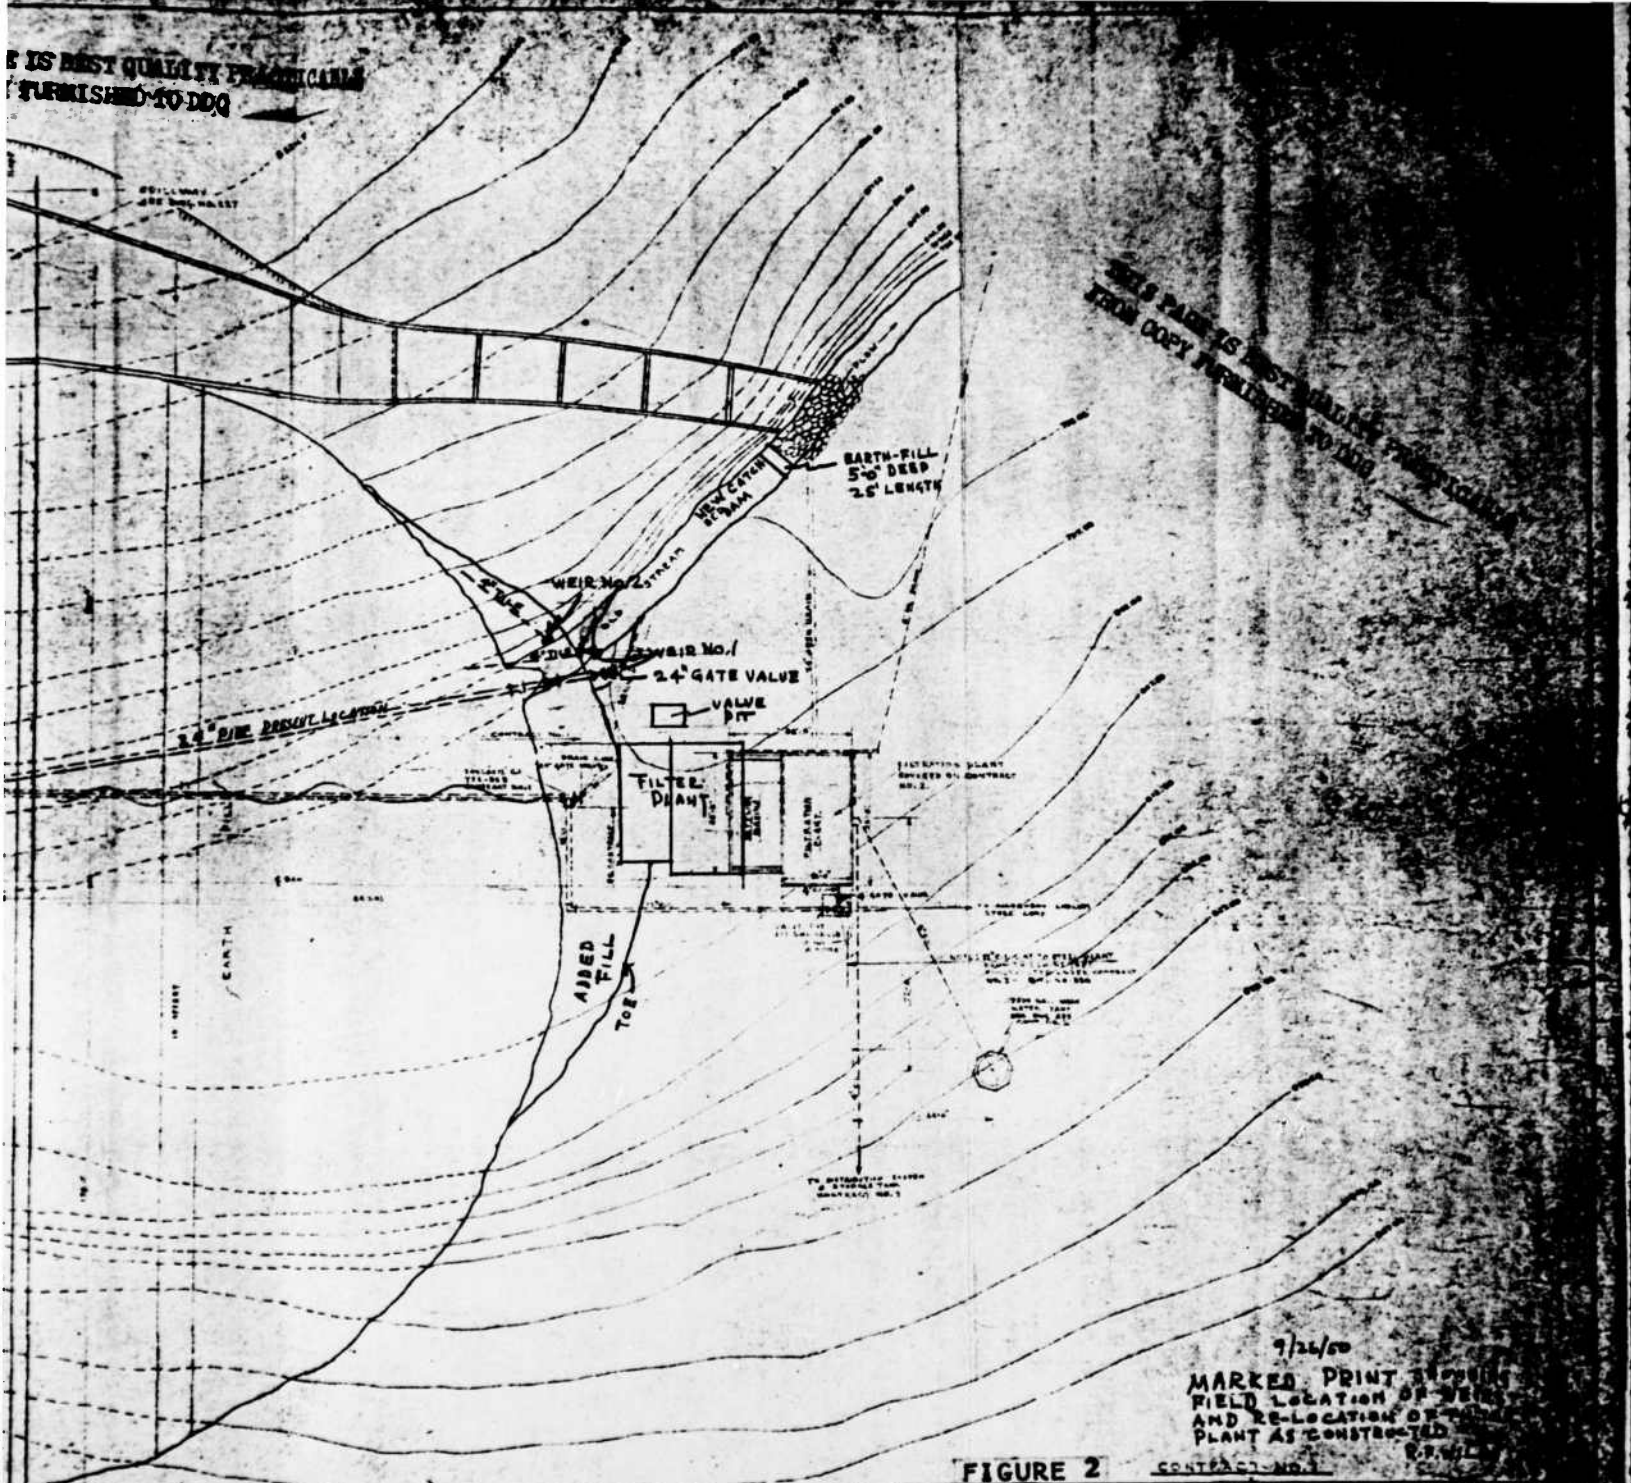
FIGURE 2 CONTRACT NO. 1

Tile drains observed adjacent to the discharge of the blow-off conduit located approximately 25 feet to the left of the treatment facility at the toe of the embankment. The location of the drain lines are shown on design drawings (see Figure 2, Appendix F).
