National Dam Inspection Program. Locust Lake Dam (NDS-ID-PA-00666, DER-ID-54-164) Delaware River Basin, Locust Creek, Schuylkill County, Pennsylvania. Phase I Inspection Report.

LOCUST LAKE DAM

NDS ID No. PA-00666
DER ID No. 54-164

PHASE I INSPECTION REPORT

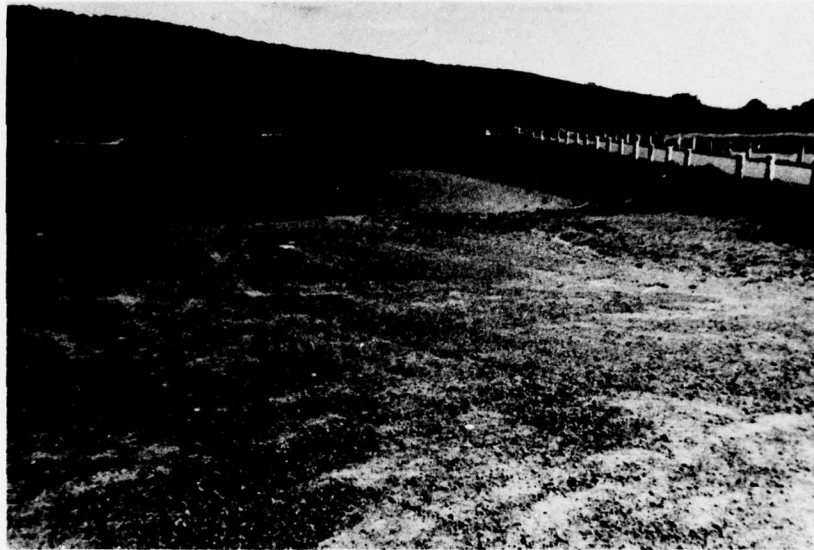
(2) There is some concern for the fact that the riprap on the upstream face does not extend to the top of the embankment. General practice is to provide upstream slope protection from the top of the dam to a safe distance below normal pool level. The unprotected portion of the upstream slope could be eroded by wave action during a flood condition.

(2) Upstream Slope. It was observed that the riprap does not extend to the dam crest. The detailed description and evaluation of the condition are in Paragraphs 3.1b. and 3.2a.(2), respectively.

A. Upstream Slope of Embankment.
View from Spillway Approach Channel.

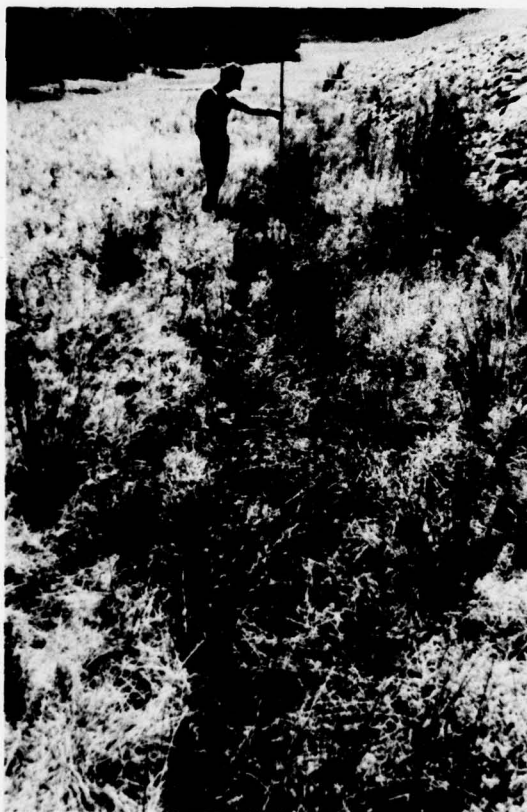
(3) There is some concern for the wet area at the downstream toe of the embankment. Wet areas were first observed near the toe in 1972, and the drainage ditch system described in Paragraph 2.1b. was built to provide an outlet for the wet areas. Control of the wet area by the drainage ditch system is satisfactory. The general area is being monitored by the park forces.

(3) Downstream Slope. A wet area was located along the toe of the embankment. The detailed description and evaluation of the condition are in Paragraphs 3.1b. and 3.2a.(3), respectively.

F. Wet Area at the Downstream Toe of Embankment.

(1) Install two or more observation wells, or other instrumentation, downstream from the axis of the dam. The instrumentation should be located in the vicinity of the wet area at the toe of the embankment to determine the water level in the downstream embankment. Periodically monitor and record the water levels and continue to observe the wet area so that any change in conditions is apparent.

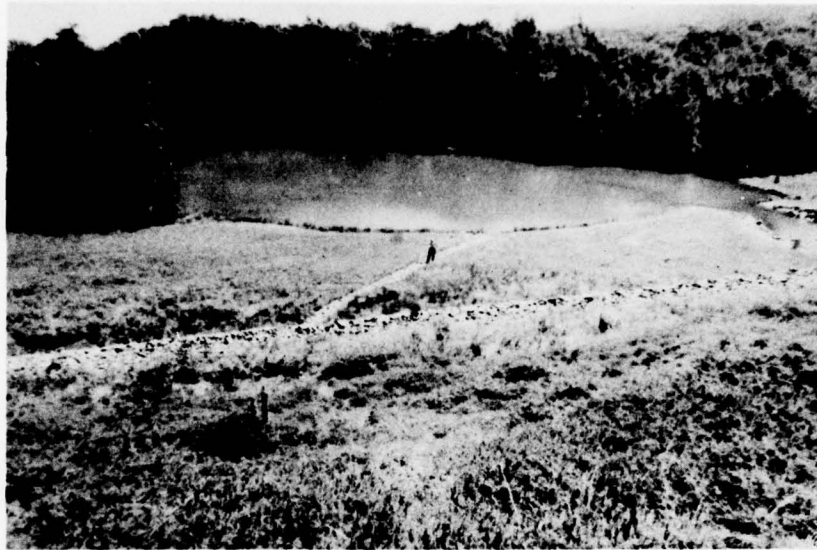
VISUAL EXAMINATION OF	OBSERVATIONS	REMARKS OR RECOMMENDATIONS
DRAINS (Continued from page B-3)	<p>The main component of the rock-fill drainage ditch system is a 3-1/2' wide, 80' long rockfill ditch that extends from the toe area to a small lake d/s from the dam. The main ditch is about 100' to the left of the outlet works. A lateral rockfill ditch is located 30' from the toe and extends 30' to the left. A second lateral rockfill ditch is located 50' from the toe and extends 20' to the right.</p>

G. Rockfill Drains below the Downstream
Toe of Embankment.

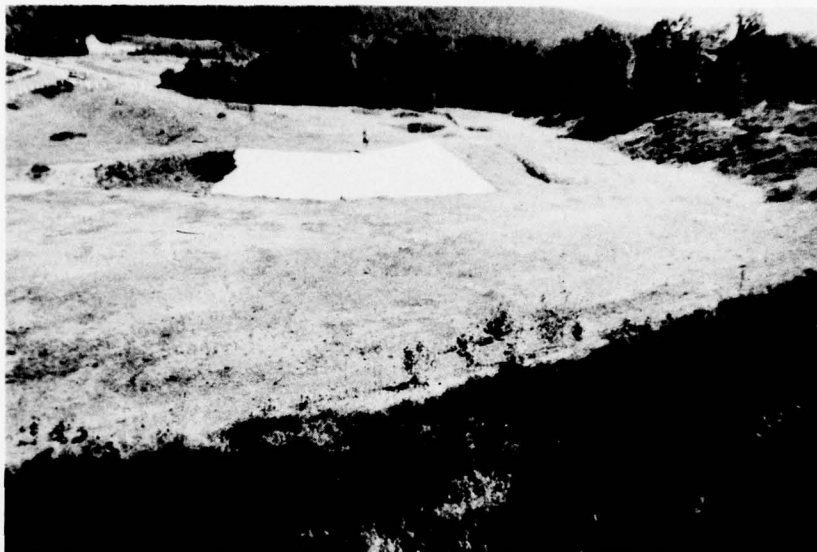
(1) Spillway. The spillway approach channel and outlet channel have a grass cover, and the sod is intact and is in good condition. No debris was present, and no abnormalities were observed.

I. Spillway Channel.
View from the Right Hillside.

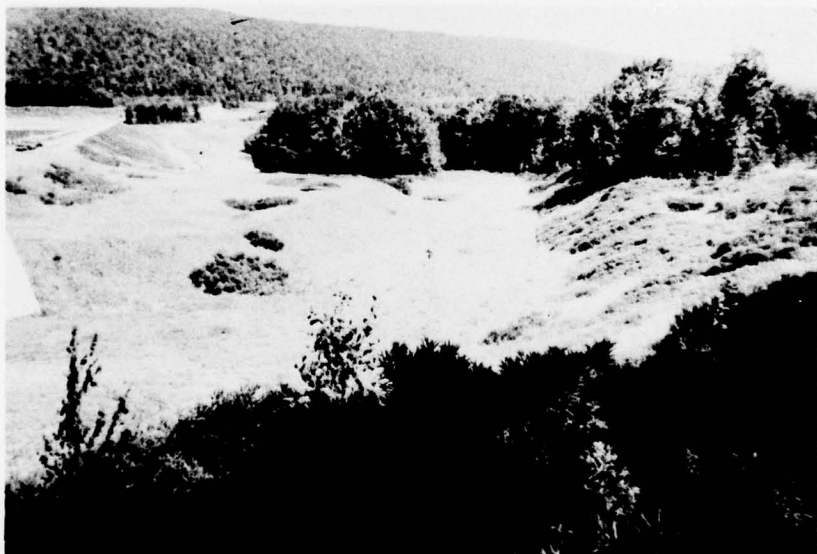
VISUAL EXAMINATION OF	OBSERVATIONS	REMARKS OR RECOMMENDATIONS
CONCRETE WEIR	None.	
APPROACH CHANNEL	Flat and clear.	
DISCHARGE CHANNEL	Clear. The channel is grassed, and the sod is intact and in good condition.	
BRIDGE AND PIERS	None.

J. Spillway Outlet Channel.
View from the Right Hillside.

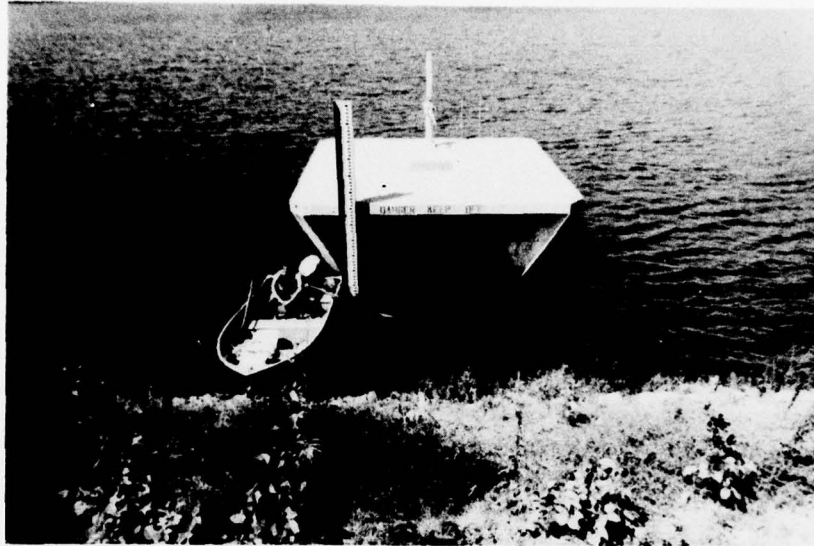
(2) Outlet Works. There is a fine crack about 18 inches long on top of the intake structure deck over the air vent at the southeast corner. There is another crack on the intake structure on the downstream face where the staff gage is bolted to the structure. The crack is about 2 feet long and about 1/8 inch wide. Both cracks are above normal pool elevation. The concrete of the outlet conduit is in very good condition. There is a fine crack in the

(2) There is slight concern for the two cracks on the intake structure. The cracks are relatively small, and the integrity of the intake structure is not in question. Because the air vent on the intake structure would be submerged at maximum pool level, the ultimate capacity of the outlet works is uncertain. In addition, debris could cause significant blockage of the intake structure and greatly reduce the outlet works capacity.

K. Intake Structure and Staff Gage.

(3) Visually monitor the two small cracks on the intake structure deck. Also, visually monitor the fine crack in the right wall of the outlet conduit. If changes are noted, take appropriate action.
