**SAWMILL RUN DAM
(ARMCO)**

NDI I.D. NO: 915

**PHASE I INSPECTION REPORT
NATIONAL DAM INSPECTION PROGRAM**

**D'APPOLONIA CONSULTING ENGINEERS
10 DUFF ROAD
PITTSBURGH, PA. 15235
SEPTEMBER 1978**

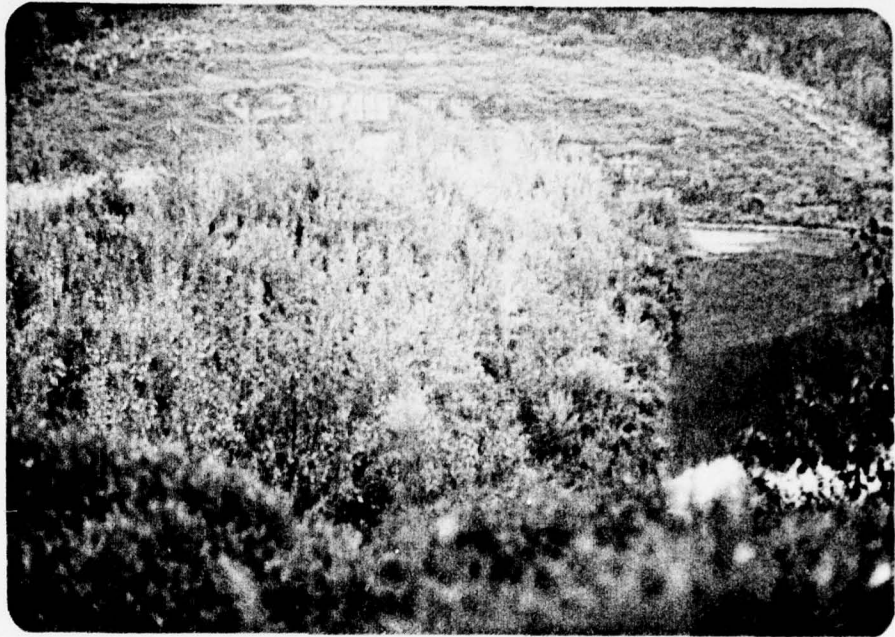
Upstream Face

Both upstream and downstream faces of the dam were observed to be covered with brush and trees up to 10 feet high. This condition precluded close inspection of the embankment. To the extent that is visible, no signs of distress or seepage were found on the embankment or immediate area below the toe. A swampy area was observed on the left abutment approximately 200 feet downstream from the dam located between the valley wall and the ash disposal area haul road. Standing water is visible, but no flow was observed. It appeared that the probable source was surface runoff trapped due to surface grading for the slag disposal area.

1. Brush and trees should be removed from the upstream and downstream faces of the dam.
2. The steep rock cut along the spillway channel should be observed frequently and necessary remedial measures taken to prevent major rock slides that may partially block the spillway channel.
3. It is also recommended that an upstream control be installed on the outlet pipe, consisting of either a permanent structure or temporary means of blocking the upstream end of the pipe in the event it is necessary to drain the outlet pipe.
4. The owner should provide around-the-clock surveillance during periods of unusually heavy runoff and develop a formal warning system to alert the downstream residents in the event of emergencies.
5. It is recommended that the owner be advised that the dam and the appurtenant structures should be inspected regularly and be properly maintained.

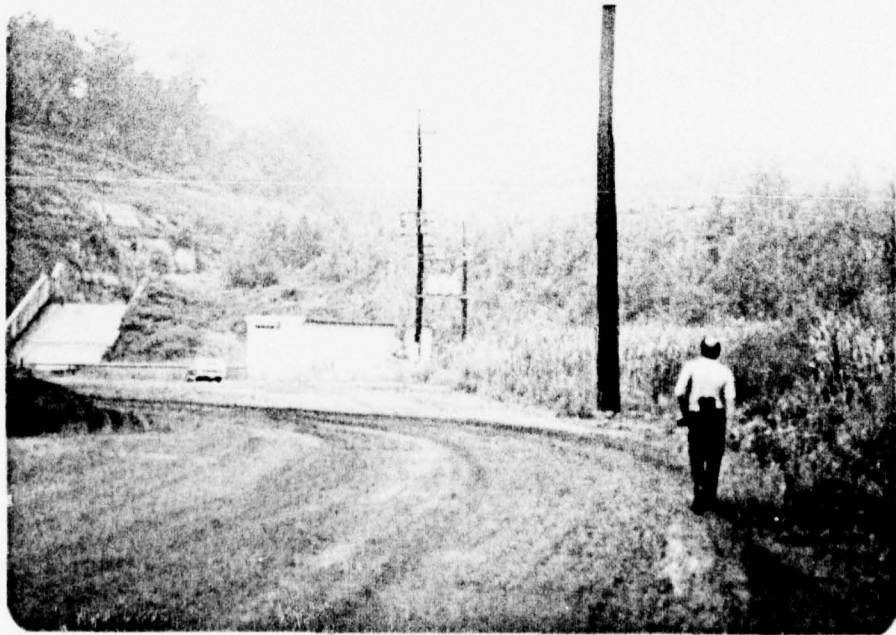
Downstream Face

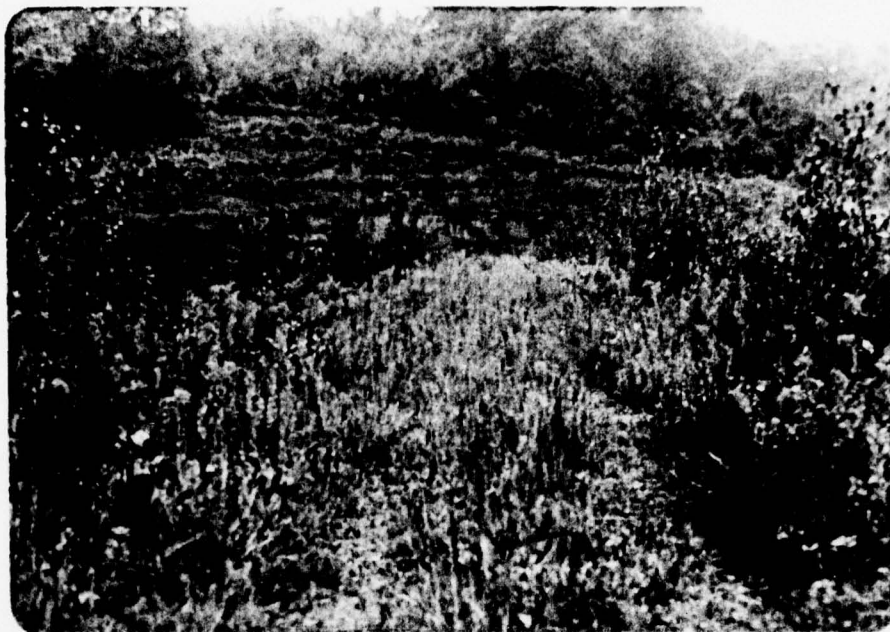
Photograph No. 1
Crest (looking west).

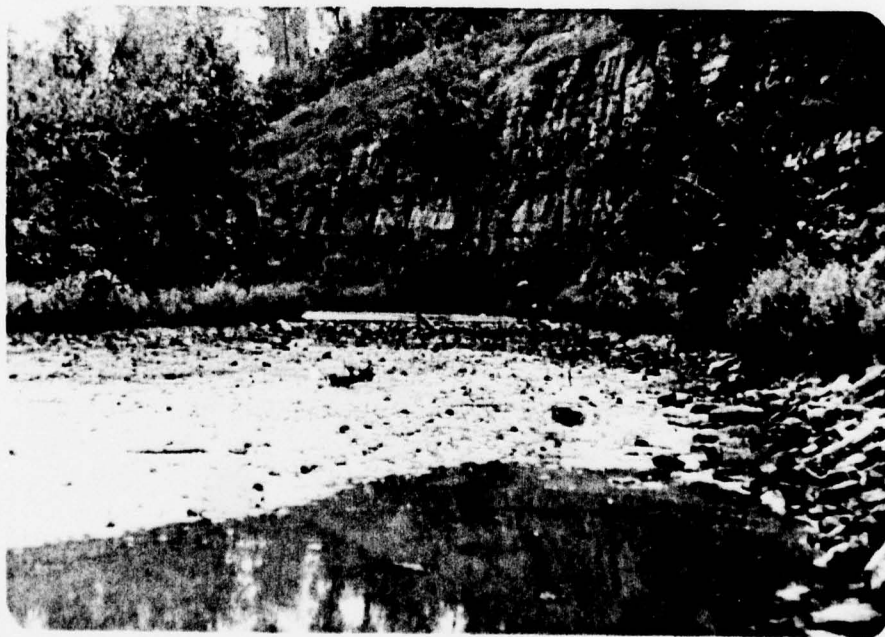
Photograph No. 2
Spillway approach channel.

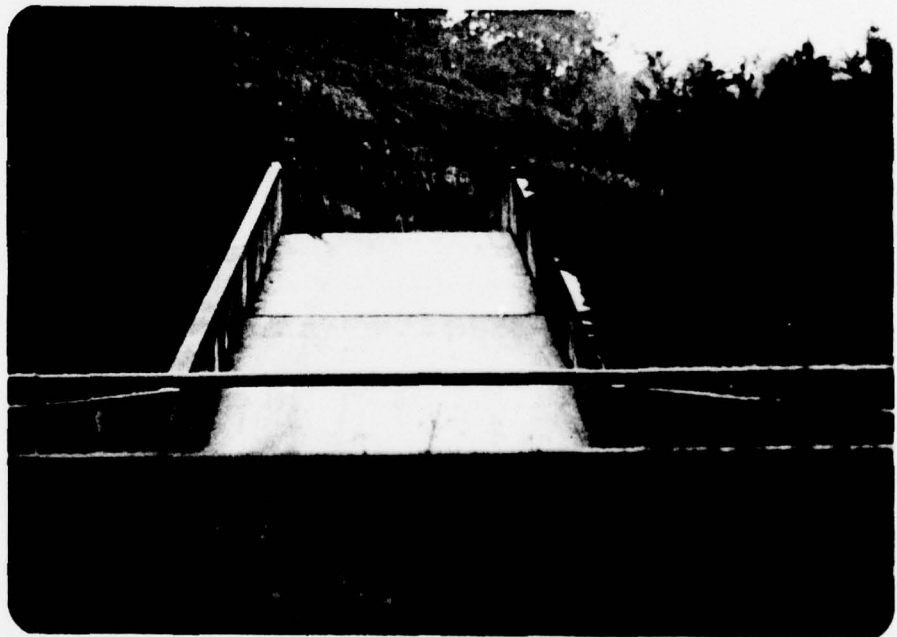
Photograph No. 4
Spillway chute.

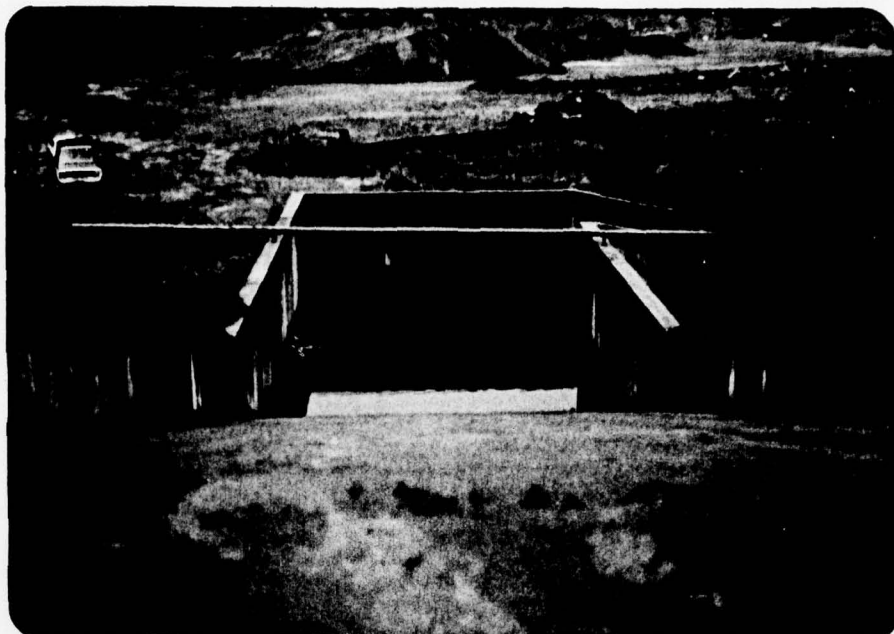
Photograph No. 5
Stilling basin.

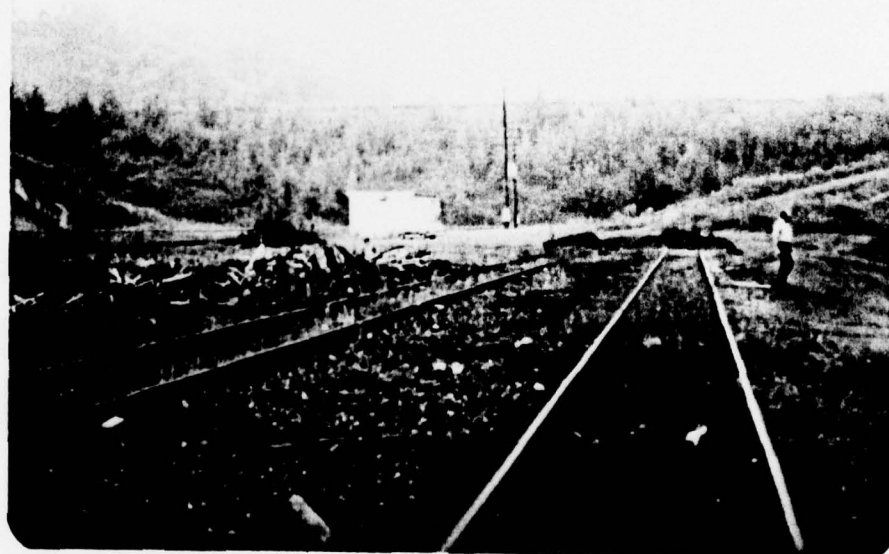
Photograph No. 6
Valve and pump house at the toe of the dam.

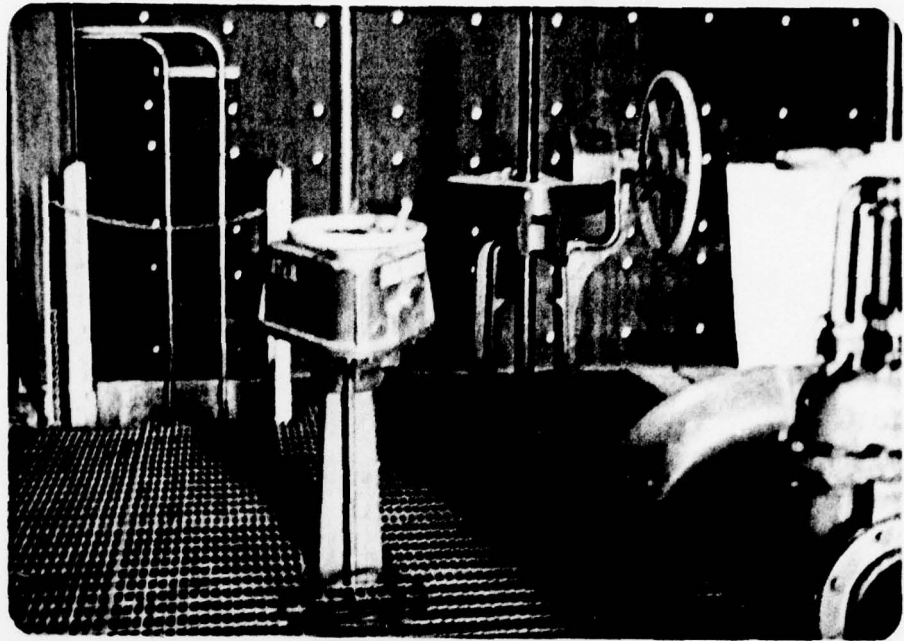
The blow-off valve was operated and observed to be functional.

Photograph No. 7
Blow-off valve control.

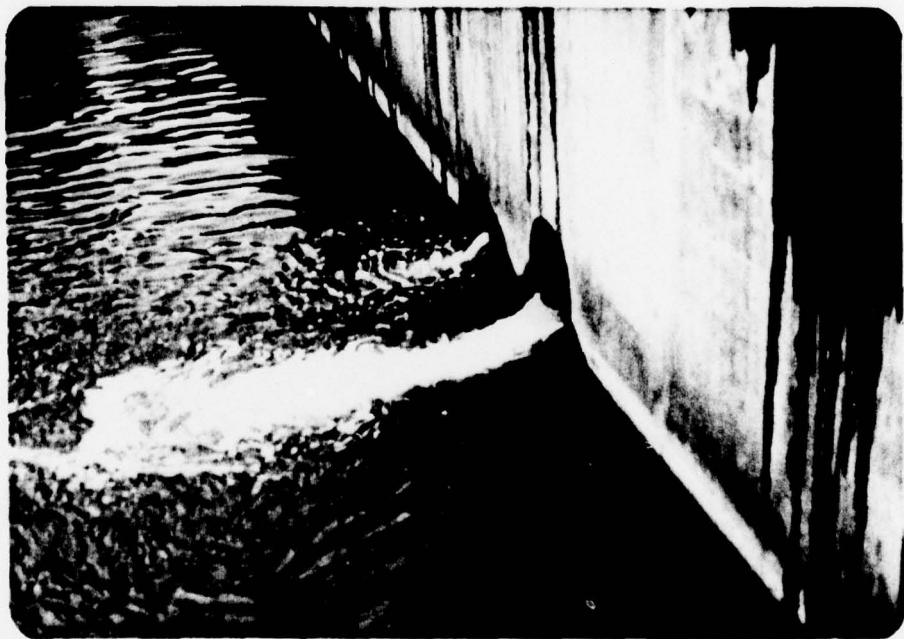
Photograph No. 8
Blow-off pipe discharging.
