PHASE I REPORT
NATIONAL DAM INSPECTION PROGRAM

NAME OF DAM: Indian Lake Dam
STATE LOCATED: Pennsylvania
STREAM: Calendar Run, secondary tributary of Stoney Creek, a tributary
of the Conemaugh River
DATE OF INSPECTION: (May 17 and 30, 1978),

INDIAN LAKE DAM
MAY 16, 1978

PHASE I
NATIONAL DAM INSPECTION PROGRAM
INDIAN LAKE DAM
NDI I.D. NO. 228
DER I.D. NO. 56-103

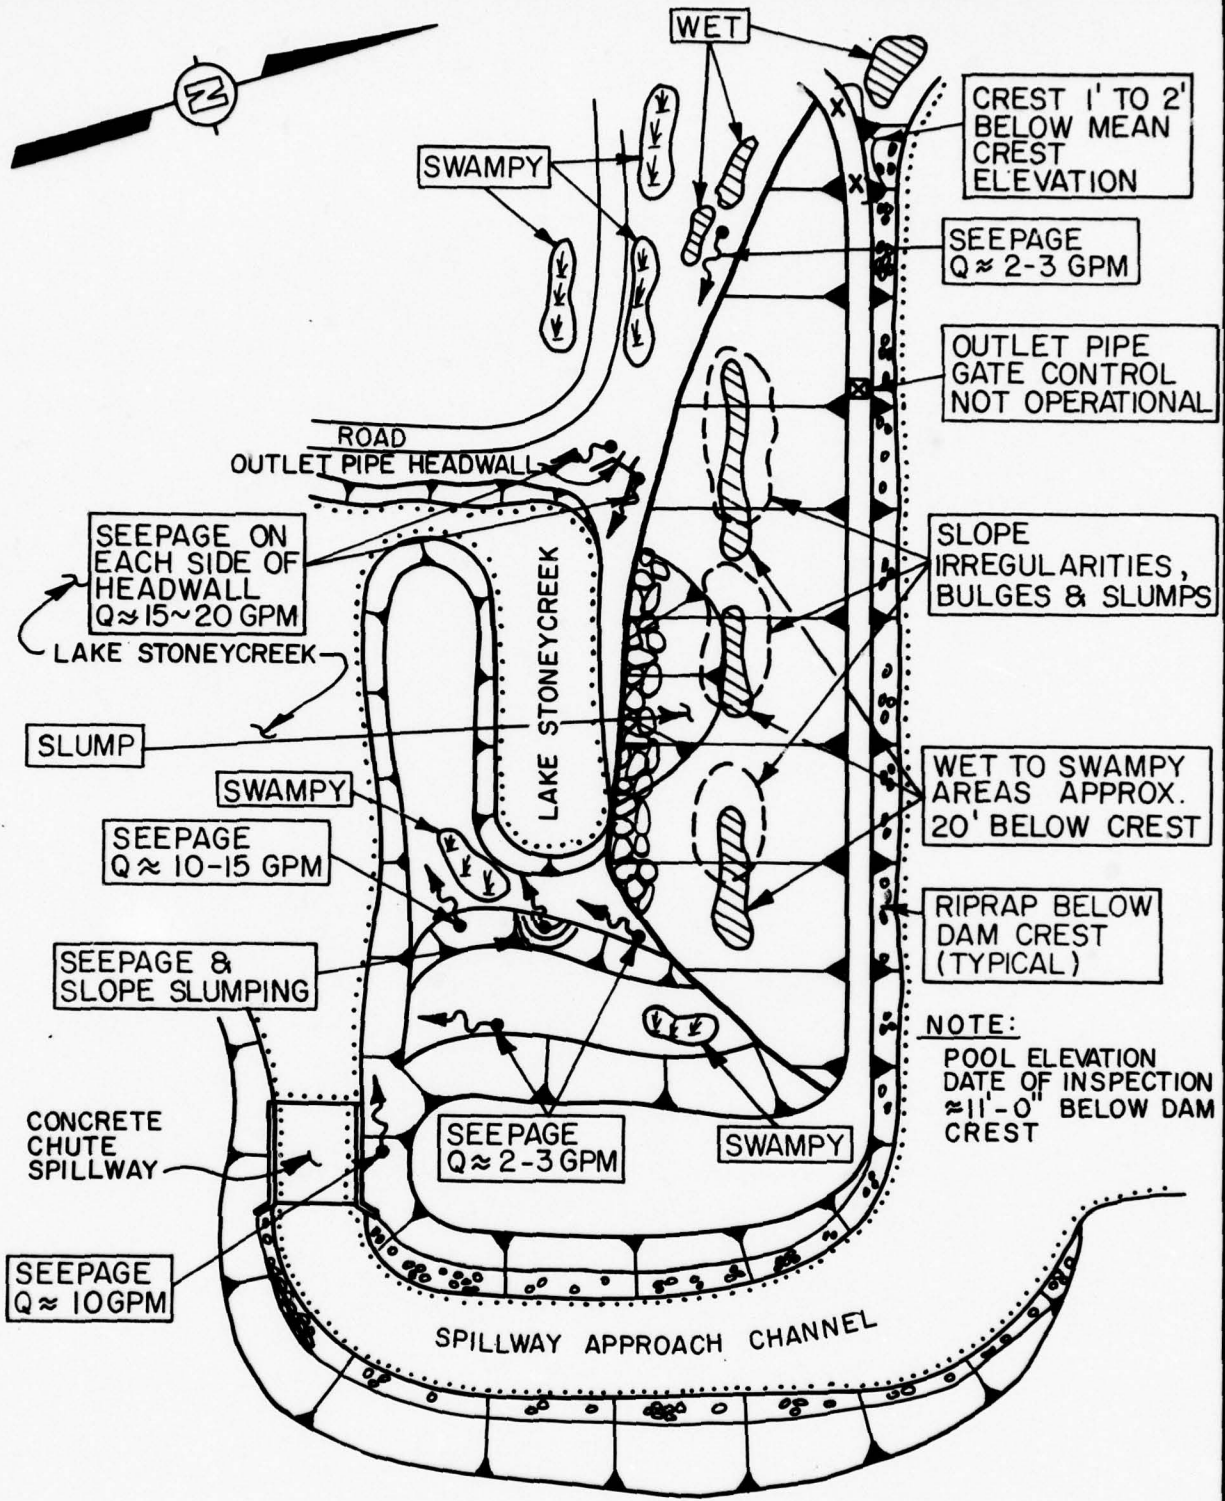
CREST 1' TO 2'
BELOW MEAN
CREST
ELEVATION

SEEPAGE
Q ≈ 2-3 GPM

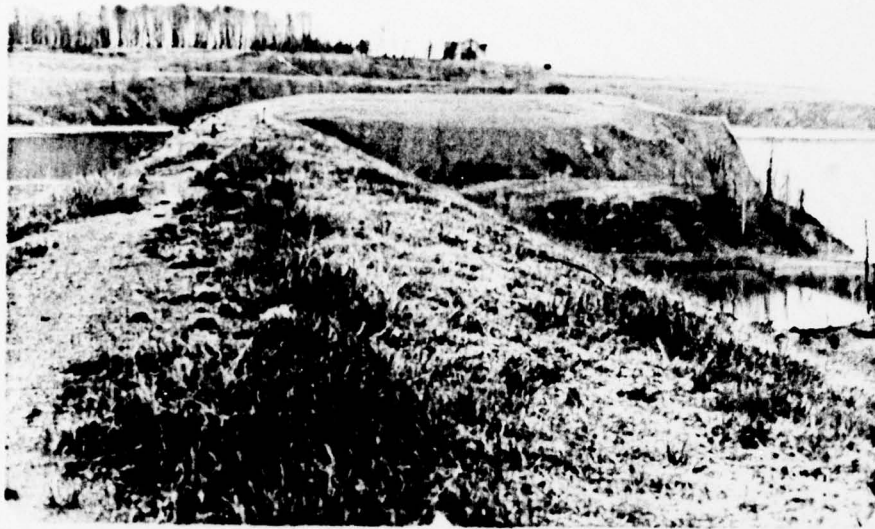
Photograph No. 1
Dam crest.

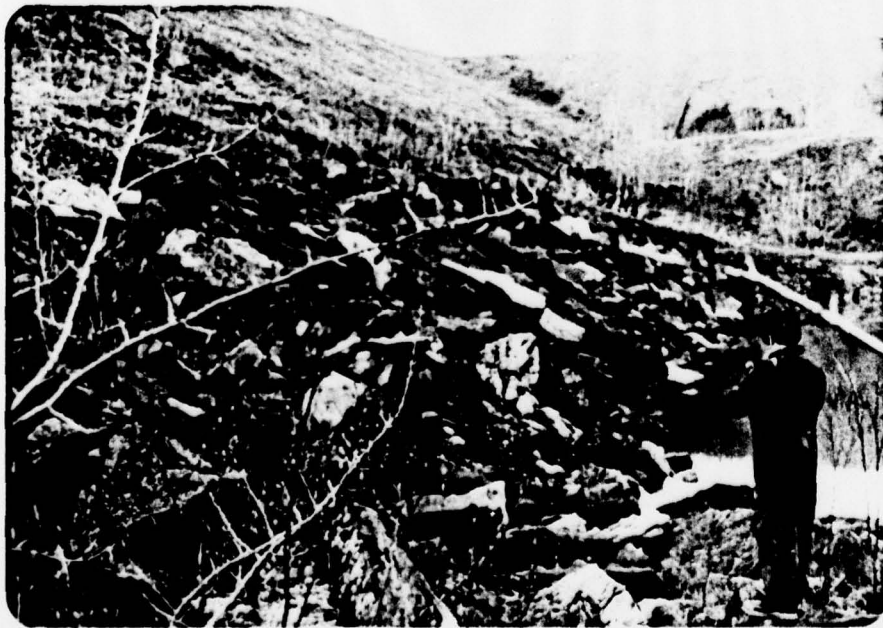
Photograph No. 2
Dam toe.

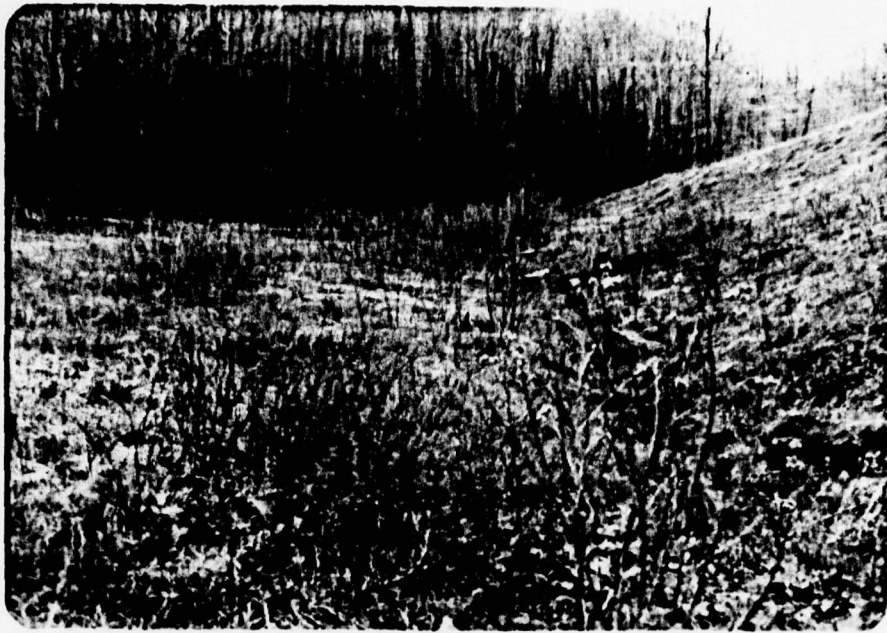
Photograph No. 3
Right abutment.

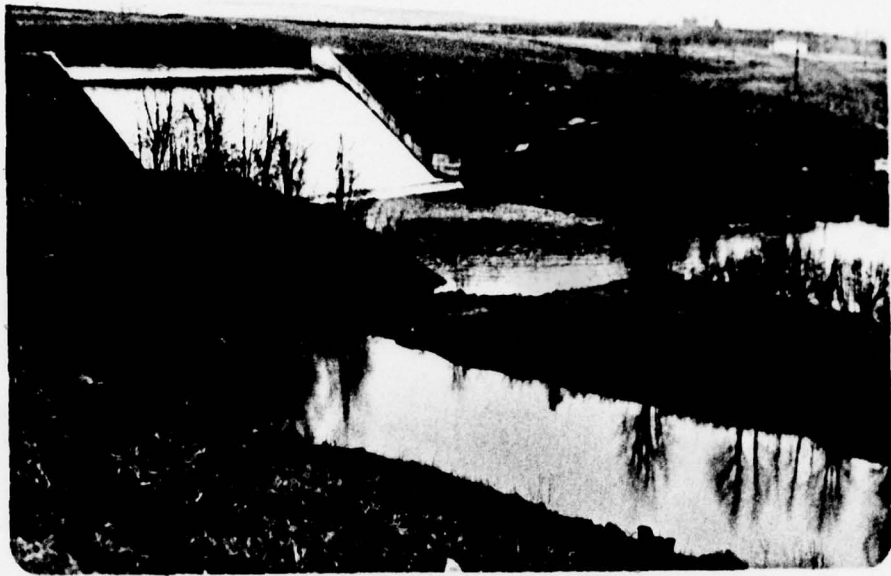
Photograph No. 5
Spillway and plunge pool.

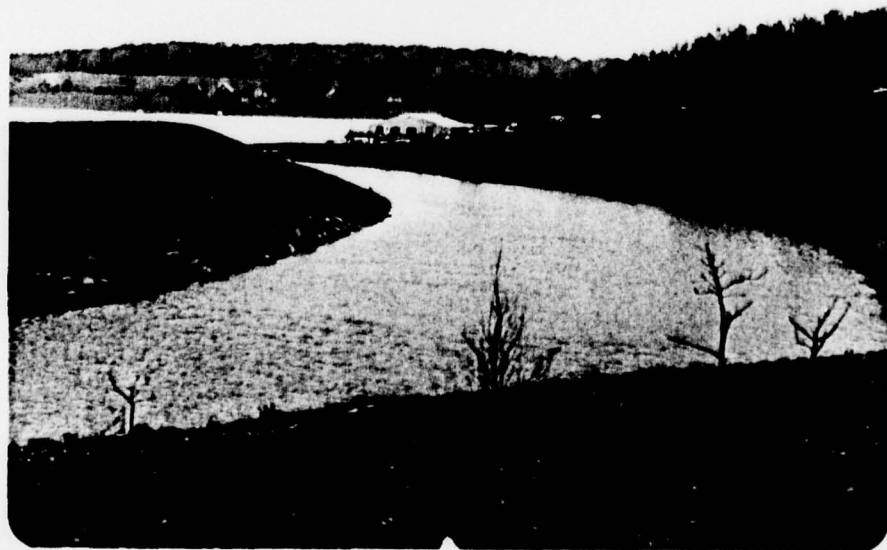
Photograph No. 5
Spillway approach channel.

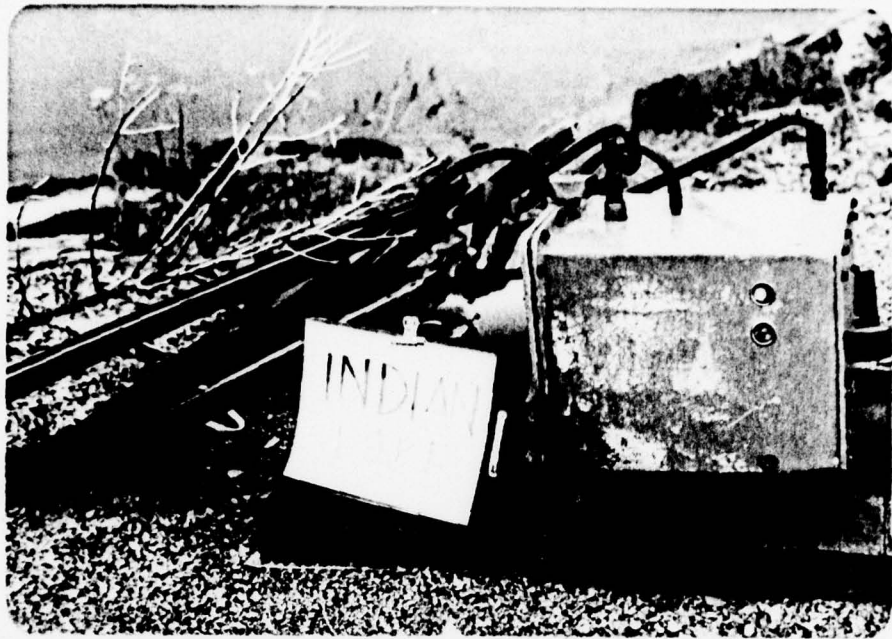
Photograph No. 7

The outlet pipe gate, which is the only emergency drawdown facility for the impoundment, is inoperative and should be repaired immediately.

Outlet pipe valve hydraulic control (nonfunctional).

c. Urgency. Further investigation of the dam and repairs to the outlet pipe sluice gate should be implemented immediately. The other recommendations should be considered as soon as practicable or on a continuing basis.

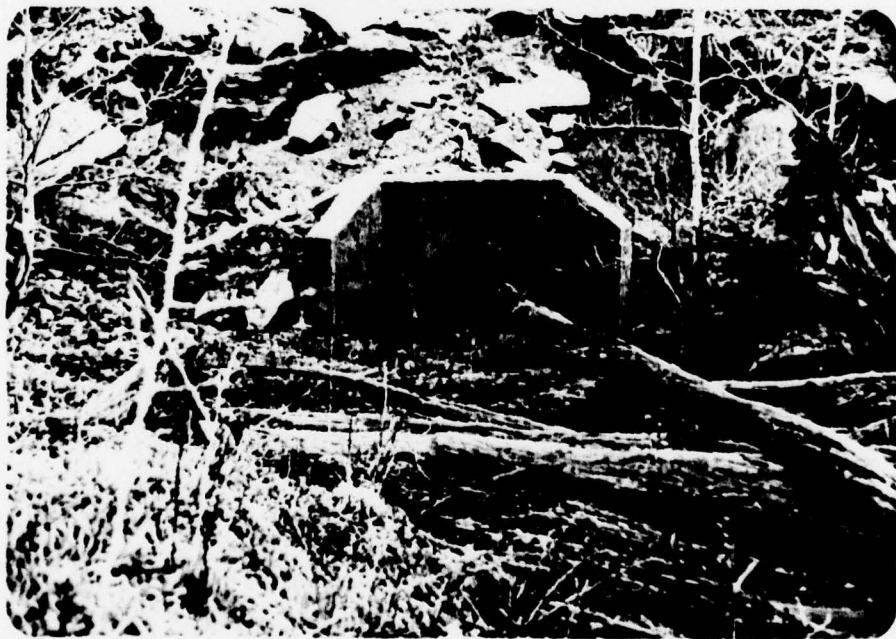
Photograph No. 8

Outlet pipe.

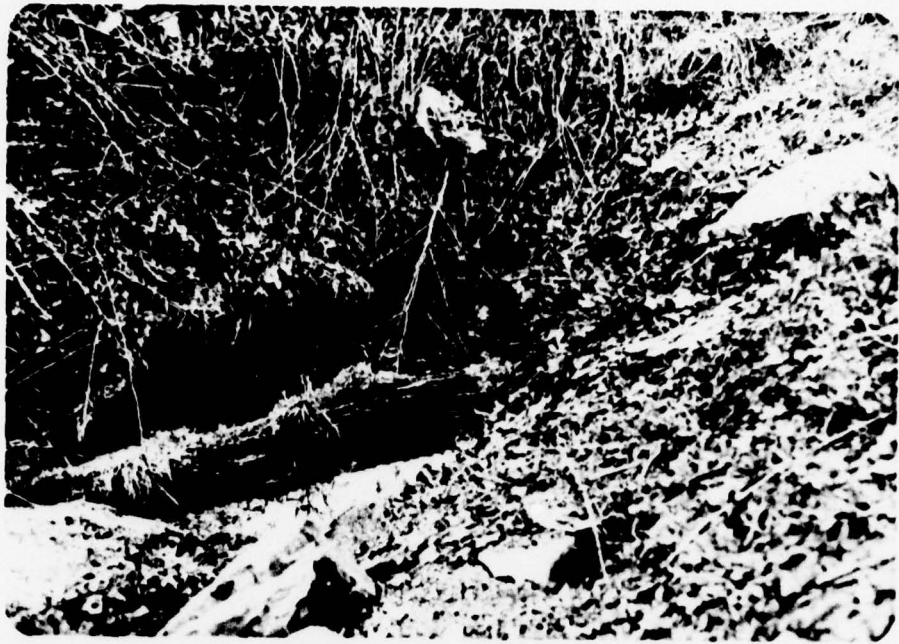
Photograph No. 9
Right abutment toe drain.

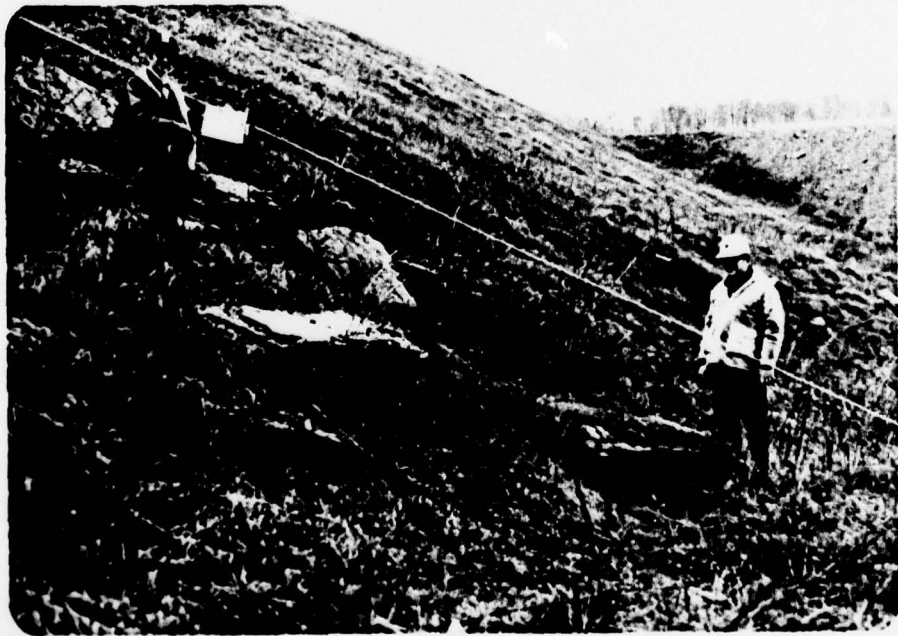
1. Numerous wet areas were observed on the downstream slope at a level approximately 20 feet below the crest of the dam.
2. The middle one-third of the downstream slope in the vicinity of the toe appeared to have slumped in the past. However, no surficial cracks were observed.
3. Numerous concentrated seeps and wet areas were observed on the left abutment through the natural ground. The estimated quantity of seepage is shown in Plate 6. Seeps were clear and no indication of internal erosion was observed.
4. Several wet and swampy areas were also observed on the right abutment in the vicinity of the toe of the dam.

The most significant condition at the dam appears to be the wet areas noted on the downstream face and associated surface irregularities. These conditions suggest possible high phreatic surface (probably perched) through the embankment and consequent instability.

Photograph No. 10
Dam downstream slope irregularity near center.

1. The stability of the dam and methods for controlling existing seepages should be further evaluated in view of the following conditions: (a) the presence of slope irregularities and wet areas on the downstream slope, and (b) numerous seeps on each abutment.
2. Outlet pipe sluice gate controls should be repaired immediately.
3. The crest of the dam should be regraded and the upstream riprap should be extended to the design crest level.
4. The dam and appurtenant structures should be inspected regularly and any unusual conditions should be reported to the appropriate authorities.
5. The owner should develop a formal warning system to alert the downstream residents in the event of emergencies.

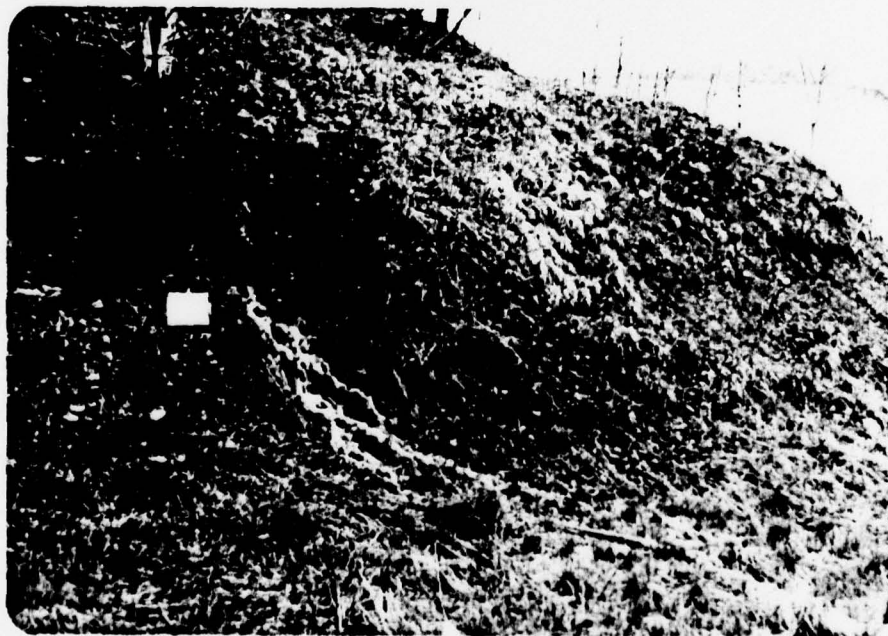
Photograph No. 12

Field observations show that wet areas and slope irregularities exist on the downstream face of the dam, which suggests potential instability of the embankment. Various seepages on the left abutment also require further evaluation, to determine the effect of these conditions on the overall performance of the dam.

Seepage at left abutment.

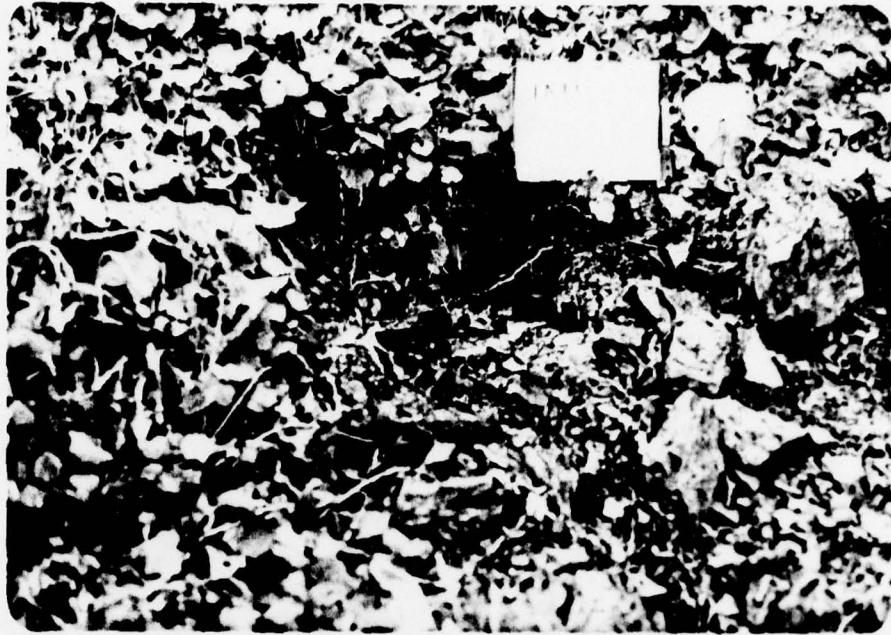
Photograph No. 13
Seepage near spillway right wing wall.

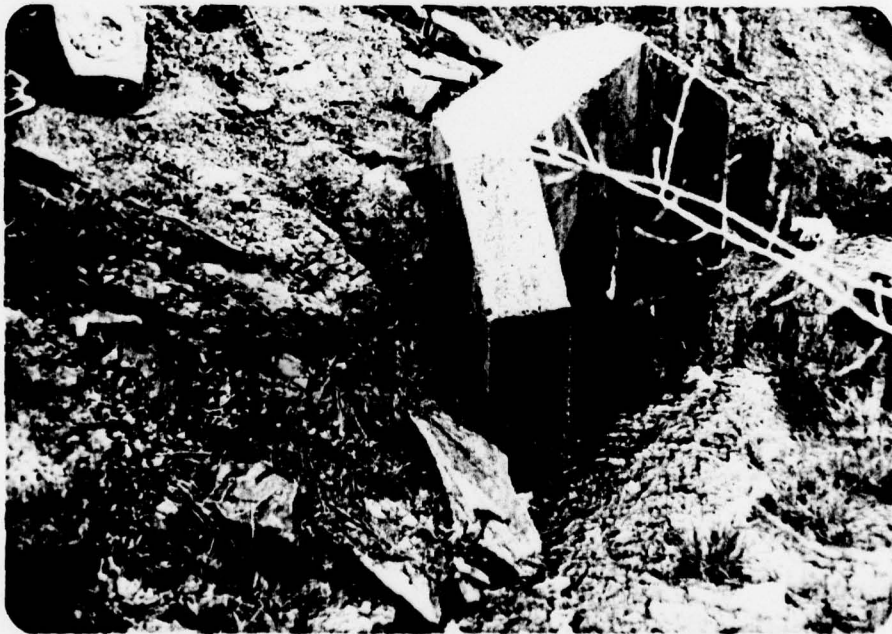
Photograph No. 14
Seepage around outlet pipe headwall.
