TECHNICAL REPORT E-79-6

FAILURE ANALYSIS INVESTIGATION OF NIKE-HERCULES HOISTING CHAIN

U.S. ARMY
MISSILE
RESEARCH
AND
DEVELOPMENT
COMMAND

22 December 1978

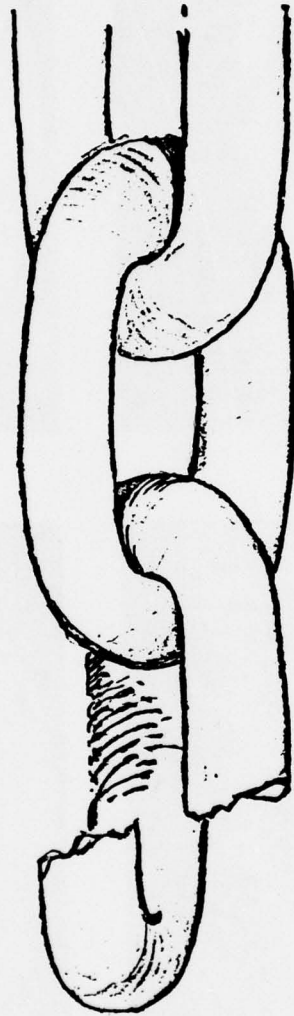
Reports received from NEAS (Dave Kutz) were that the chain failed during lifting and handling of the missile, and that upon failure the missile dropped approximately 6 in. (15.24 cm) before coming to rest. Failure in the chain link was approximately 2-ft (0.61-m) above the chain hook.

Approximately 12 ft (3.7 m) of the chain was received from DRSMI-NSS with the failed link attached to the main chain body as shown in Figure 1.

Figure 1. Isometric representation of NIKE-HERCULES hoisting chain as received.

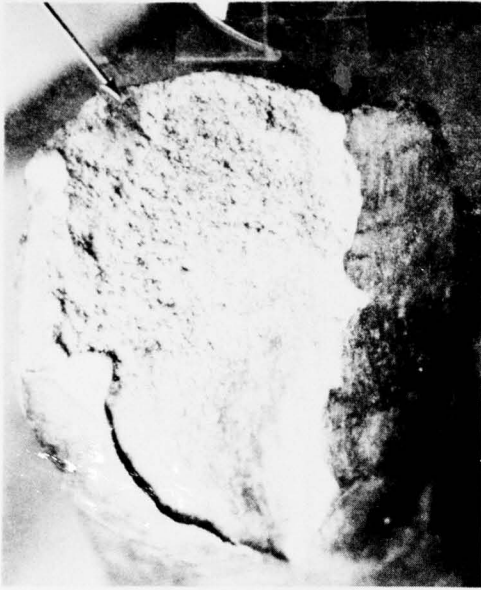
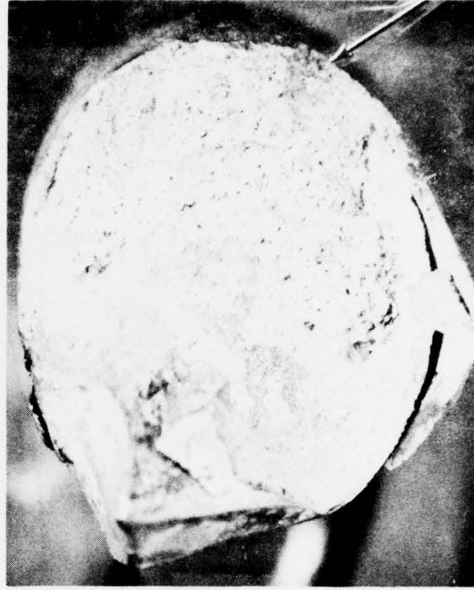
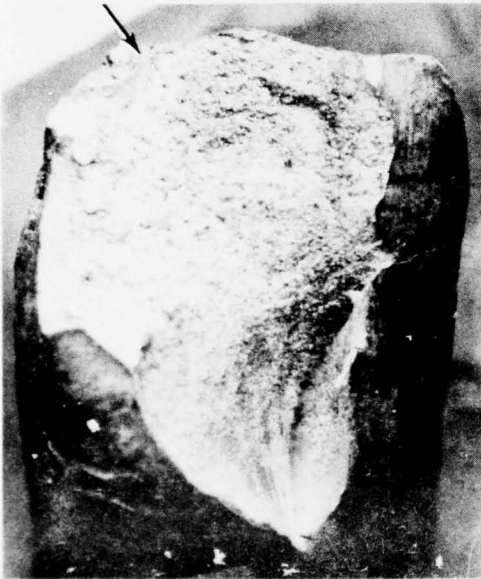
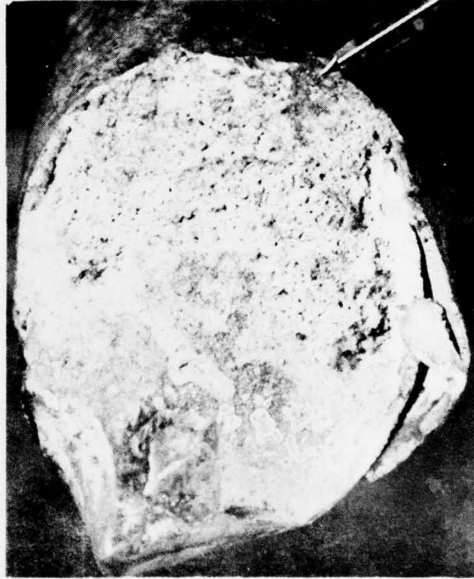
The failed link of chain was cut from its present link and macrographs of the fracture surface were taken. Figure 2 shows the mirror image fracture surfaces with the origin of failure indicated.

Because of the previously mentioned findings it is the opinion of the Materials Engineering and Development Laboratory that the chain failure was caused by an overloading condition and that the failure initiation site is as shown in Figure 2.

Figure 2. Macrograph mirror image of fracture surface (fracture origin at arrow) (magnification 6X).

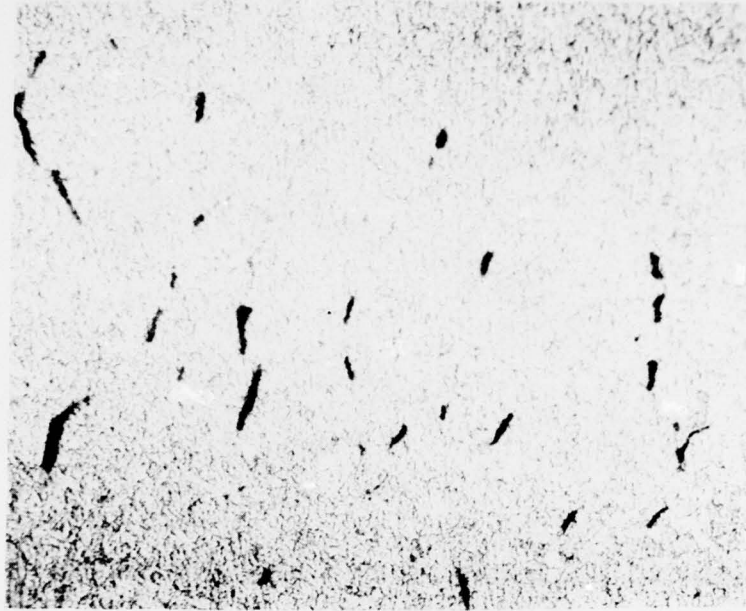
The metallurgical examination of the weld area, Figures 5 and 6, revealed cracks and voids in the old chain are representative of a typical welded chain link. The maximum depth of these internal cracks is 0.0022 in. (0.057 mm) as shown by Area (A) of Figure 6. (This scale factor is 0.4 in. = 0.0001 in.) The macrograph of the old chain weld area (Figure 3, Area C) shows surface cracks, the maximum depth of which is 0.0166 in. (0.4 mm). (This scale factor is 0.1 in. = 0.0166 in.)

Figure 5. Micrograph of Area (A) of Figure 3 (magnification 400X).

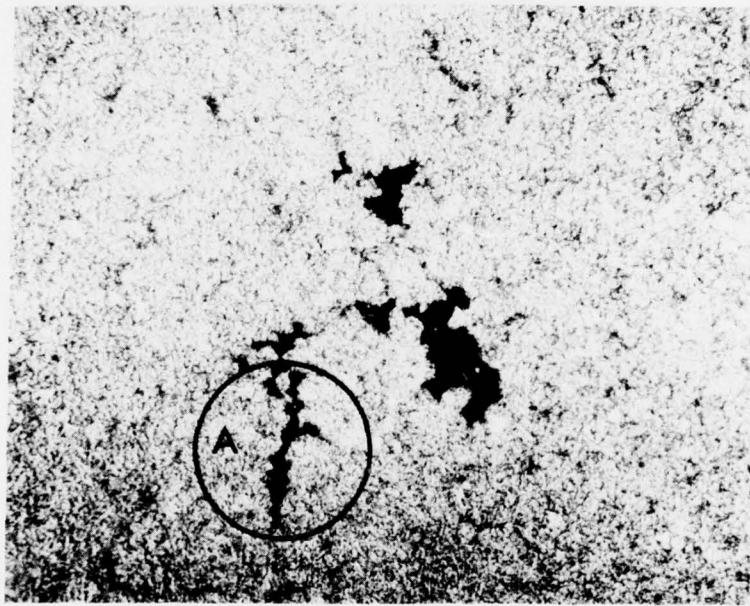
Previous studies conducted in the area of notch sensitivity of chains¹ of this alloy type indicate that this chain is virtually unaffected by the presence of a 0.1-in. (2.54-mm) deep flaw. As a result of this study one can readily see that the 0.0022-in. (0.057-mm) and 0.0166-in. (0.4-mm) crack depths, Figures 6 (Area (A)) and 3 (Area (C)), respectively, are of no serious consequence to sudden fracture of chains investigated in this study.

Figure 6. Micrograph of Area (B) of Figure 3.

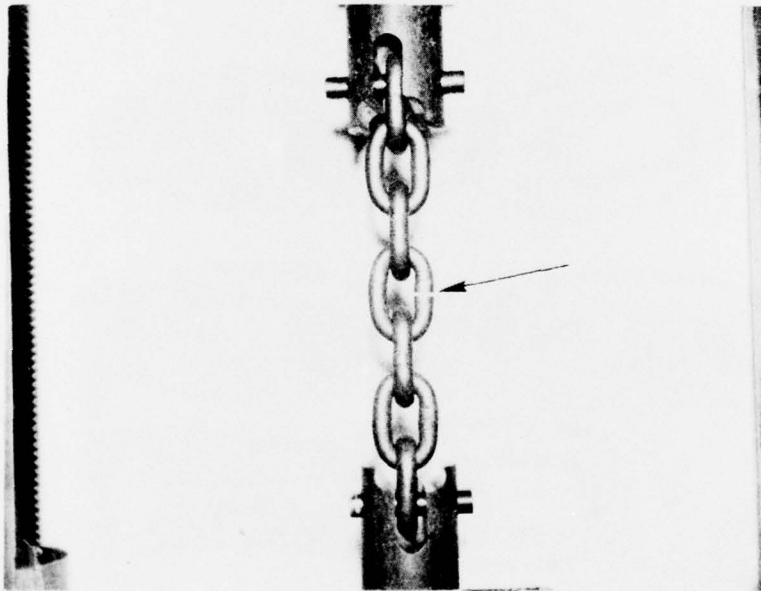
The tensile test conducted on the old chain with the weld cut through (Figure 8) exhibited an upper load limit of 6450 lb (28.7 KN). This link had an initial opening of 0.0700 in. (1.78 mm) at zero load. Deflection measurements were taken at five different load levels by stopping the test machine and using a feeler gage to measure the displacement in the cut link.

Figure 8. Tension test with weld area cut through (old chain).

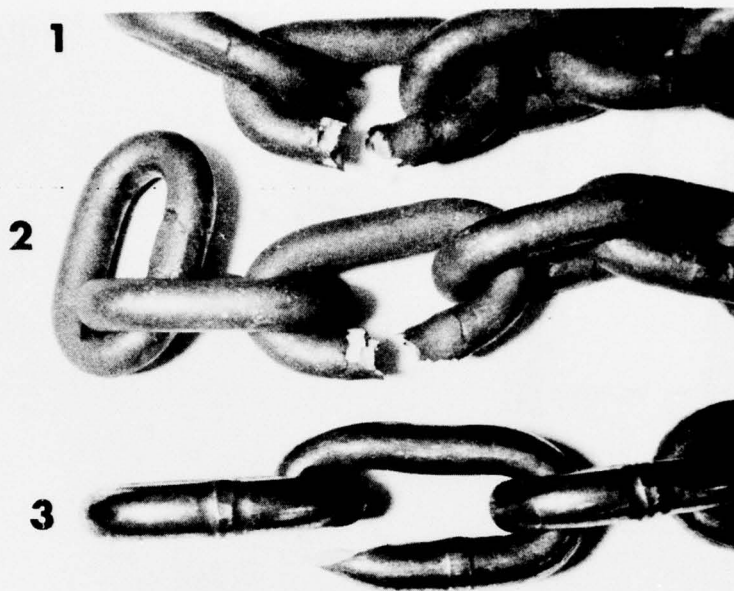
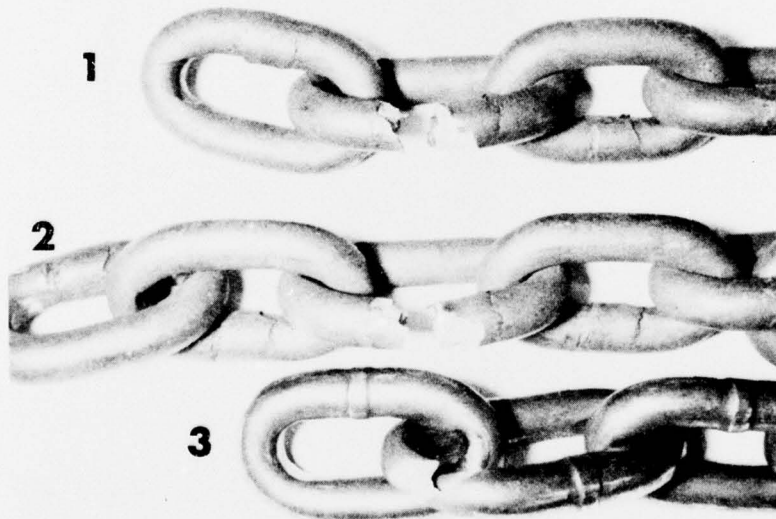
It should be noted that the fracture area in the old chain was through the weld area, while the new chain fractured in the base metal (Figures 9 and 10). This mode of failure is primarily because of the smaller effective weld area in the old chain. [See Figure 3, Area ① dimension, and Figure 4, Area ② dimension, for respective diameters of 0.482 in. (1.22 cm) and 0.550 in. (1.4 cm).]

Figure 9. Chain tensile failures on old chain Nos. 1 and 2, and new chain No. 3.

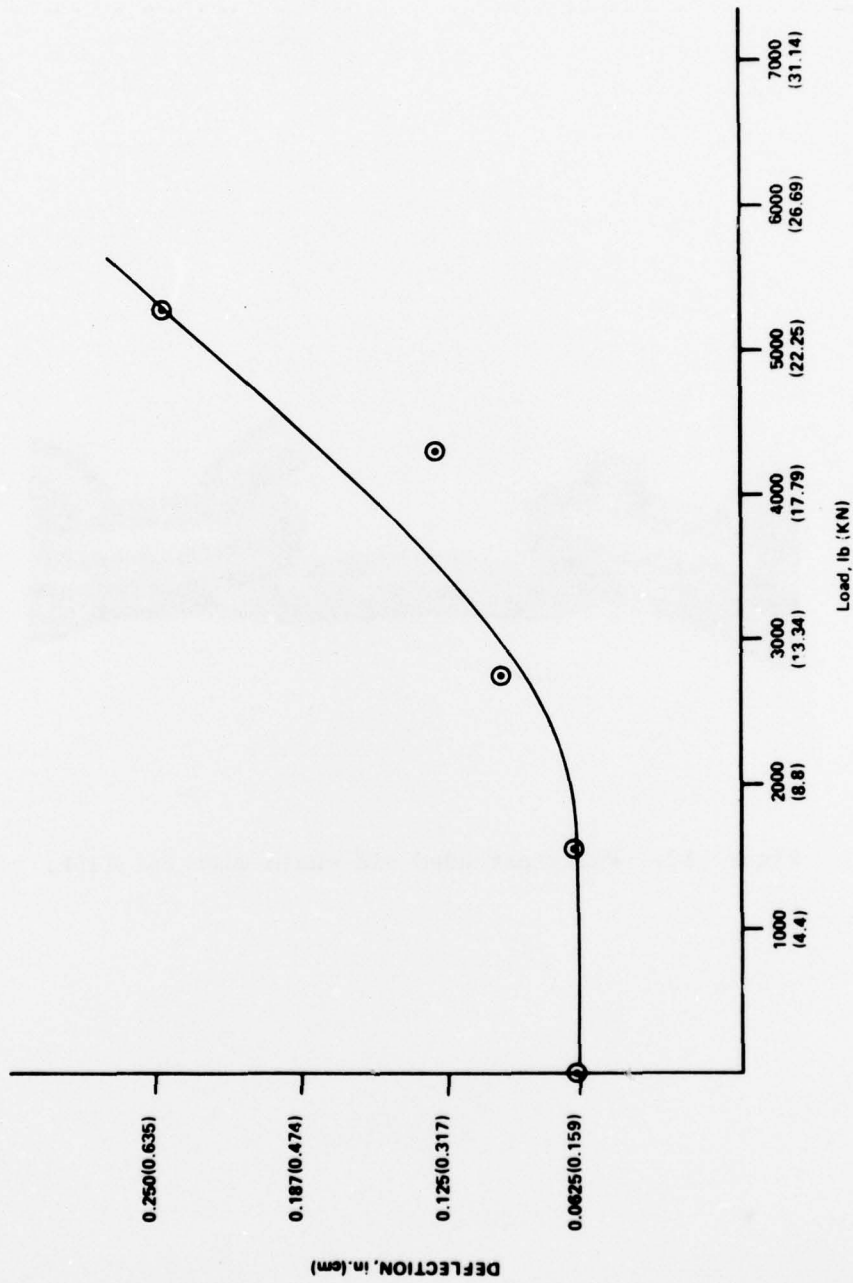
The cut opening increased in size as loading increased on the chain link. When the load level reached 6450 lb (29.6 KN) there was no further load increase (Figure 11), and the cut link extended and became disengaged from its parent link (Figure 12).

Figure 11. Load deflection curve of old chain with cut through weld.

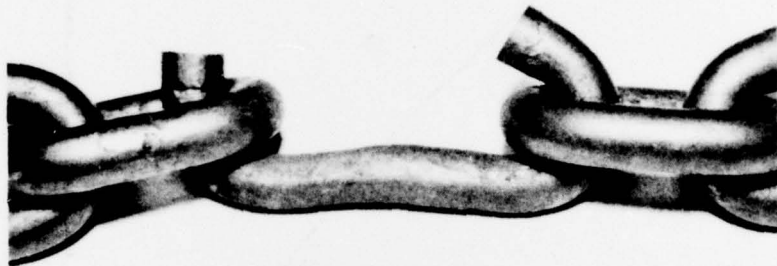
Figure 12. Fully extended old chain with cut link.
