MUSCOUT DAM

WESTCHESTER COUNTY  
NEW YORK

INVENTORY NO 61

**PHASE I INSPECTION REPORT  
NATIONAL DAM SAFETY PROGRAM**

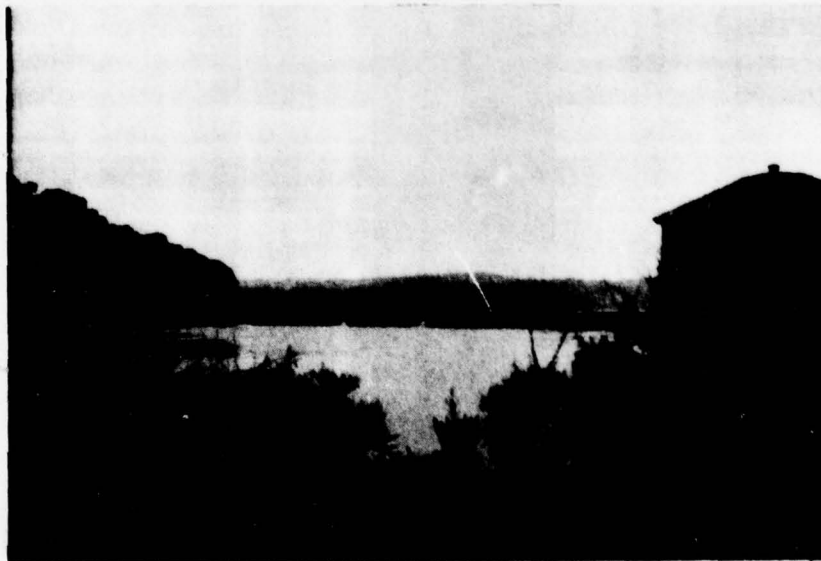
4. View from below dam.

The gate house was inspected (the structure can be seen in the right position of Photograph 4). Six sluice gates control the flow. One of the gates is jammed in the open position. The other five gates are operable.
