CEEDO-TR-78-16

Evaluation of Materials for Post-Attack Pavement Repair

U. S. ARMY ENGINEER WATERWAYS EXPERIMENT STATION
GEOTECHNICAL LABORATORY
P.O. BOX 631, VICKSBURG, MISS. 39180

SEPTEMBER 1978

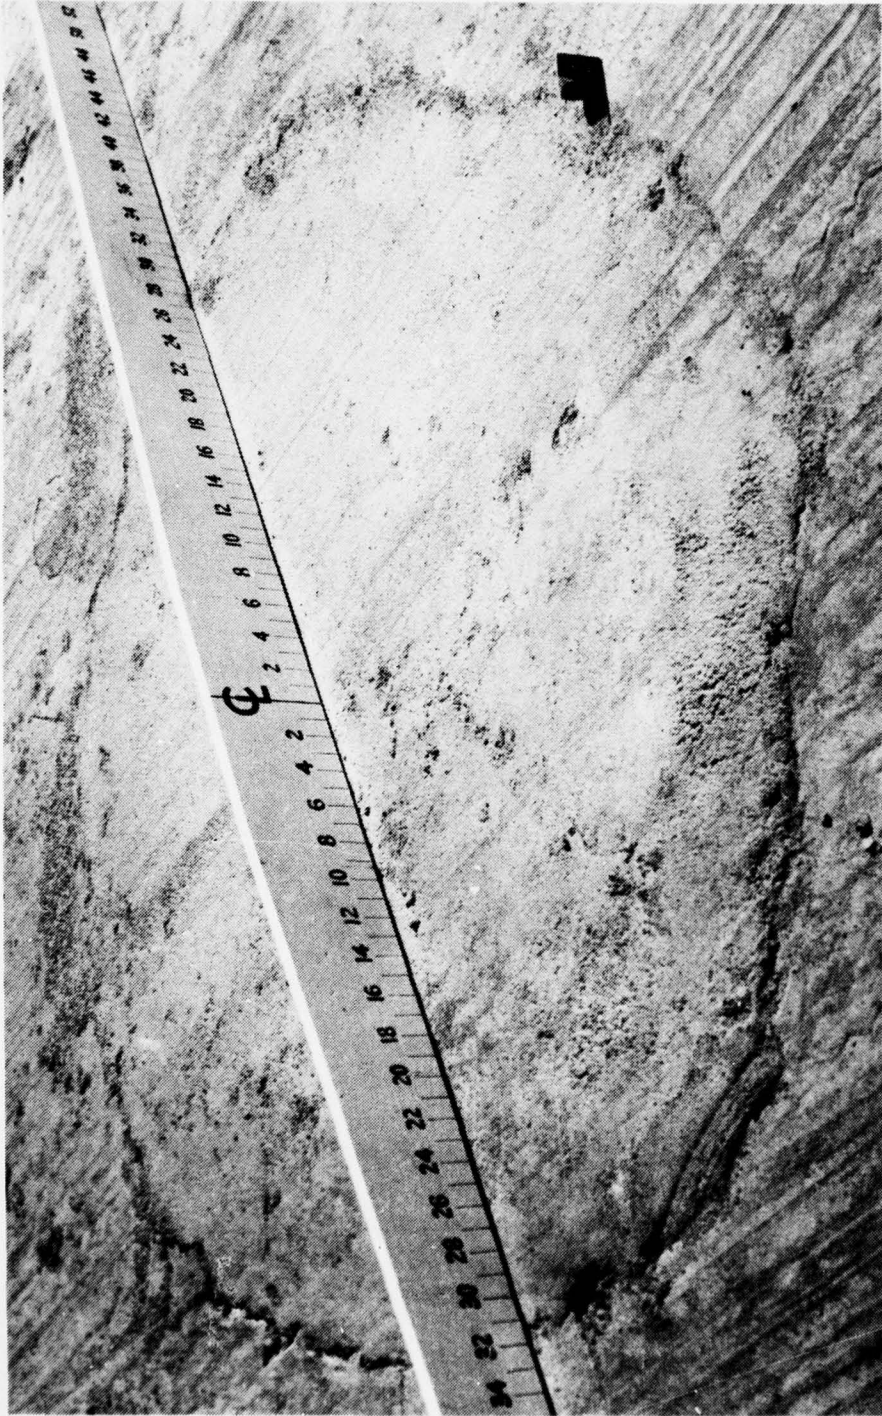
Traffic was applied to the repaired areas 42 minutes after placing. No damage was noted after 20 coverages (192 passes in 10-foot-wide traffic lane) as shown in Figures 13 and 14 for 2- and 5-foot repair area, respectively.

Figure 14. Surface of Darex 240 in 5-Foot-Diameter Area After 20 Coverages

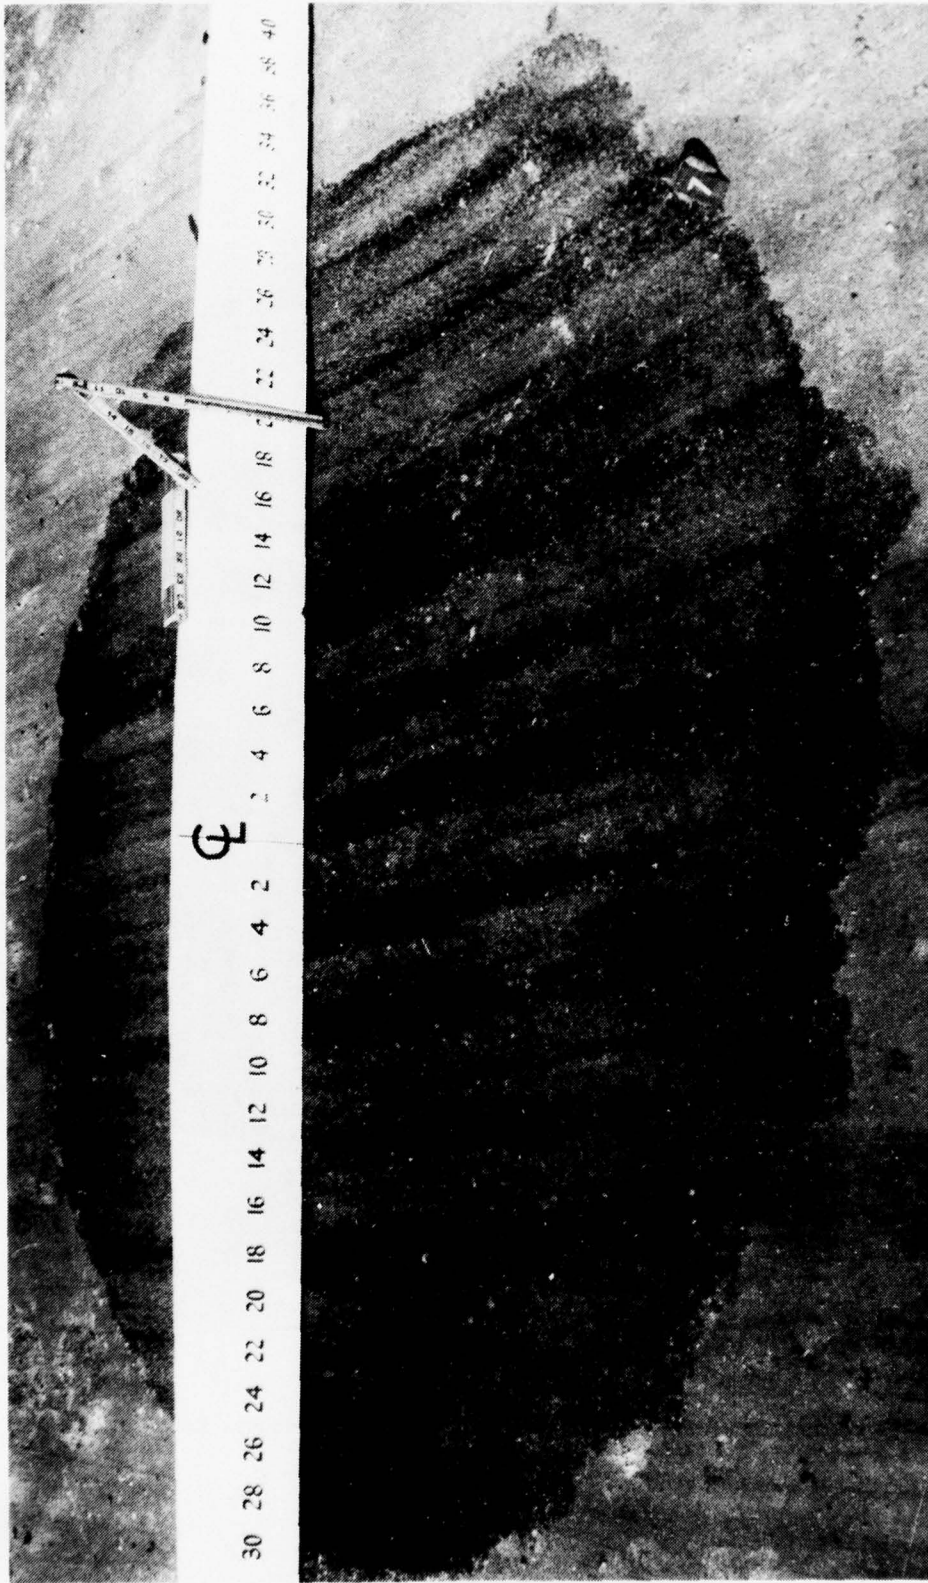
Traffic was applied to the repaired area immediately after material was placed and compacted. During the first 10 coverages (96 passes), the surfacing material moved under the load wheel, and 1-inch ruts, including upheaval at the edge of the tire, developed in the 5-foot-diameter repair area as shown in Figure 19. Uniform deformation of 1 inch occurred in the 2-foot-diameter repaired area as shown in Figure 20. After 10 coverages of traffic, both areas were repaired by raking and adding Zor-X to the surface and compacting with a mechanical tamper. Ten additional coverages of traffic were applied after repair, and the 2-foot-diameter area performed satisfactorily, but material in the 5-foot-diameter area continued to move under the load wheel and worked out of the hole at the edges of the repaired area.

2. Zor-X rutted during traffic enough that it would probably be hazardous to aircraft traffic.

Figure 19. Surface of Zor-X in 5-Foot-Diameter Area After 10 Coverages

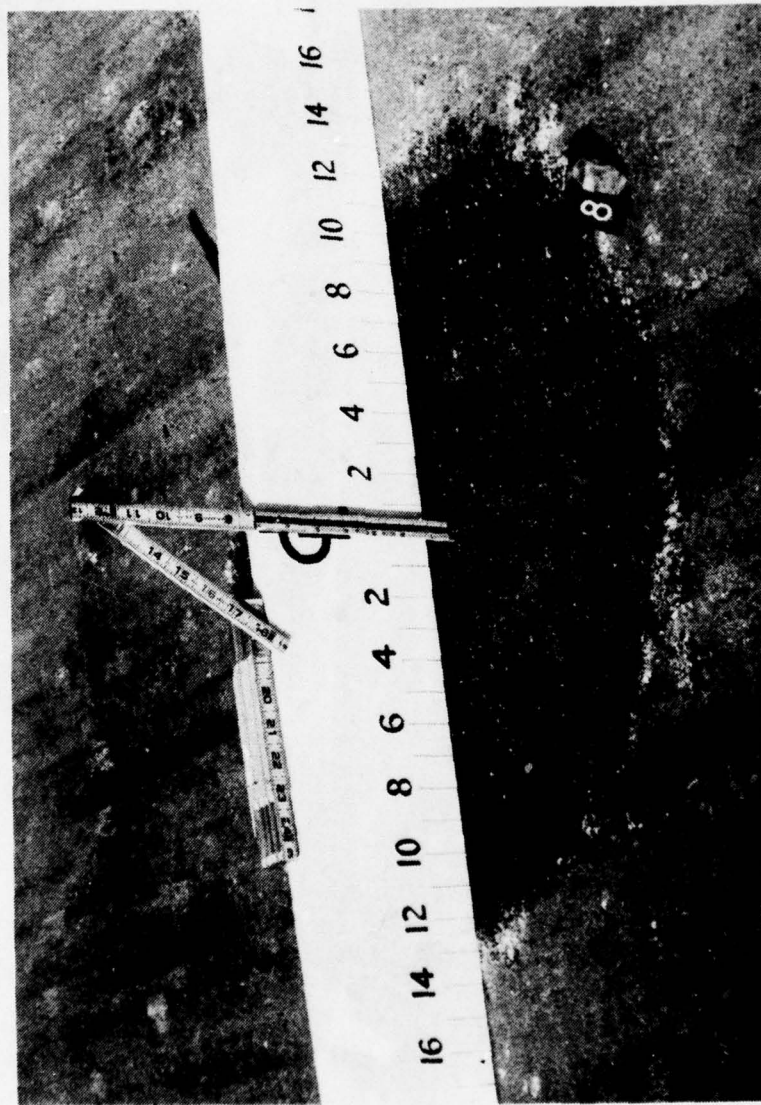
Figure 20. Surface of Zor-X in 2-Foot-Diameter Area After 10 Coverages

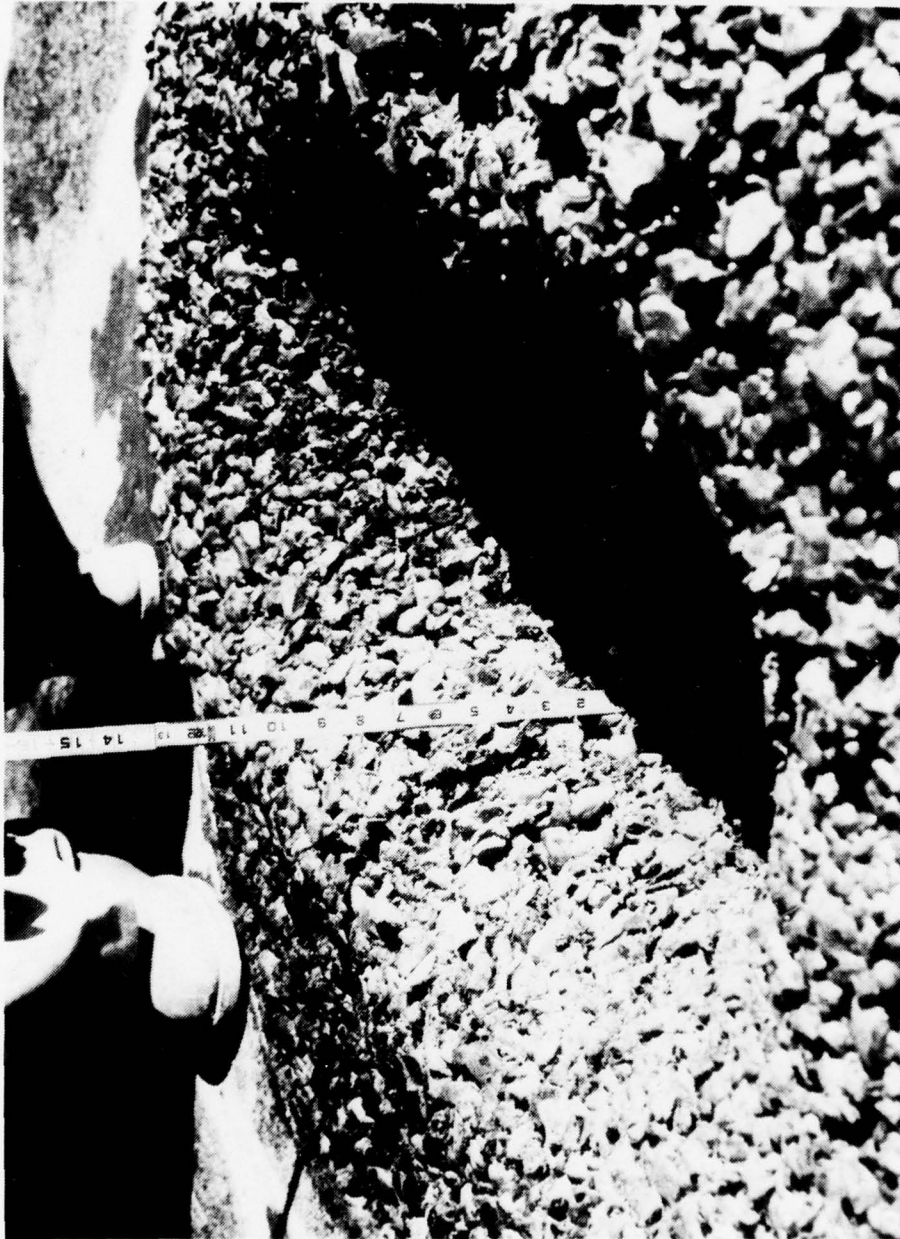
Although the material had swelled above the pavement surface enough to be unsatisfactory for aircraft operation, traffic was applied to the repaired

areas 34 minutes after the last batch of Hathane 1600A had been poured over the gravel. The material would not support the load wheel and failed on the first pass. The failure developed by the load wheel is shown in Figure 25. The failed area was repaired by shaping the areas with hand tools and compacting with a mechanical tamper. After 30 minutes additional time, the material would support the load wheel, but deformation of approximately 3 inches occurred in the 5-foot-diameter area as the load wheel moved across.

Figure 25. Failure Developed on First Pass of Load Wheel in
Hathane I600A

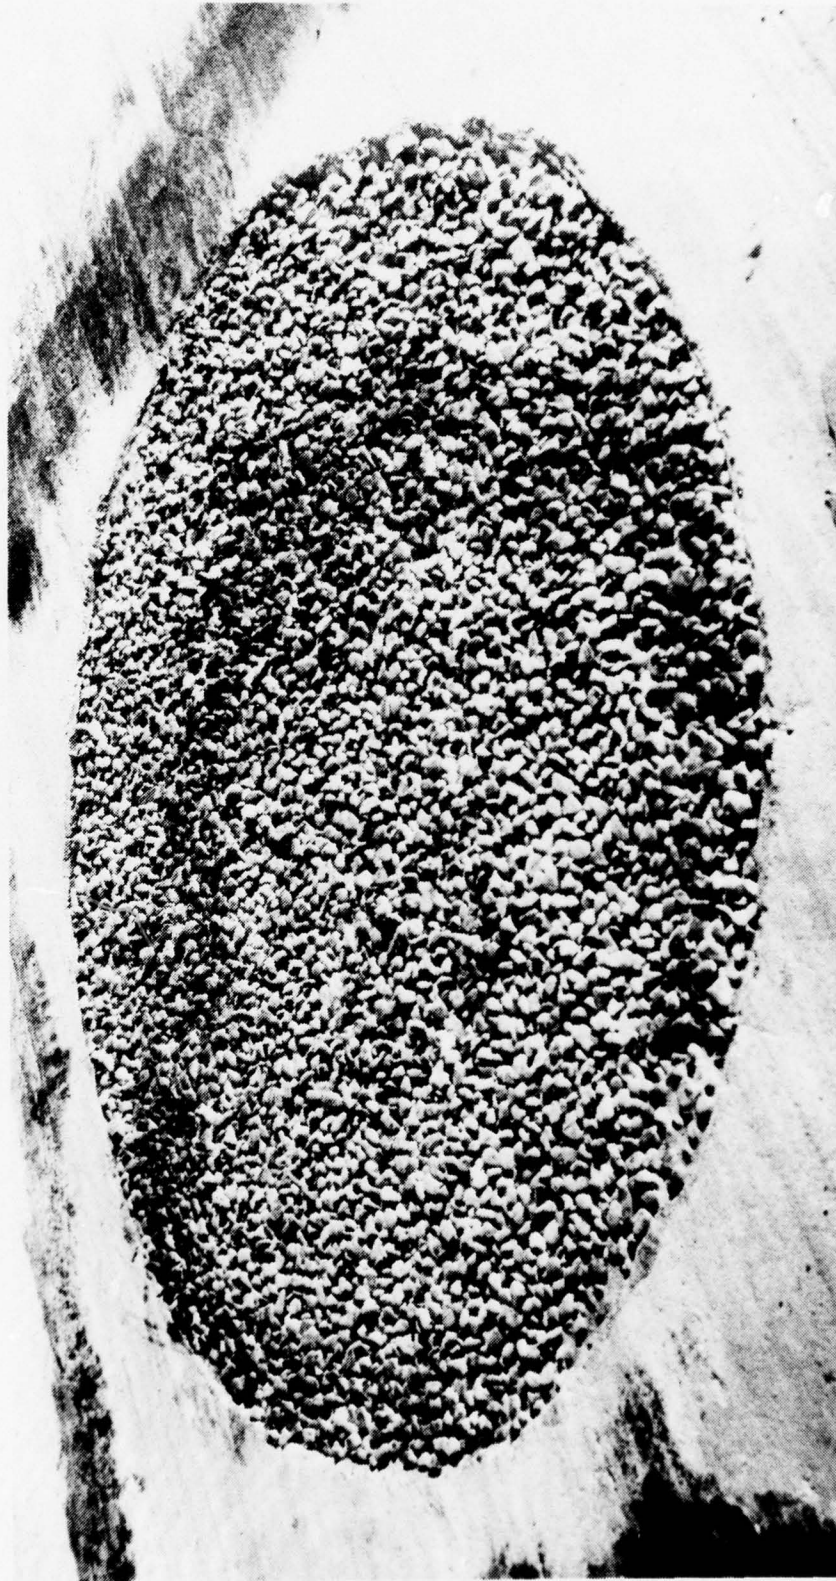
The epoxy resin was allowed to cure for 30 minutes before traffic was applied. After 10 coverages of traffic, the only detrimental effect noted was a very small amount of gravel at the surface of the repair had been broken loose. Figure 29 shows the surface of the 5-foot-diameter area after 10 coverages of traffic. An additional 10 coverages of traffic were applied with no distress other than additional gravel breaking loose on the surface.

Figure 29. Surface of Epoxy Resin Repair After 10 Coverages

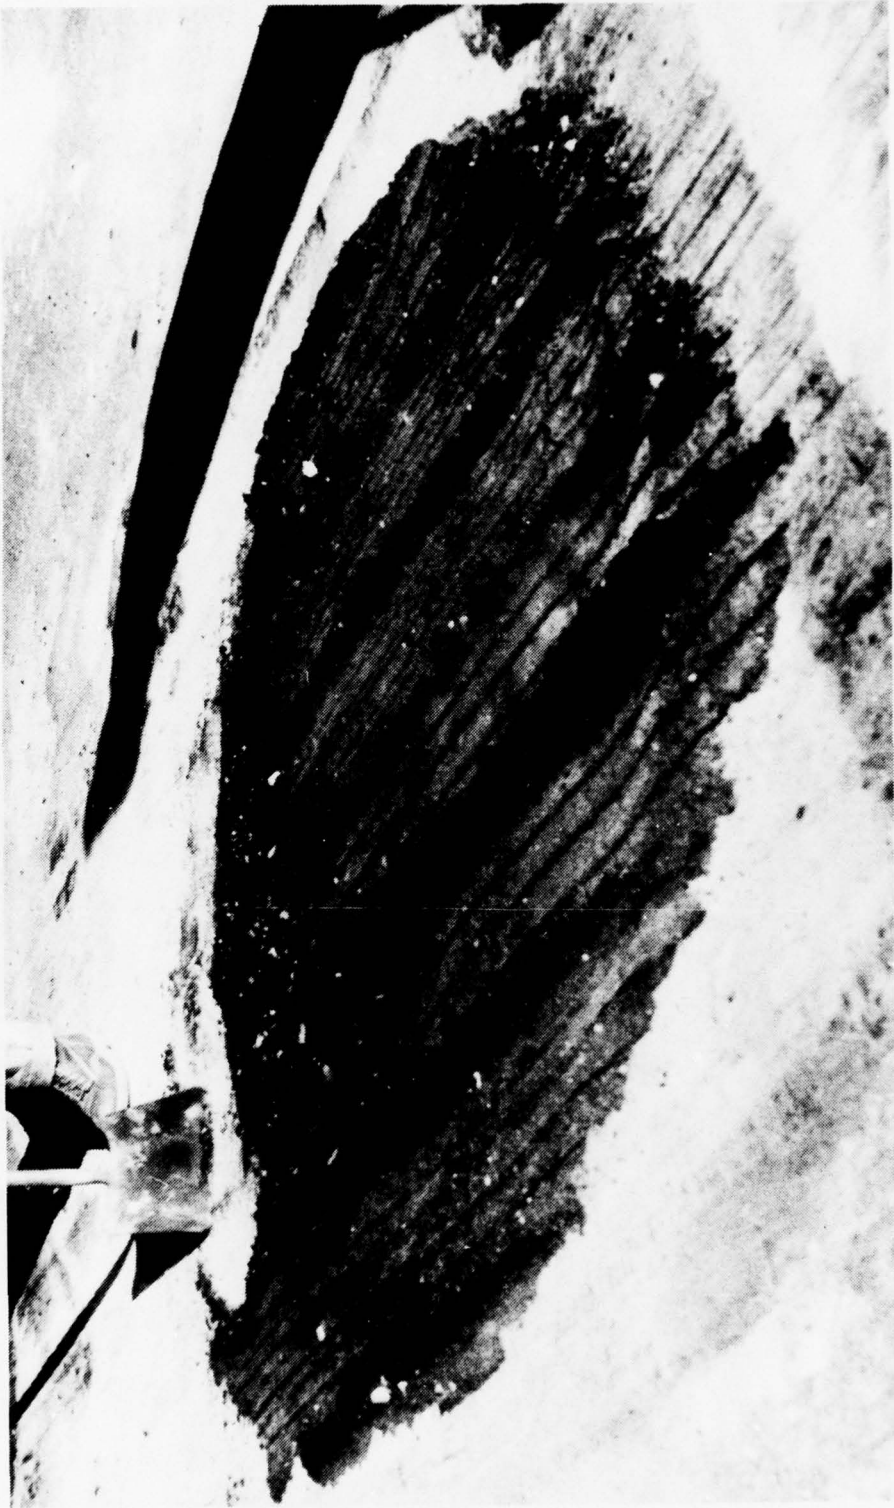
Traffic was applied immediately after cold mix was placed and compacted. The cold mix rutted under each pass of the load wheel; and after two coverages, the 5-foot-diameter area was repaired by leveling and placing material that had worked out of the area back in the test area (see Figure 32) and compacting with the mechanical tamper. After two more coverages, ruts of approximately 2 inches deep had developed in the 5-foot-diameter area as shown in Figure 33, but the 2-foot-diameter area was in fair condition. Traffic was terminated after four coverages due to rutting in the 5-foot-diameter area. An examination of the base course showed no signs of failure in the crushed limestone base course.

Figure 32. Repairing Cold Mix No. 1 in 5-Foot-Diameter Area After
Two Coverages

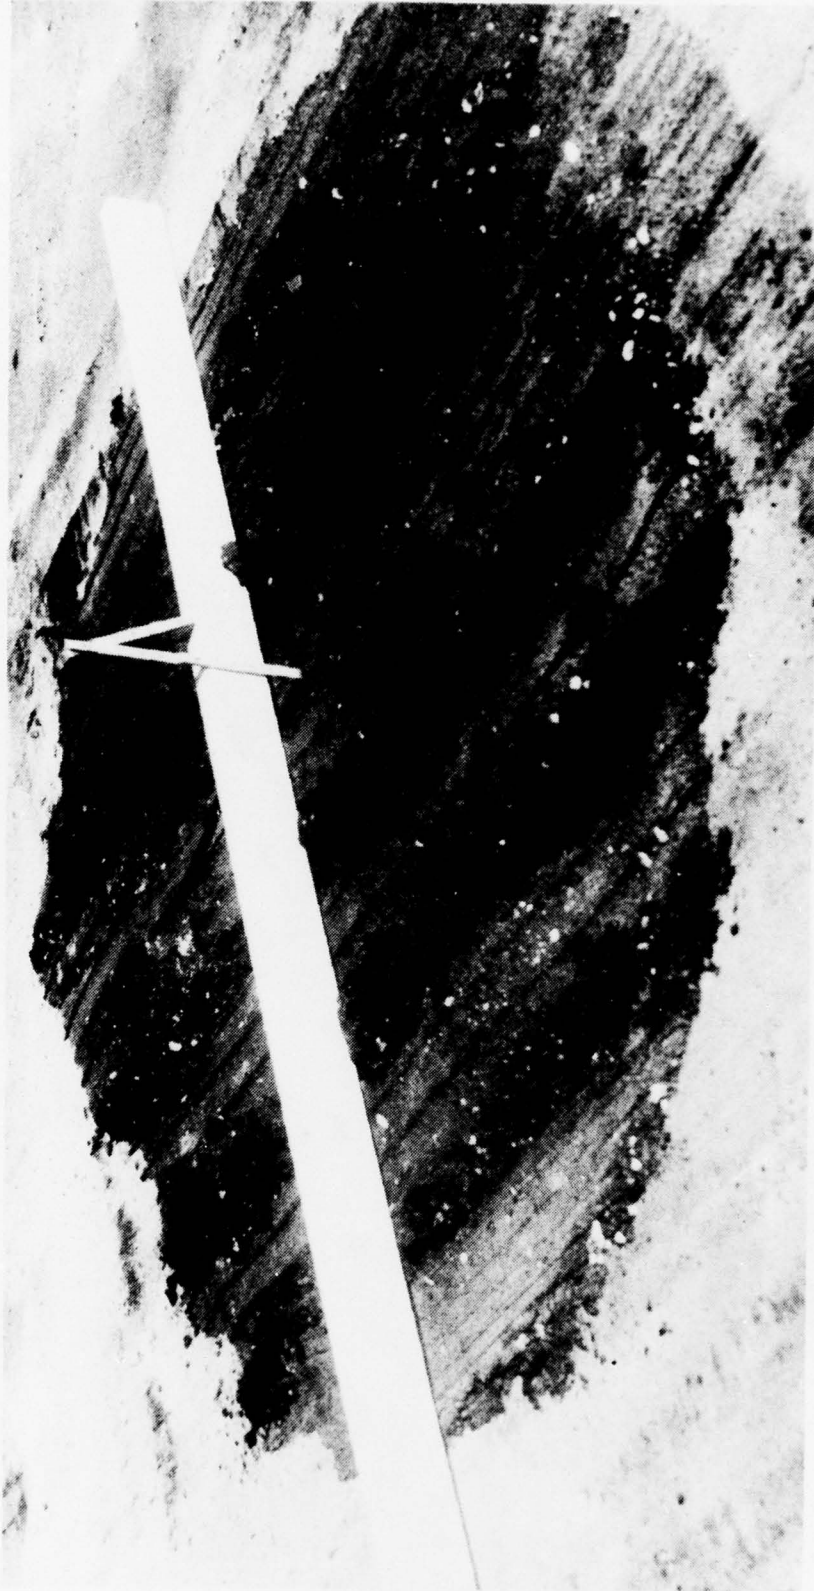
Figure 33. Surface of Cold Mix No. 1 in 5-Foot-Diameter Area After
Total of Four Coverages

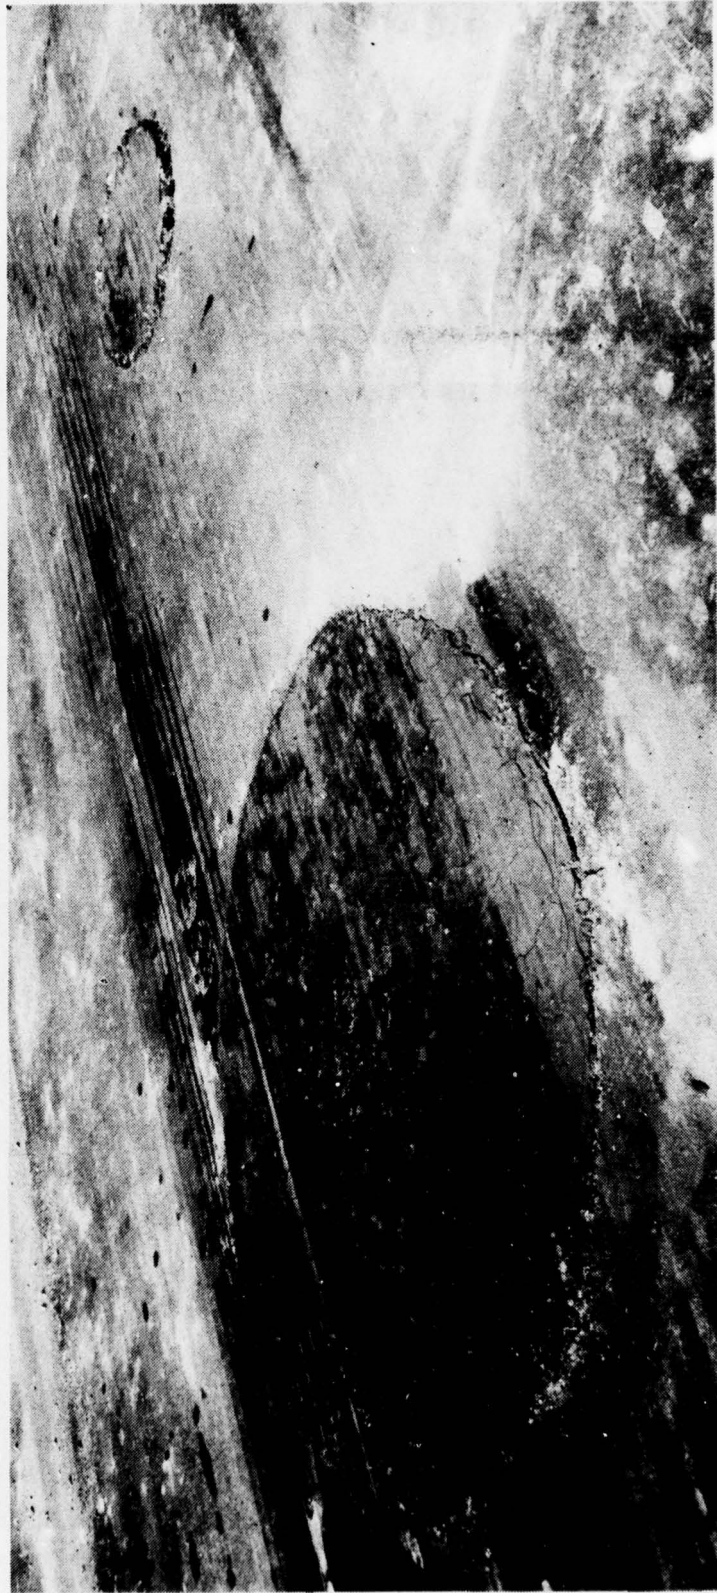
Traffic was applied to the repaired areas 29 minutes after the last batch of polyester resin was placed. During traffic, polyester resin at the surface of the 2- and 5-foot areas cracked and loose particles were noted. The 2-foot-diameter area did not bond to the sides of adjacent pavement, and movement of the patch was noted during traffic. After 10 coverages, the 2-foot-diameter area was completely loose from adjacent pavement. Figure 39 shows the condition of the 2-foot- and 5-foot-diameter areas after 10 coverages. The 8-foot-diameter area did not have as thick a film of polyester resin without aggregate at the surface as the 2-foot- and 5-foot-diameter areas, and a less number of loose particles was noted after 10 coverages of traffic. Figure 40 shows the condition of the surface of the 8-foot-diameter area after 10 coverages.

Figure 39. Surface of Polyester Resin in 2-Foot- and 5-Foot-Diameter Areas After 10 Coverages

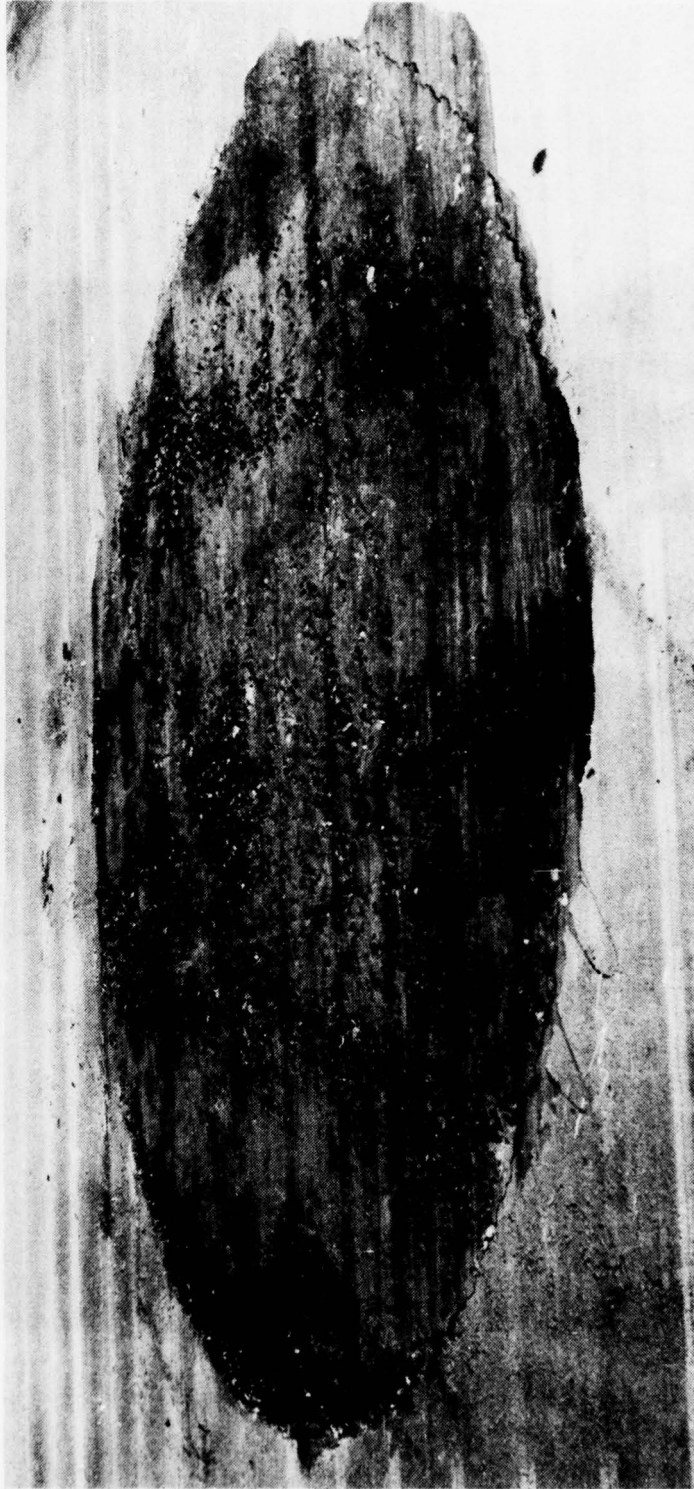
Figure 40. Surface of Polyester Resin in 8-Foot-Diameter Area After
10 Coverages

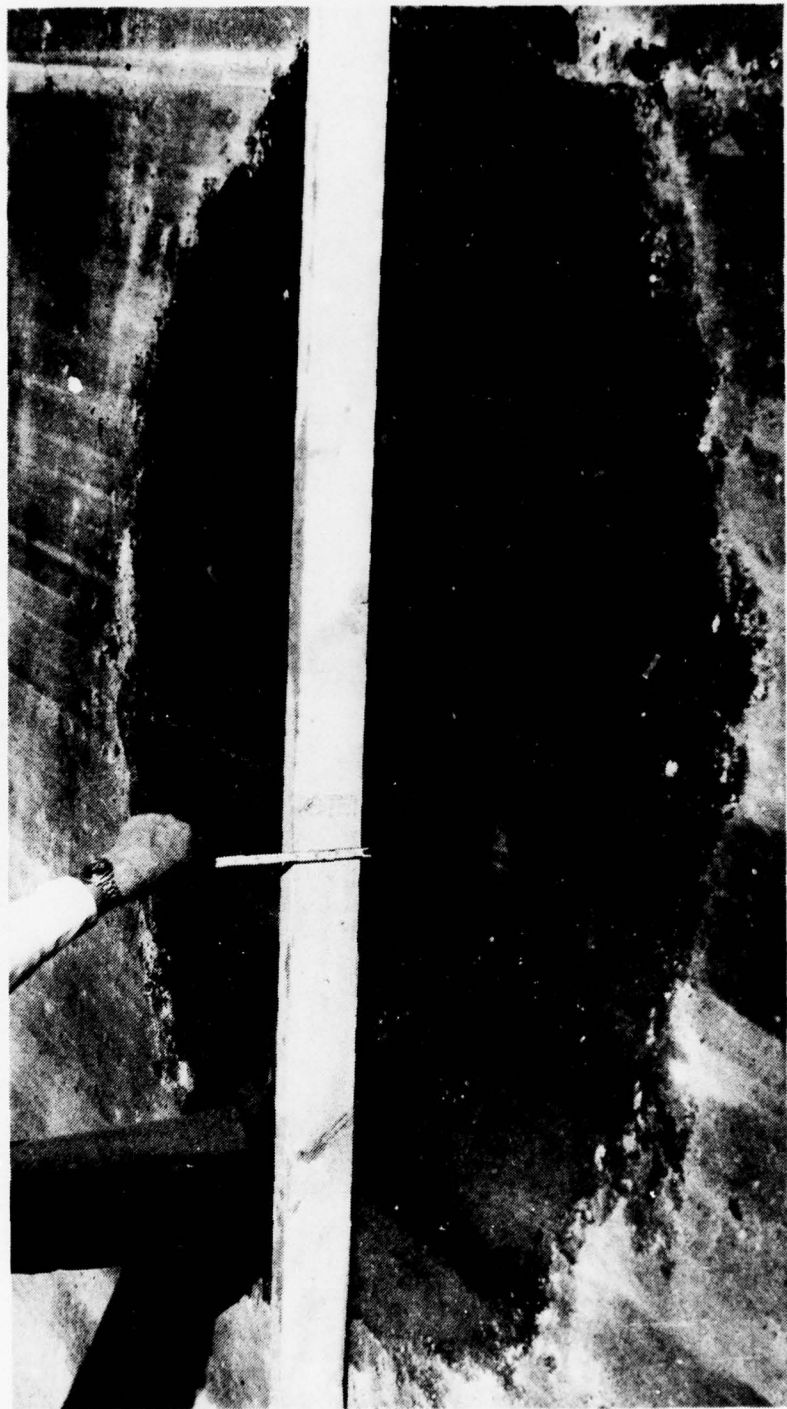
Traffic was applied to the repaired area immediately after finish rolling. After 10 coverages of traffic, a deformation of $3/4$ inches was noted in the 5-foot-diameter area and 1 inch in the 2-foot-diameter area, but no signs of cracking noted in either area. Additional material was added to the 2-foot-diameter area, and another 10 coverages applied to both areas. After a total of 20 coverages, the area appeared in excellent condition with no signs of distress. The condition of the surface of the 5-foot-diameter area after 20 coverages is shown in Figure 47.

Figure 47. Surface of Amalgapave After 20 Coverages

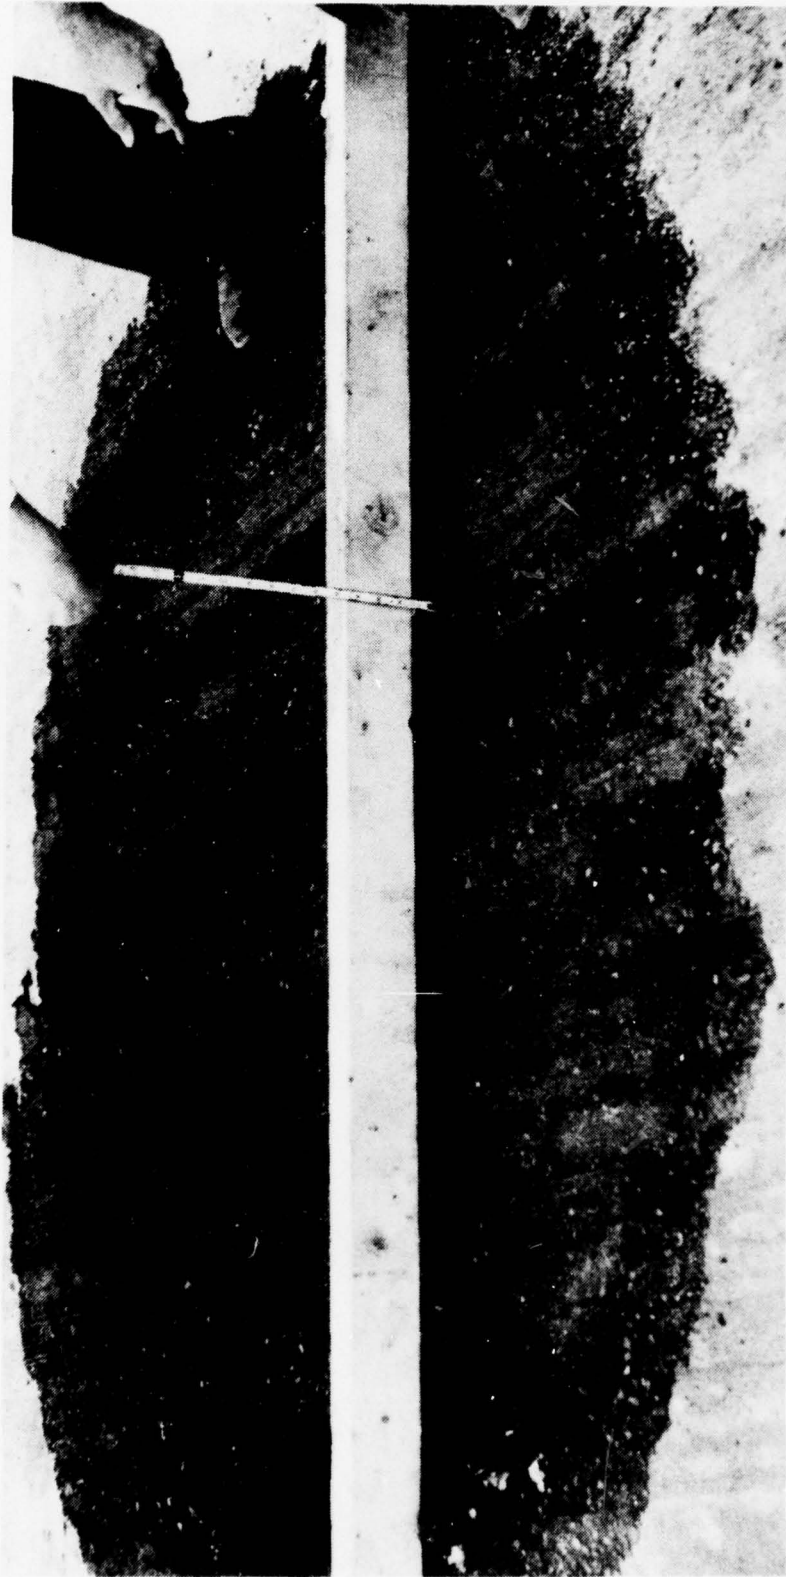
Traffic was applied immediately after areas were repaired. The cold mix shoved and rutted under each pass of the load wheel; at four coverages ruts of 1 inch deep had developed, and the material was working out of the repaired areas. Ten coverages were applied with ruts 1 inch deep measured in each area. The condition of the 5-foot-diameter area after 10 coverages is shown in Figure 49.

Figure 49. Condition of Cold Mix No. 2 After 10 Coverages

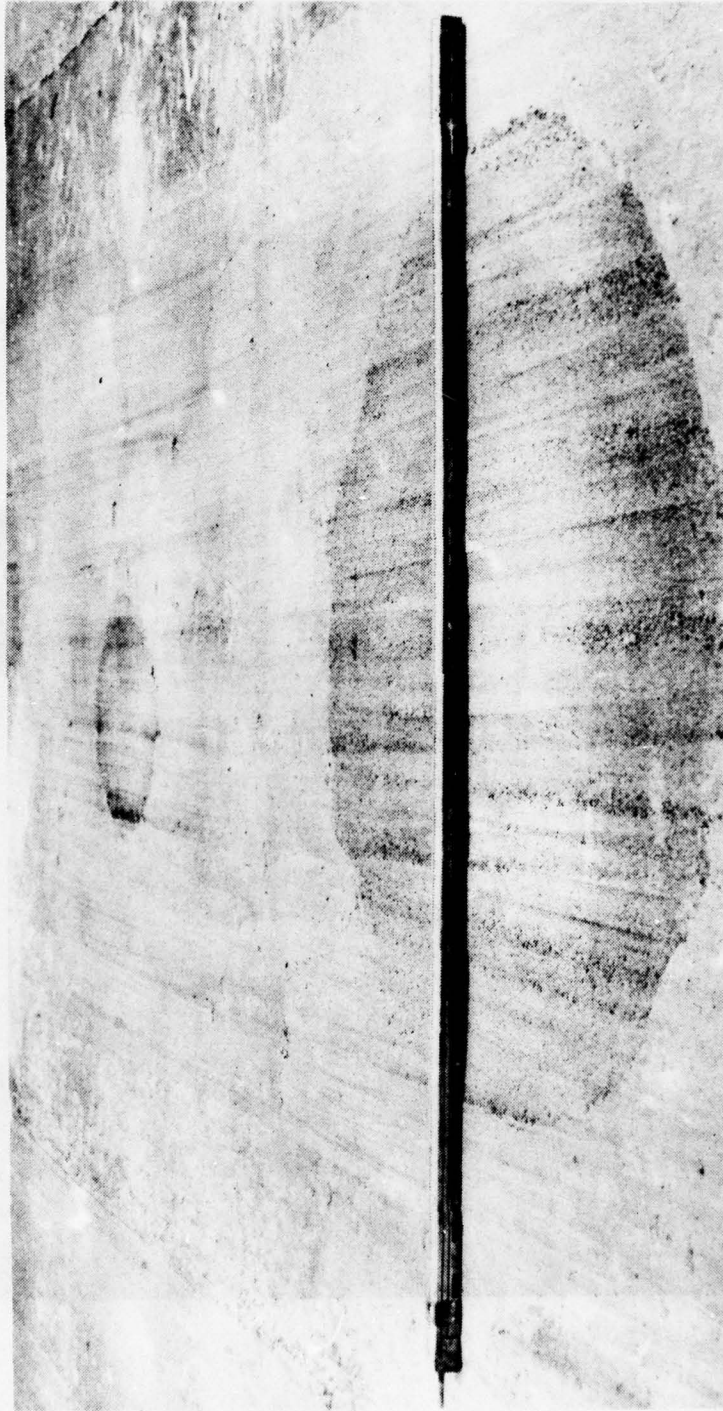
Traffic was applied immediately after compaction. Only slight movement of the material was noted under the load wheel. After 10 coverages of traffic, a deformation of 1/2 inch was measured in the 5-foot-diameter area and 1 inch in the 2-foot-diameter area. Ten additional coverages of traffic were applied to the areas without any maintenance being performed, and no signs of distress were observed. The condition of the repaired areas after 20 coverages is shown in Figure 52.

Figure 52. Condition of Future Patch After 20 Coverages

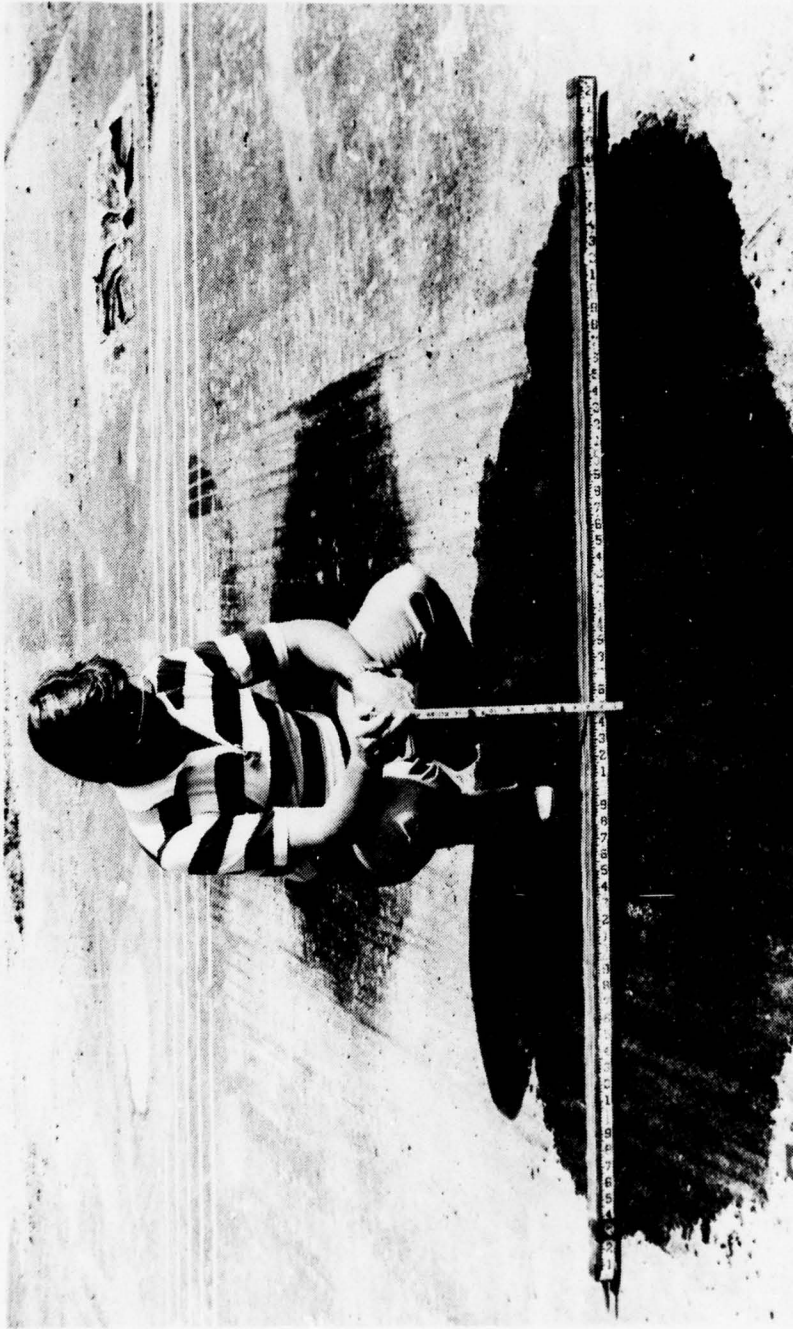
Traffic was applied immediately after compaction. The material moved under each pass of the load wheel with upheaval areas at the edge of the tire having a loose noncohesive texture. During trafficking, the material worked out of the repaired areas; and after 10 coverages, rut depths, including upheaval, measured 1-1/2 inches deep. Figure 54 shows the condition of the 5-foot-diameter area after 10 coverages.

Figure 54. Condition of Sylvax After 10 Coverages

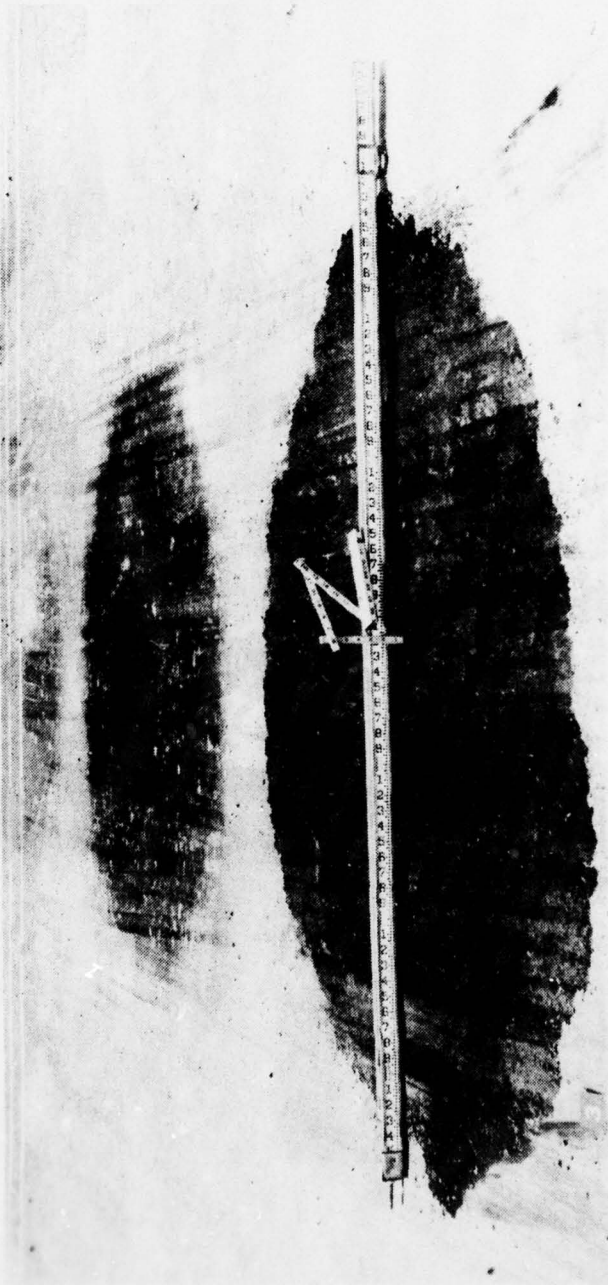
Traffic was applied to the areas immediately after compaction. The material moved under each pass of the load wheel; and after 10 coverages, ruts 1-1/2 inches deep, including upheaval at the edge of the tire were measured. Although the material had lateral displacement under the load wheel, it maintained a cohesive texture. The condition of the 5-foot-diameter area after 10 coverages of traffic is shown in Figure 56.

Figure 56. Condition of Field-Mixed Amalgapave After 10 Coverages

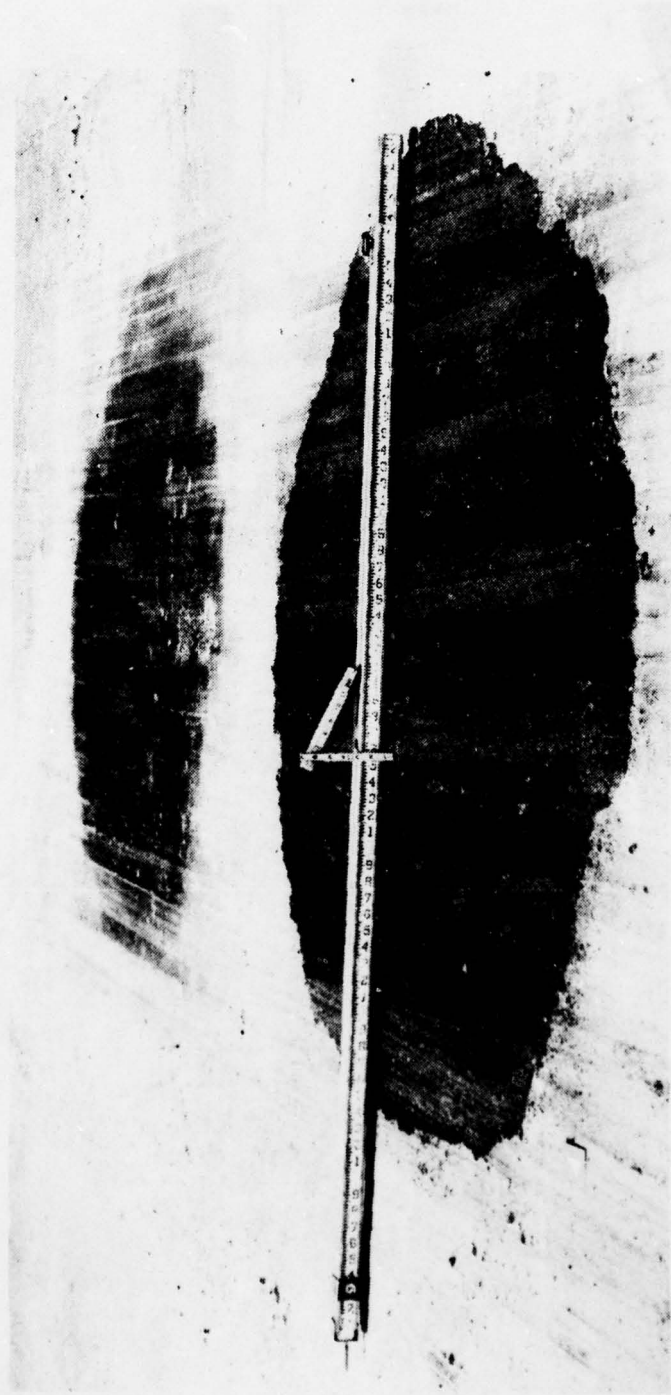
Traffic was applied to the repaired area immediately after compaction. The material moved under each pass of the load wheel; and after 10 coverages, ruts 1-1/2 inches deep were measured, including upheaval at the sides of the load tire, and the material had a loose noncohesive texture. Figure 58 shows the condition of the 5-foot-diameter area after 10 coverages.

Figure 58. Condition of Field-Mixed Cold Mix After 10 Coverages

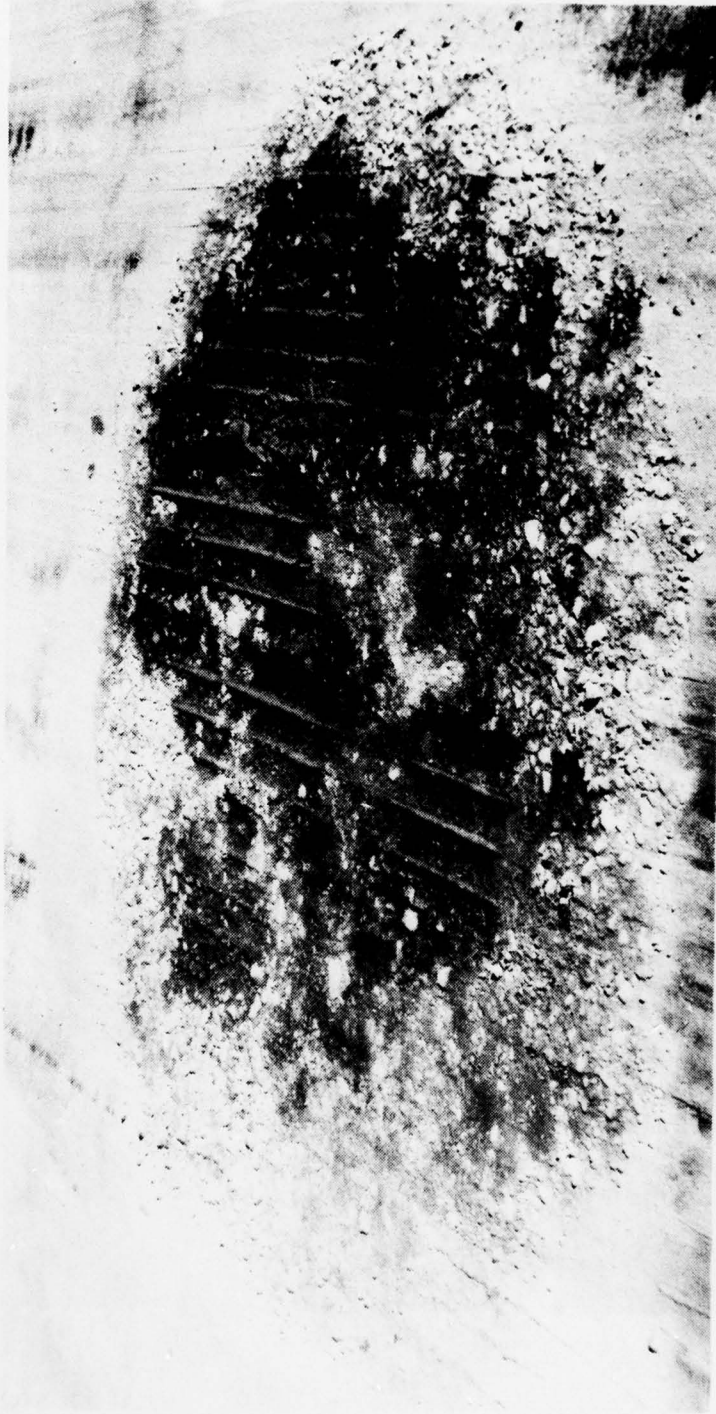
Traffic was applied to the repaired areas immediately after compaction. Ten coverages of traffic were applied to the areas with no sign of failure; however, tire printing was noted at the surface where an excessive amount of water had been sprinkled on the surface during compaction, and a small amount of loose aggregate was observed. Figure 62 shows the condition of the patch after 10 coverages. Ten additional coverages were applied, and no distress was noted other than the small amount of loose aggregate.

Figure 62. Condition of Crushed Limestone and Portland Cement Mixture
After 10 Coverages

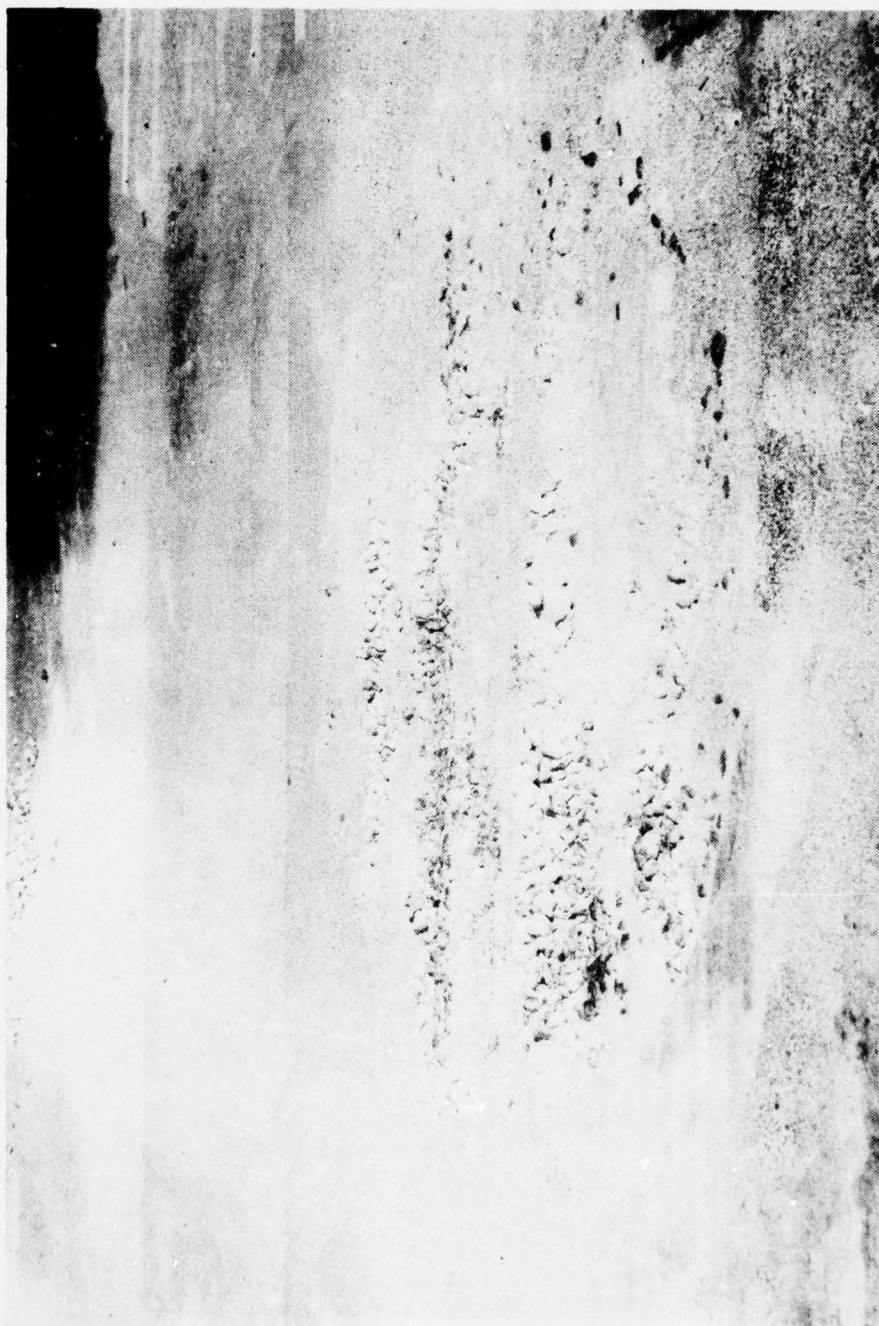
14. Asphalt Macadam was not satisfactory due to lack of stability. This type repair would require time for heating asphalt at any time and during cold weather would be difficult to place because of asphalt cooling in applicator lines.

Figure 68. Condition of Asphalt Macadam After Eight Coverages

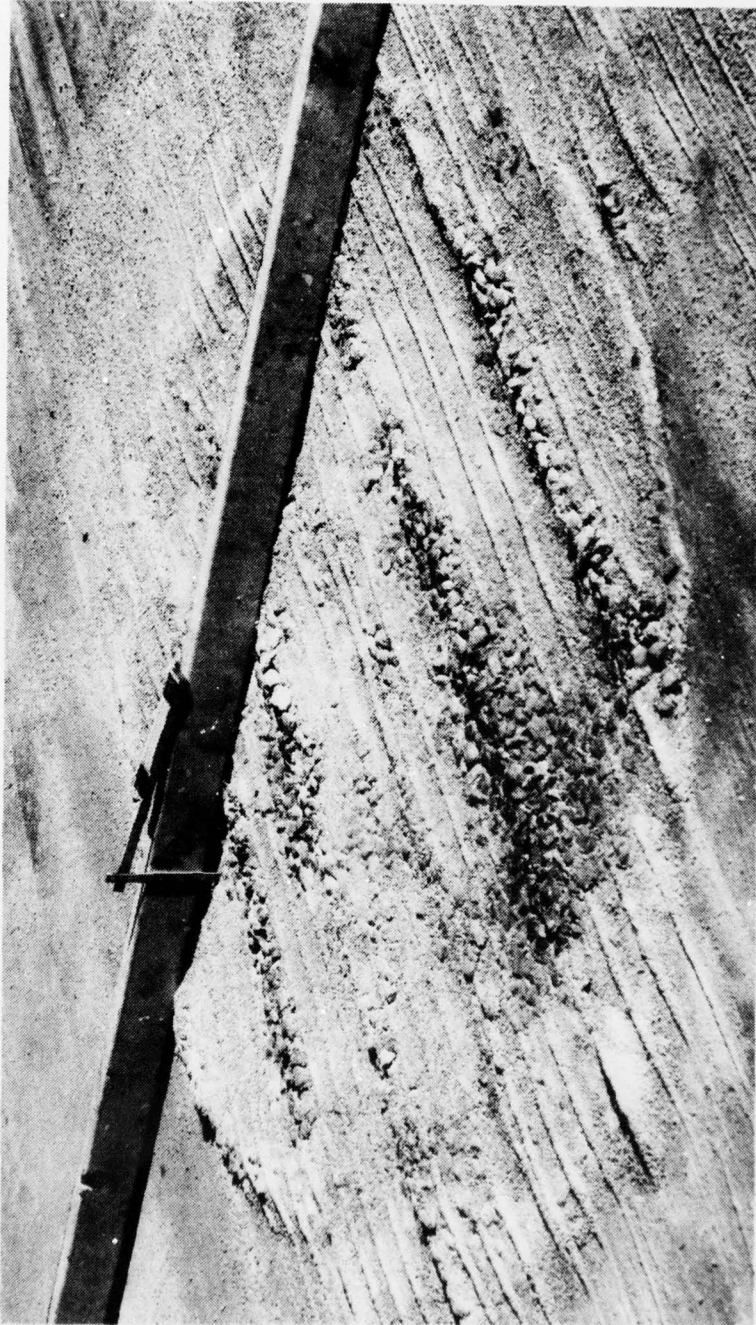
Figure 69. Condition of Asphalt Macadam After Being Repaired and Application of a Total of 18 Coverages
