**SODOM DAM  
(EAST BRANCH RESERVOIR)  
PUTNAM COUNTY, NEW YORK  
INVENTORY NO. 31**

**PHASE I INSPECTION REPORT  
NATIONAL DAM SAFETY PROGRAM**

Name of Dam: SODOM DAM (I. D. NO. 31)  
EAST BRANCH RESERVOIR

Date of Inspection: 27 APRIL 1978

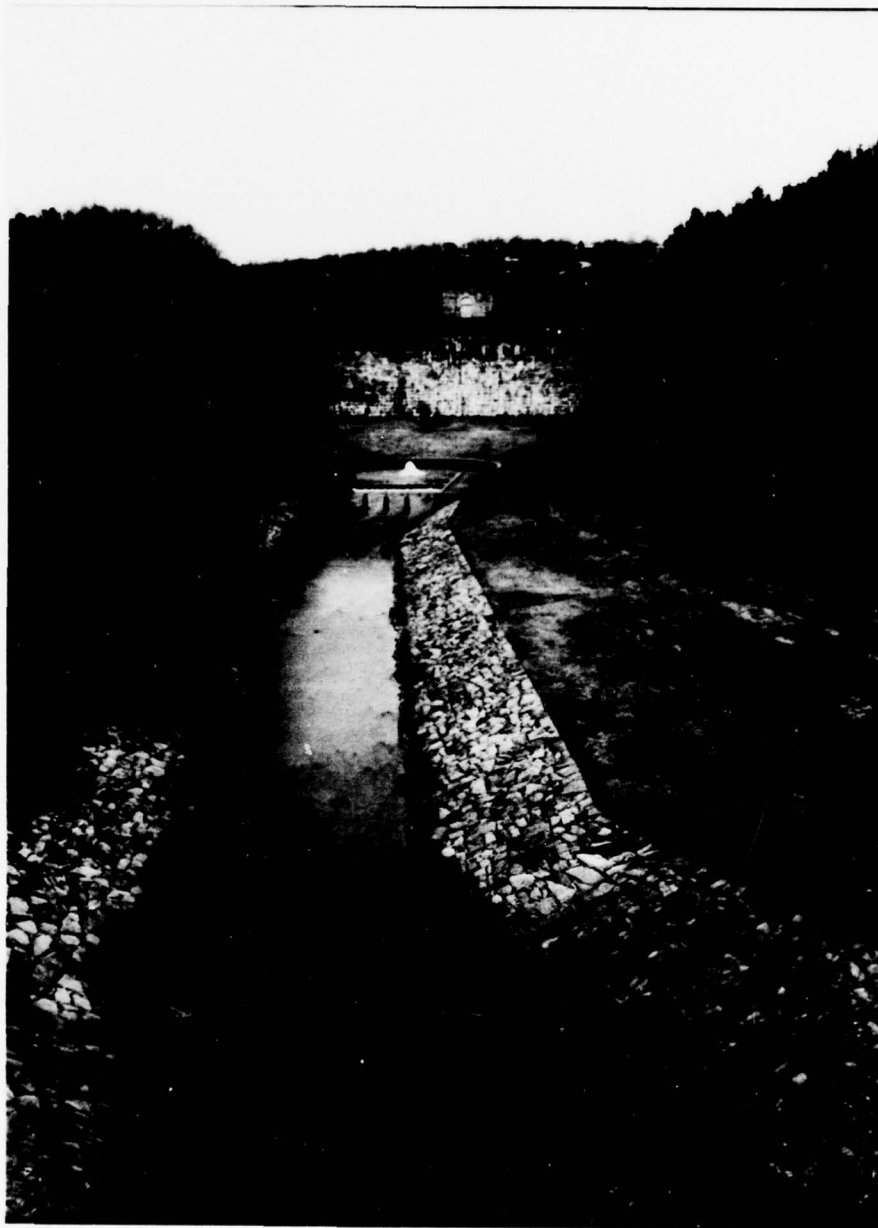
OVERVIEW OF MASONRY DAM

The visible surfaces of the masonry dam were in good condition; there were no signs of seepage, movement or other distress.

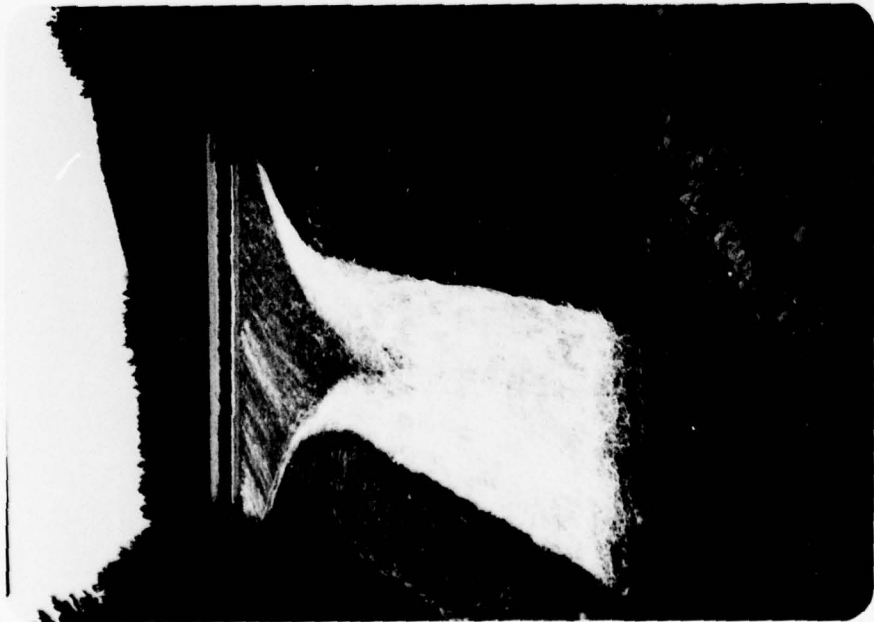
At the time of the inspection water was flowing over the spillway. However, the condition of sill and visible portions of the masonry spillway wall were in good condition. The spillway tailrace channel did not contain steps as shown on the early drawings.

OVERVIEW OF SPILLWAY

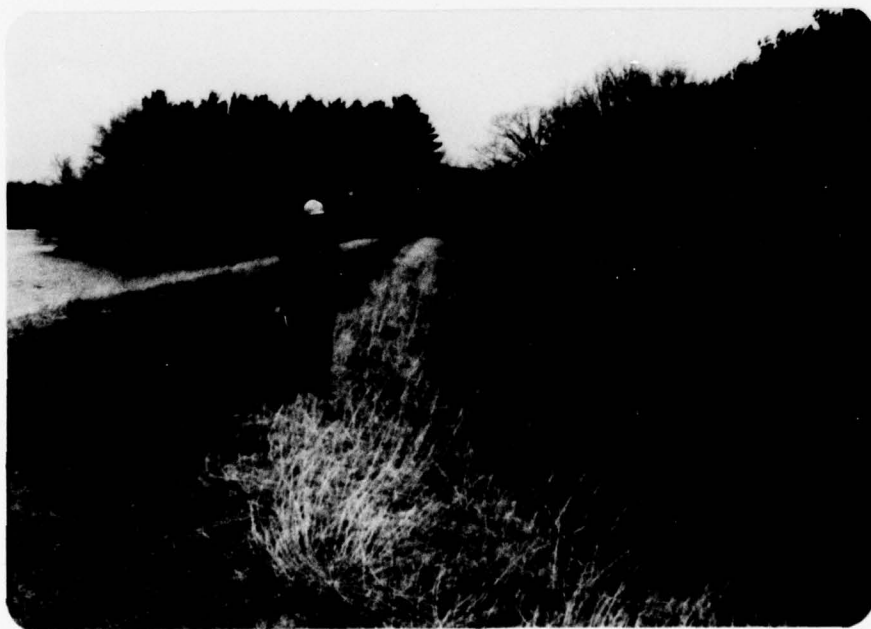
There were no visible signs of sloughing, erosion, cracking or other distress on either the crest or upstream and downstream slopes of the dam. No seepage was visible. There were some minor ruts on the downstream slope; these were apparently caused by the tractor mower used to maintain the grass slope protection. The grass slope protection appeared to be generally well maintained.

EMBANKMENT SECTION, CREST AND DOWNSTREAM SLOPE

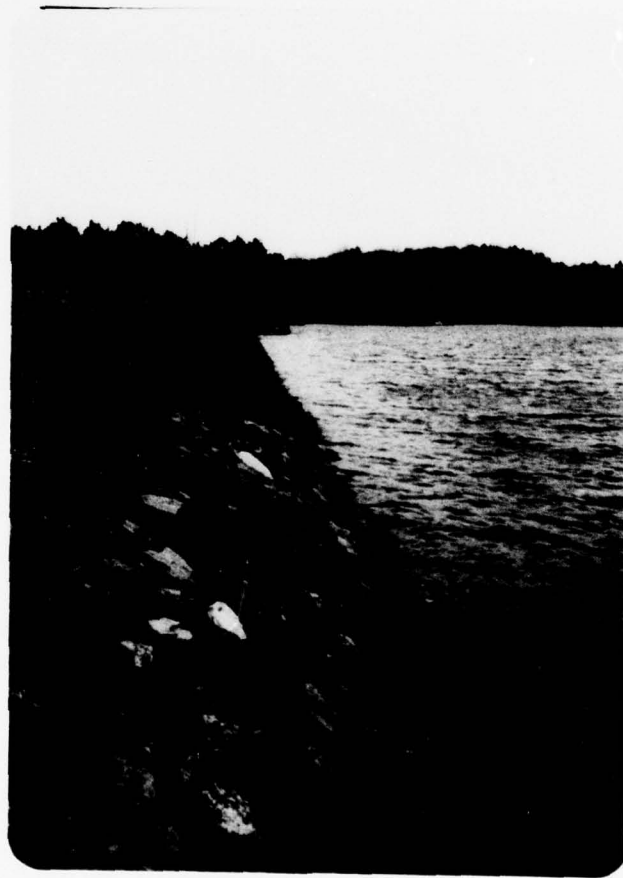
The riprap was hand placed, tight and in good condition.

EMBANKMENT SECTION , UPSTREAM SLOPE
