TARRYTOWN WATERWORKS DAM

WESTCHESTER COUNTY, NEW YORK

INVENTORY NO. 54

**PHASE I INSPECTION REPORT
NATIONAL DAM SAFETY PROGRAM**

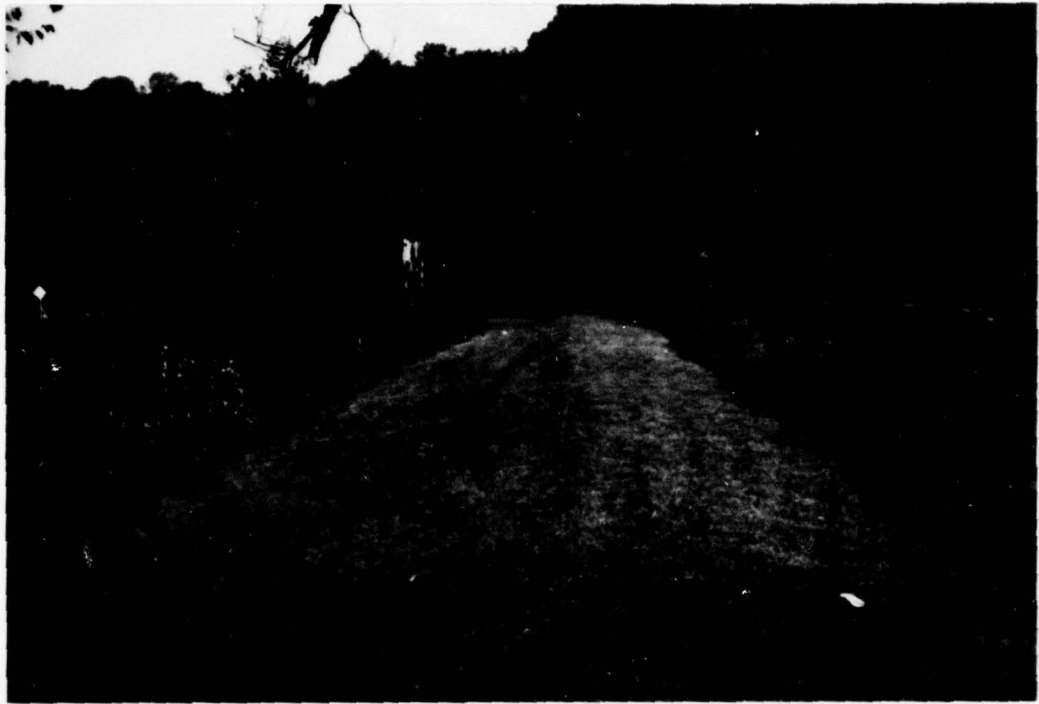
The earth embankment appears to be in generally good condition. The horizontal and vertical alignments of the crest are generally good except for some minor rutting and a few depressions about 3 feet in diameter and 4 inches deep. A shaft located on the crest about 10 feet south of the gatehouse was an access to an alum injection system which is no longer in use. The shaft is covered with a steel plate.

2) CREST OF DAM LOOKING NORTH , NOTE RUT ALONG CENTER OF CREST

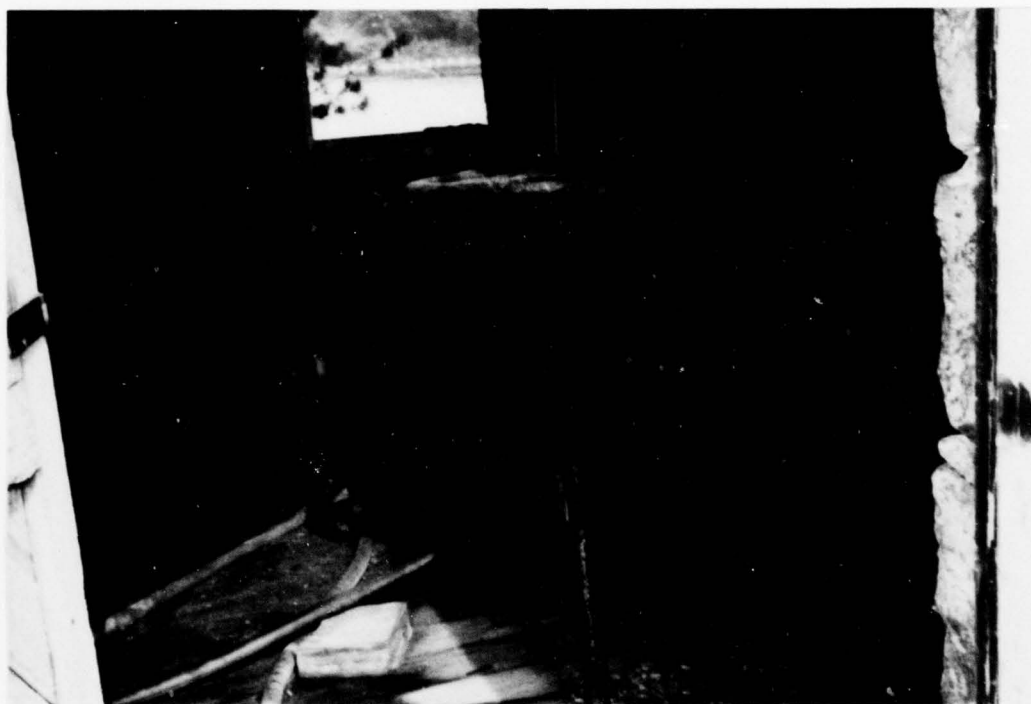
Reportedly, the valves located in the gate chamber have not been operated in at least 24 years. Water Department personnel do not operate these valves for fear they may break or that they may not be able to return the valves to the proper positions. The floor stands appear to be in good condition although the wooden floor of the gatehouse is in poor condition and is considered to be unsafe. The access ladder to the gate chamber is severely rusted. Because of these conditions, the inspection of the equipment in the chamber was limited to what could be seen through a hatchway in the gatehouse floor. The condition of the valves could not be assessed although the valve stem extensions show rusted surfaces with metal loss. The bottom of the chamber appears to be silted to a height equal to the bonnets of the gate valves. The gate chamber appears to be in relatively good condition with some dampness noted on the brick walls.

4) VALVE OPERATING STANDS IN GATE HOUSE

- a) Repair and/or replace the rotted gatehouse flooring and access ladder to the gate chamber.
- b) Inspect all surfaces and equipment in the gate chamber and make any necessary repairs.

- c) All valves should be made operable and maintained.
- d) Repair the missing and displaced riprap along the upstream slope.
- e) Repair the rotted and broken planks on the pedestrian bridge.

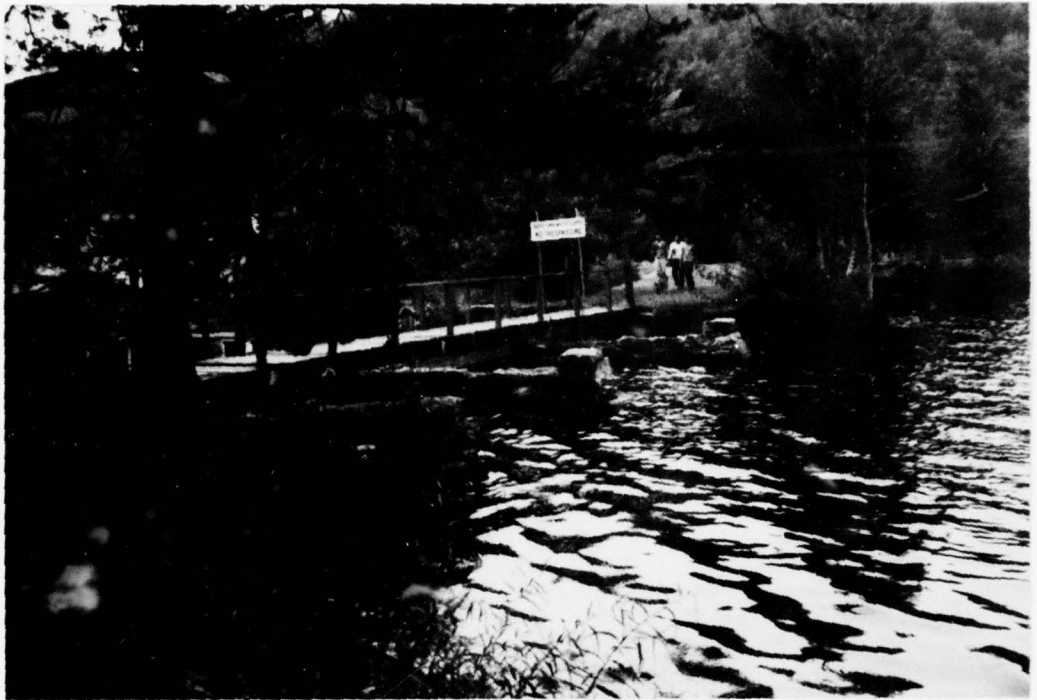
7) APPROACH CHANNELS TO SPILLWAY

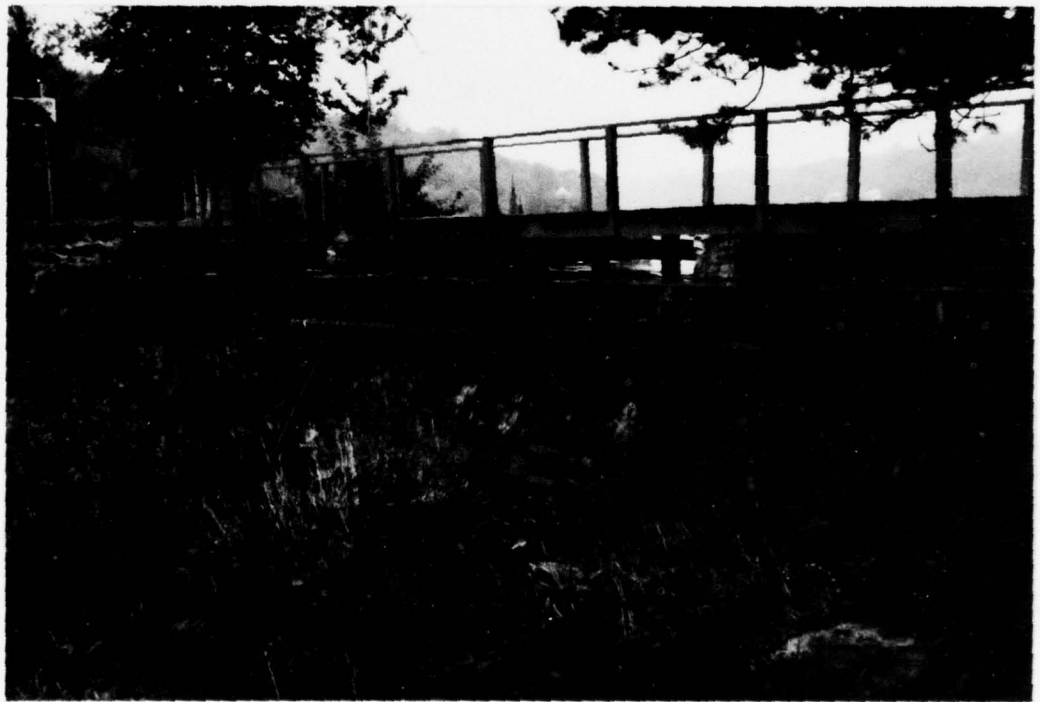
The spillway appears to be in generally fair condition. The concrete capping is in good condition and there is relatively new pointing on the stone masonry chute. There are, however, several loose and missing stones at the bottom of the chute. Several leaks were observed at the contact

8) SPILLWAY CHUTE, NOTE DISPLACED MASONRY AT CHUTE TOE

- f) Repair the loose masonry along the training walls and spillway chute, adding new pointing where necessary.
- g) Remove the loose concrete blocks from spillway channel.

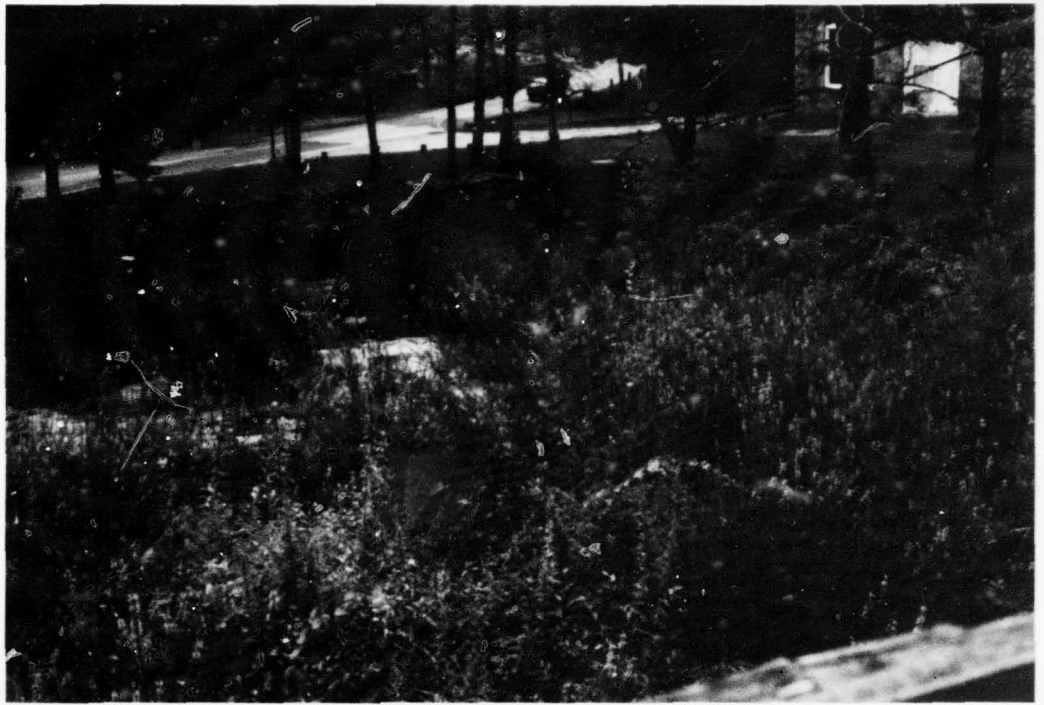
The channel immediately downstream from the spillway is heavily overgrown with vegetation. There are blocks of concrete at the bottom of the spillway chute. However, the minor flows which were observed were not impeded by this condition. The channel, further downstream, is a natural creek with only minimal vegetation and no overhanging trees.

9) SPILLWAY CHANNEL LOOKING DOWNSTREAM, NOTE ENTRANCE OF CONDUIT AND HEAVY VEGETATION

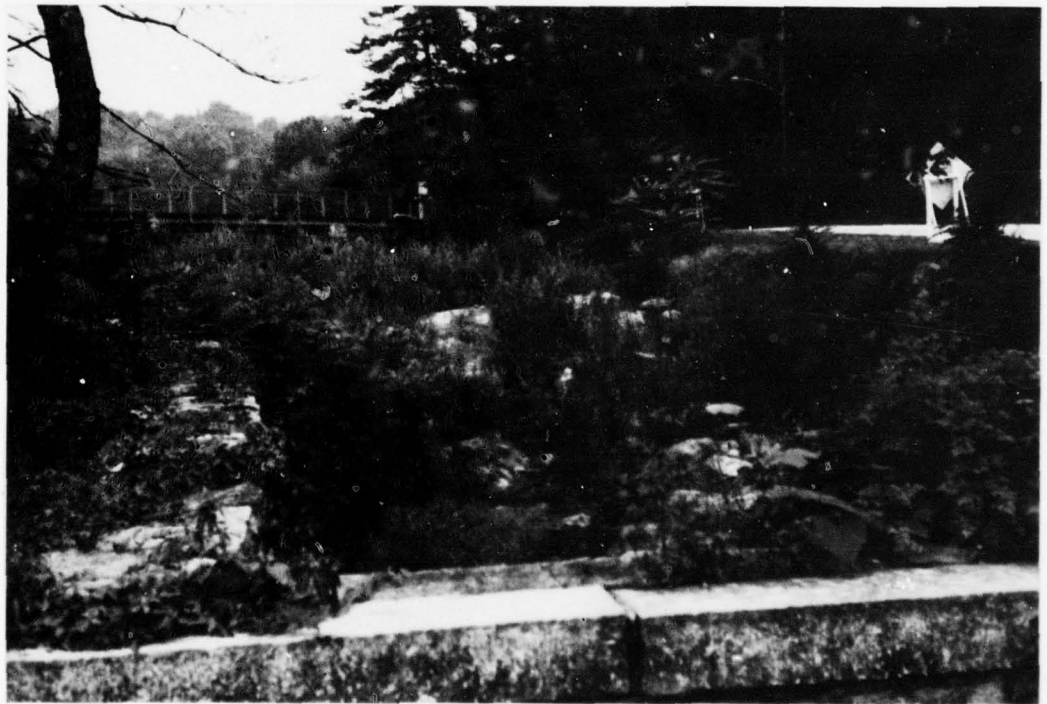
10) SPILLWAY CHANNEL LOOKING UPSTREAM

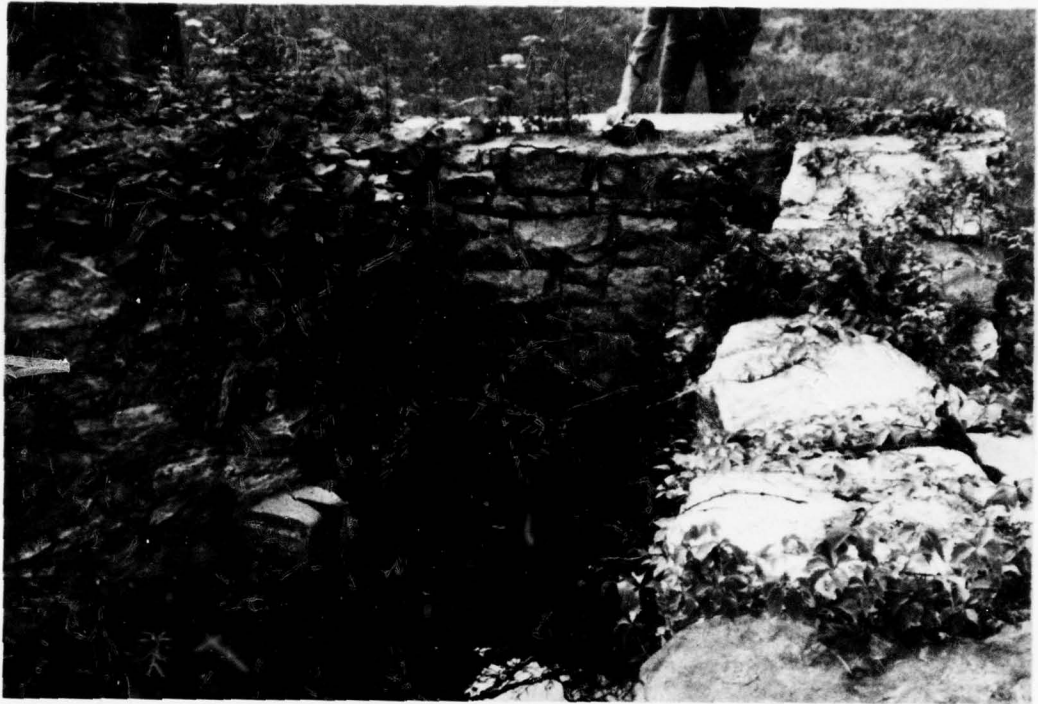
11) ENTRANCE OF CONDUIT, NOTE MEASURING WIER

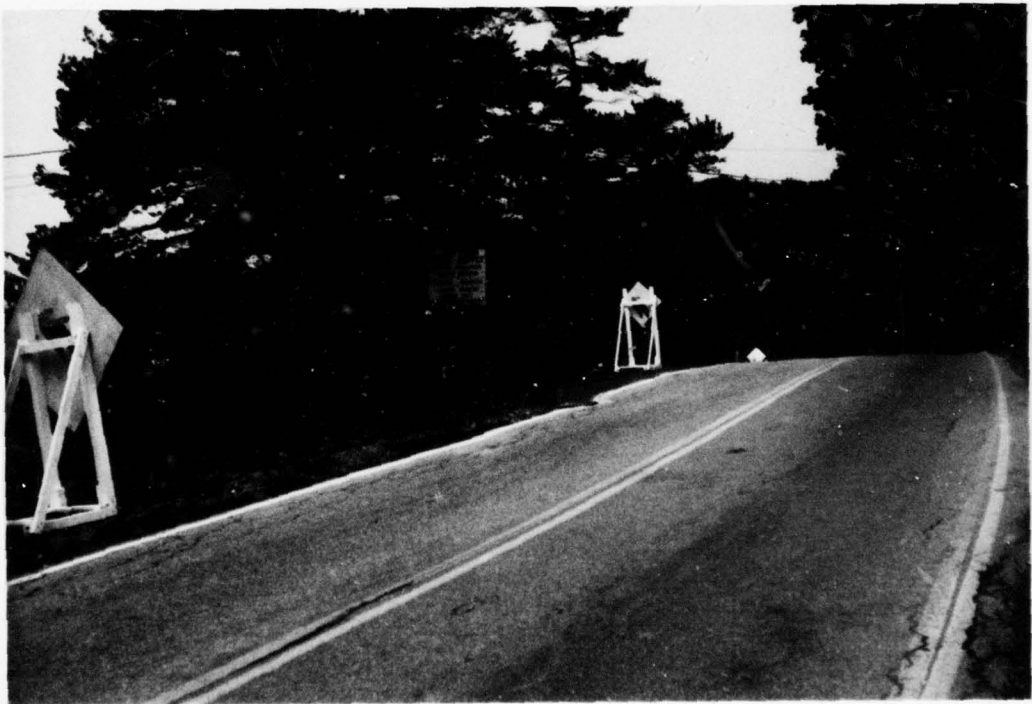
12) ROADWAY (NEPERAN ROAD) NORTH AND UPSTREAM OF SPILLWAY, NOTE DEPRESSED AREA BETWEEN ROAD AND TARRYTOWN WATER SUPPLY SIGN
