NRL Memorandum Report 656

# TANKAGE FAILURES OF AEROBEE-HI AND VANGUARD ROCKETS

J. E. Srawley

December 1956

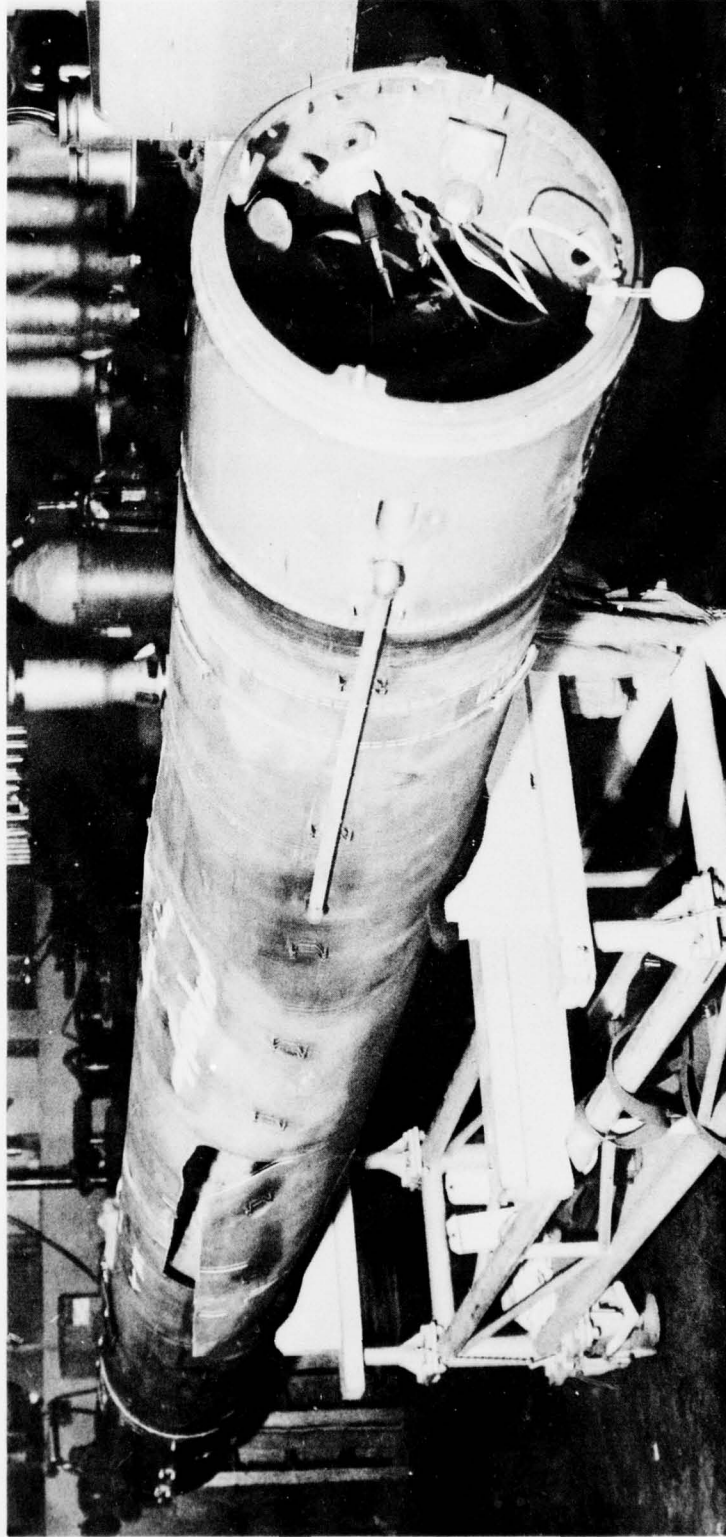
At Fort Churchill pressure was applied to the oxidizer tank hydrostatically while the rocket was resting horizontally in a suitable fixture. At approximately 520 psig pressure, corresponding to a calculated maximum principal tensile stress of 121,000 psig, the tank burst longitudinally along weld #L4. Figure 3 is a view of the whole rocket from the forward end showing the location of the failure. Figure 4 shows the burst section in more detail, while Figure 5 is a close up of the central section of the fracture.

Figure 3 - View of Aerobee - Hi NRL #48 from forward end showing burst oxidizer tank

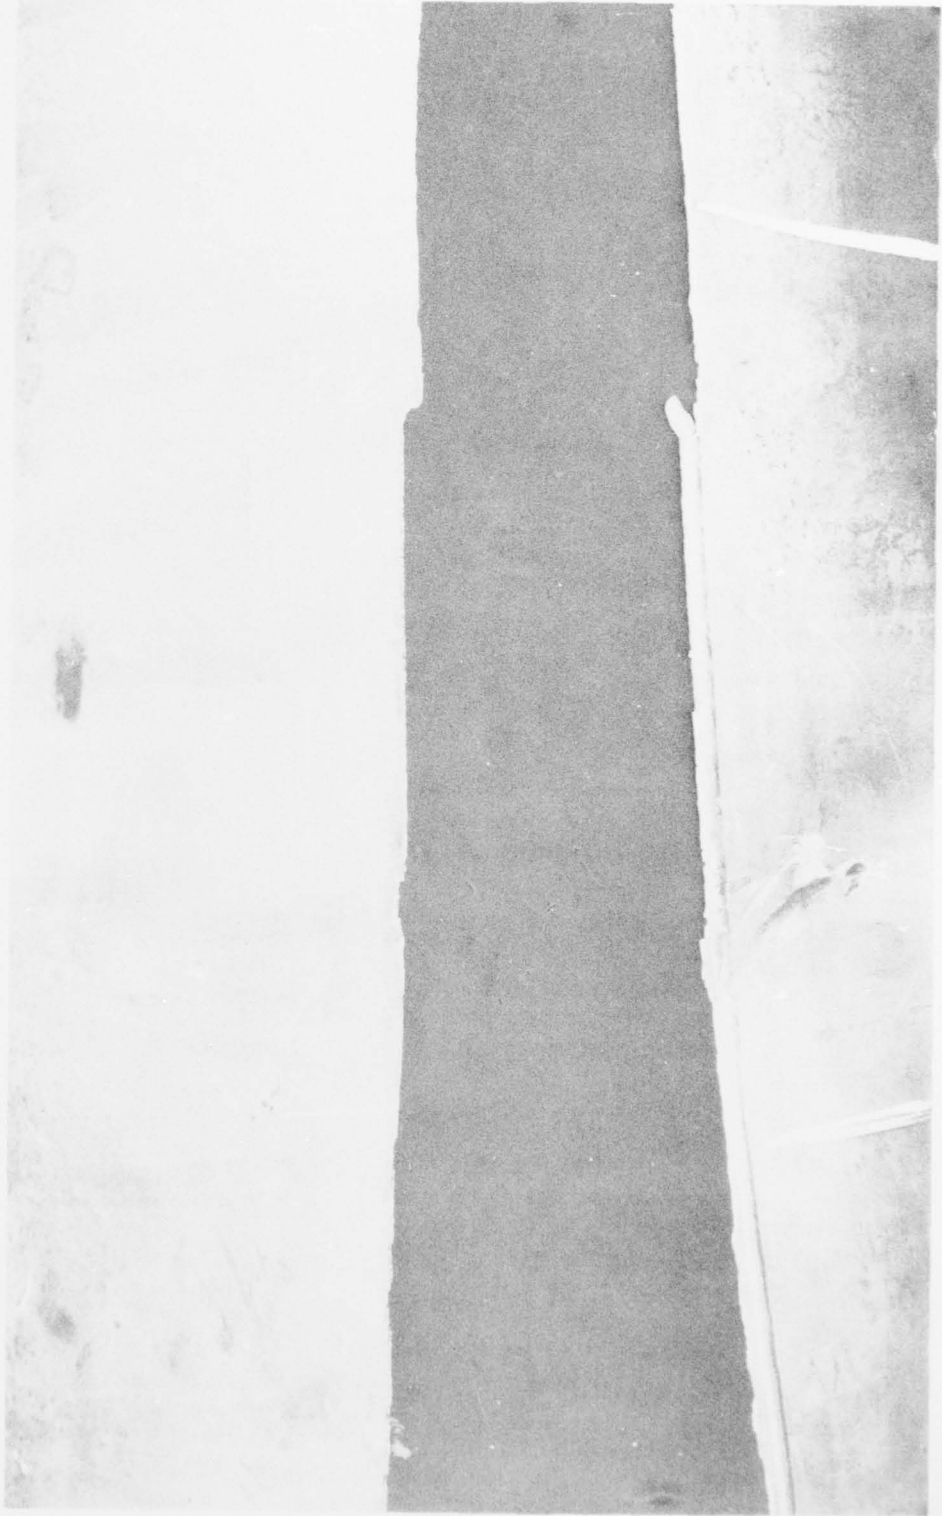
Examination of the fractured pieces shows that the run of the upper fracture through the weld follows the end of a length of repair weld. This repair weld can be distinguished in Figure 5 by its irregularity compared with the automatic weld aft of it. Forward of the crossing fracture, there is about an inch of automatic weld and then a further length of hand repair weld. The presence of these lengths of hand repair welding in the locality of the presumed origin of fracture arouses suspicion and they were therefore scrutinized. The back of the welds was characterized by considerable drop through of weld metal and by undercutting of more or less severity at the junction of the drop through and the parent metal. This is illustrated in Figure 6. Figure 7 is a photomicrograph of a typical section through the

Figure 5 - Close-up view of Central Section of Fracture in Oxidizer Tank  
of NRL #48

This is, in fact, what A. Co. propose to do. While the previous specification allowed hand repair welds at the discretion of the inspector examining the radiographs, such repairs will now be allowed only on the action of the Material Review Board consisting of two representatives from A. Co. and a Bureau of Aeronautics representative. This will certainly result in more rejections of tankages in process, and ultimately in improved quality of welding. In view of the seriousness with which the failure is regarded at A. Co. it is also likely that everyone concerned will regard the welds with more suspicion than hitherto.

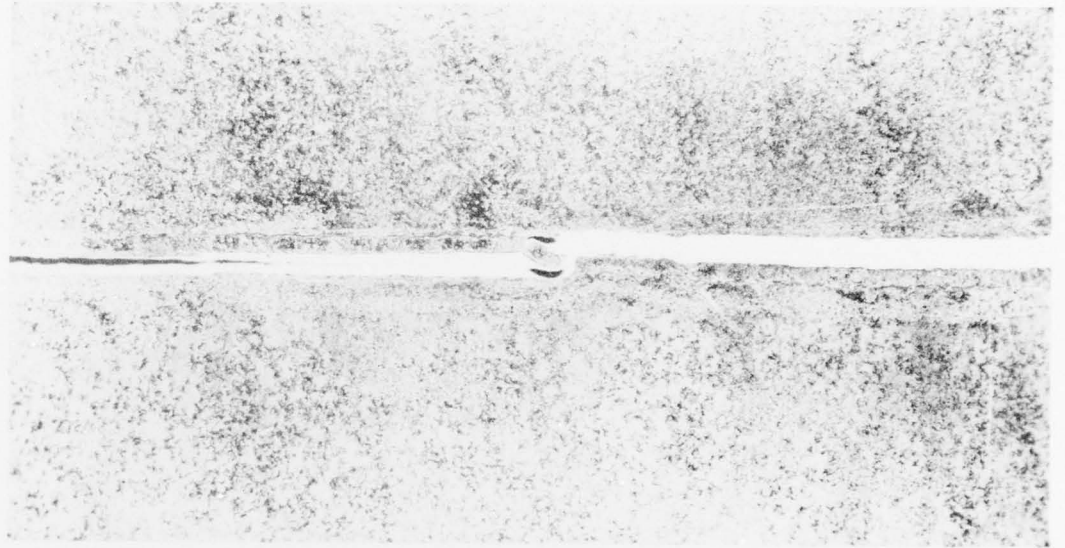
Figure 6 - View of Back of Central part of the Fracture in the Oxidizer Tank of NRL #48

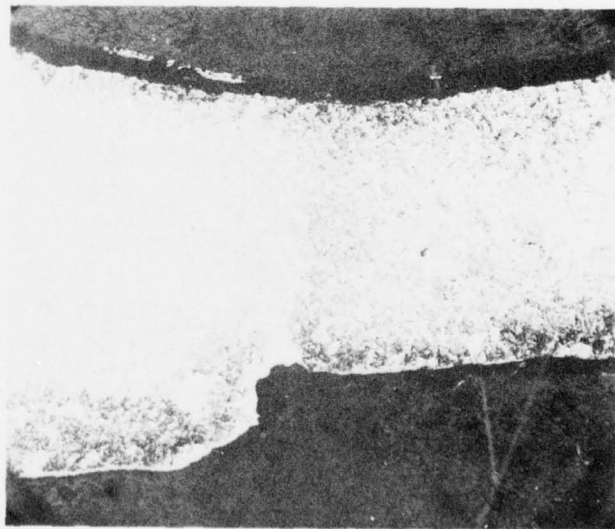
edge of the weld on the other side from the fracture. Decarburization and incipient cracking of the undercut region are clearly apparent.

Thus all the circumstances support the hypothesis of fracture initiation at the weld/parent-metal junction, near the middle of the split. No known piece of evidence is inconsistent with this hypothesis. The requirement that two cracks, which were originally not connected to one another, should have started in quick succession, would indicate that at least two significant weld imperfections existed in the region. Examination of the radiographs of the repair welds suggest that there are other regions where fracture might have initiated at slightly greater stress. Unfortunately these radiographs cannot be reproduced in sufficient detail to merit their inclusion in this report.

Figure 7 - Photomicrograph of Section through Edge of Weld on the other side from the Fracture. This is a Hand Repair Weld and shows Drop-through at the Back (bottom of photo), Undercutting and Decarburization. (40 X, Approx) Etched Nital.

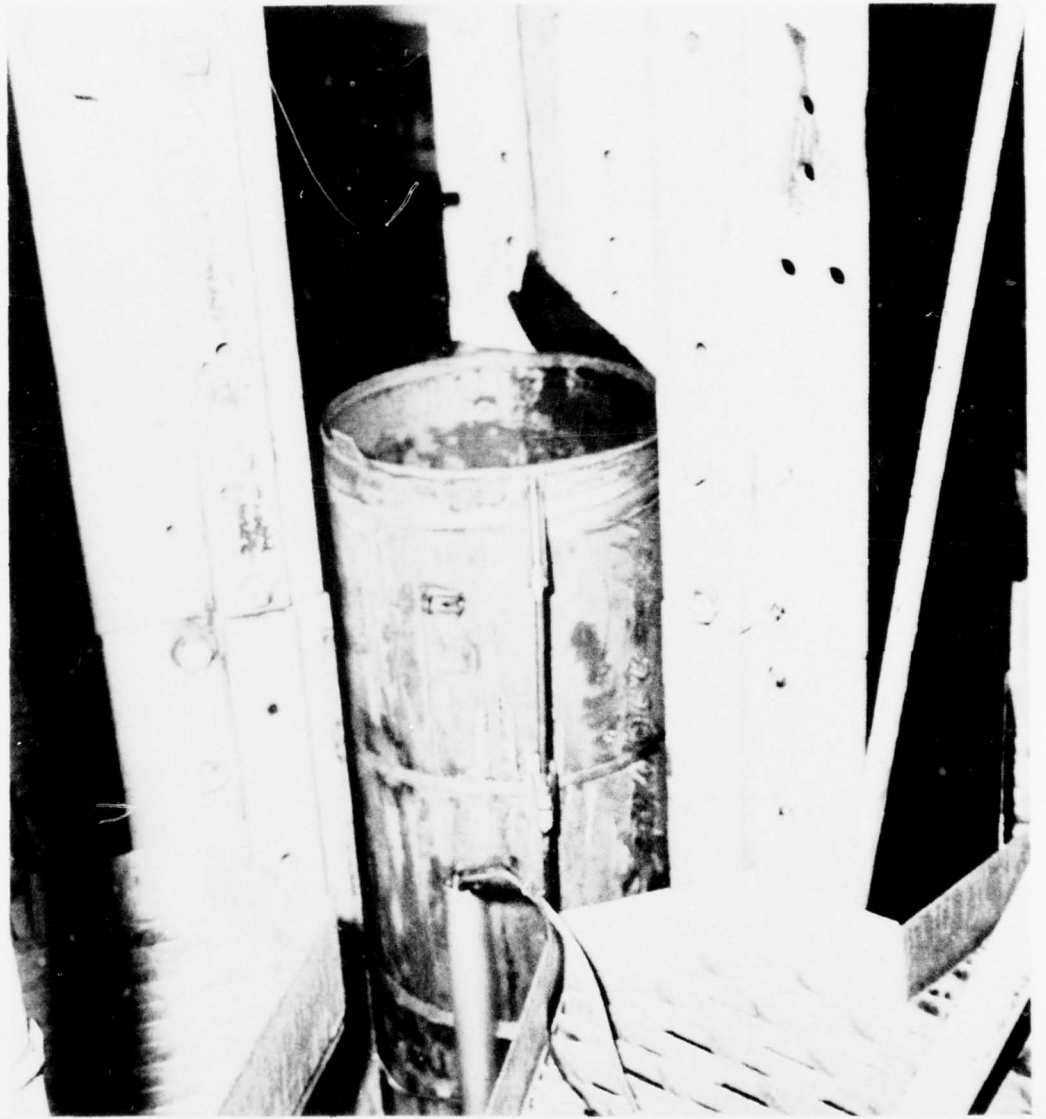
The failure was violent, the whole helium tank, together with the instrumentation section on top of it, being neatly separated from the oxidizer tank, while at the same time the lower hemispherical dome of the helium tank separated into five pieces which were projected violently away from the rocket. Two of them were found embedded in the walls of the building. Figures 8 to 11 illustrate the features of the damage.

Figure 8 - View of Top of Oxidizer Tank of NRL #45 after separation of Helium Tank

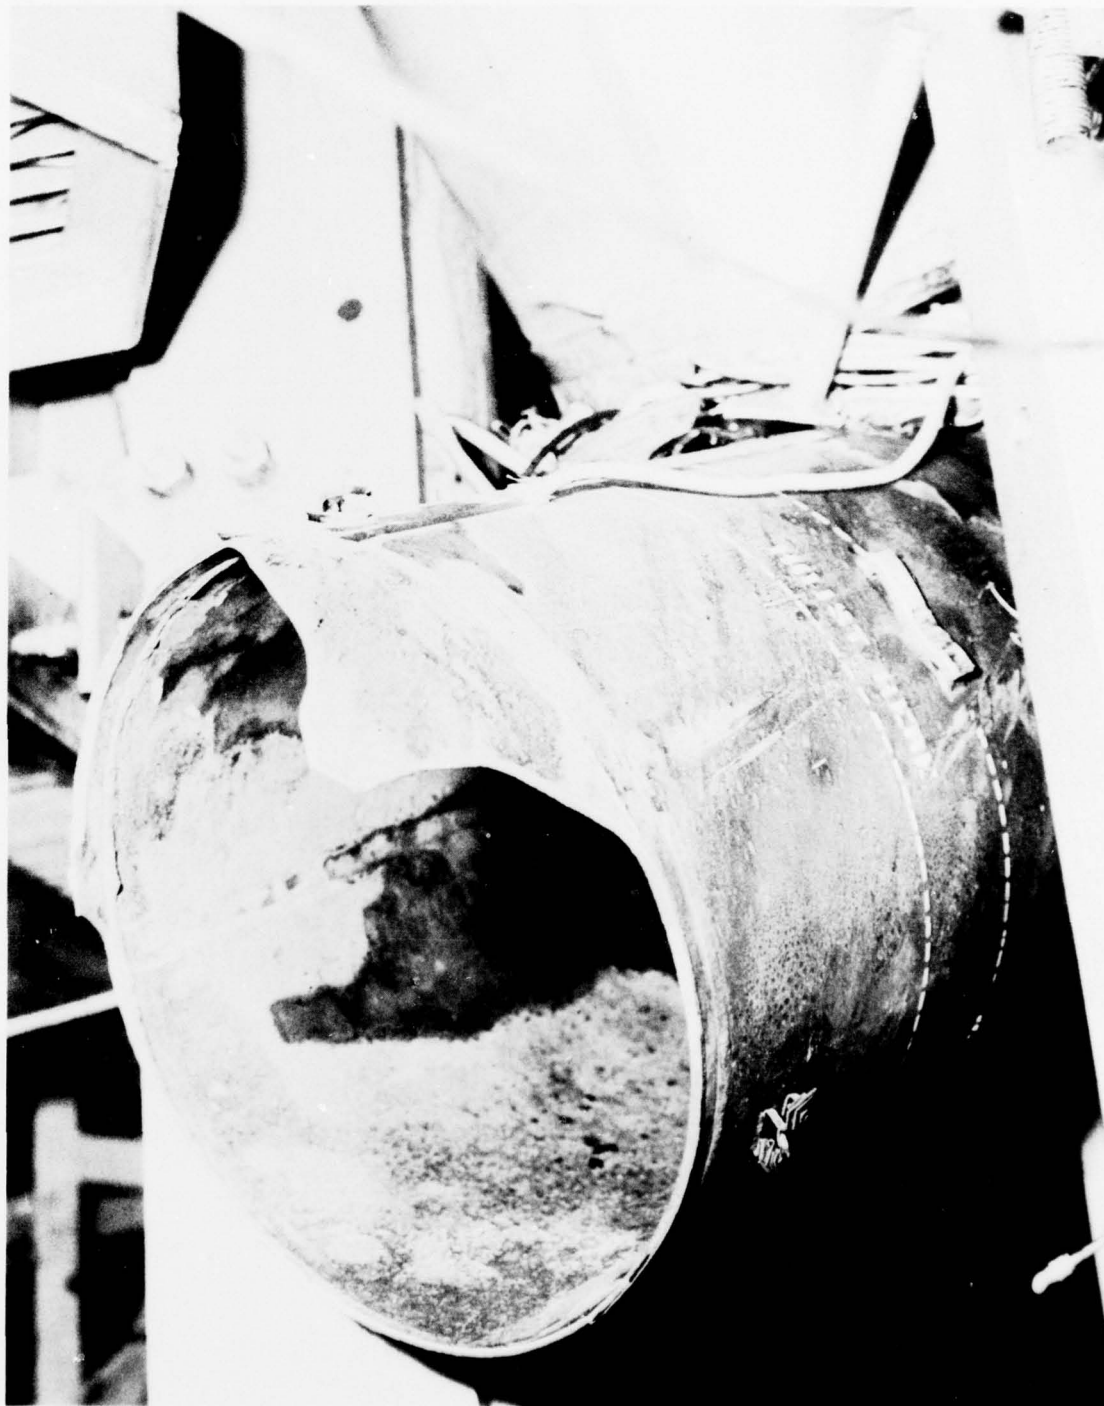
Part of the dome did not separate from the helium tank. In Figure 12 this is located along the arc CDEF, reference to Figures 9, 10 and 11 will help visualization. At D the fracture surface is several inches from the rim of the dome. From D it runs down on either side to the weld joining

Figure 9 - View of fractured end of Helium Tank in position in which it was found after Failure of NRL #45

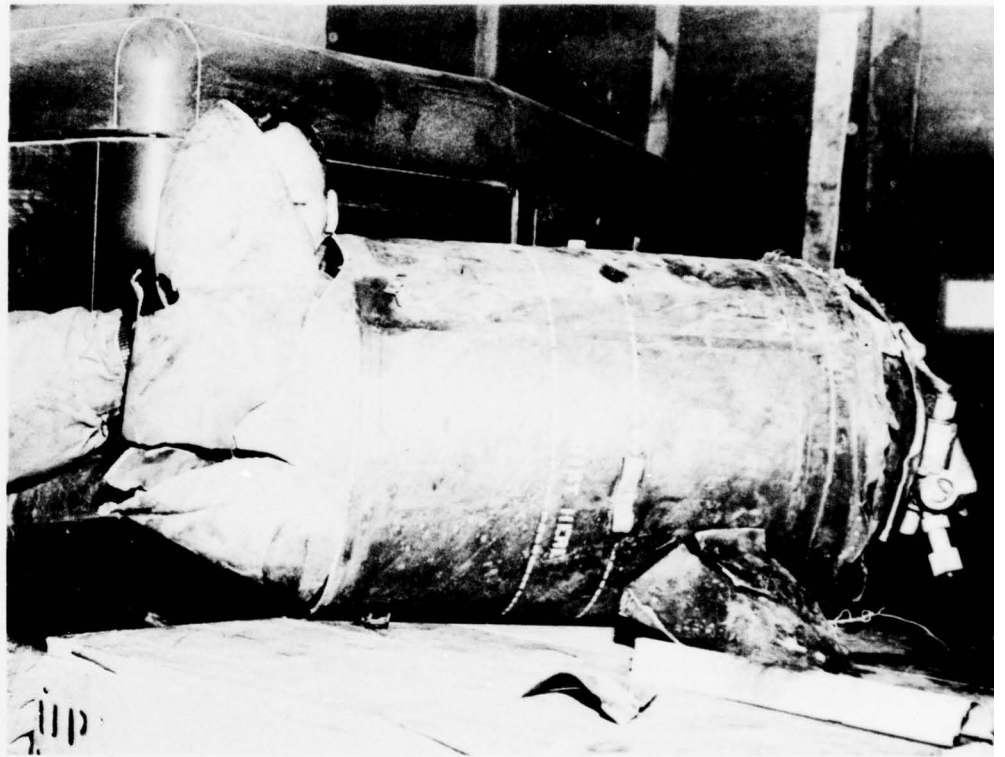
Figure 10 - View of Helium Tank of NRL #45 after removal from Launching Structure showing two separated pieces being held in position and two other pieces in foreground

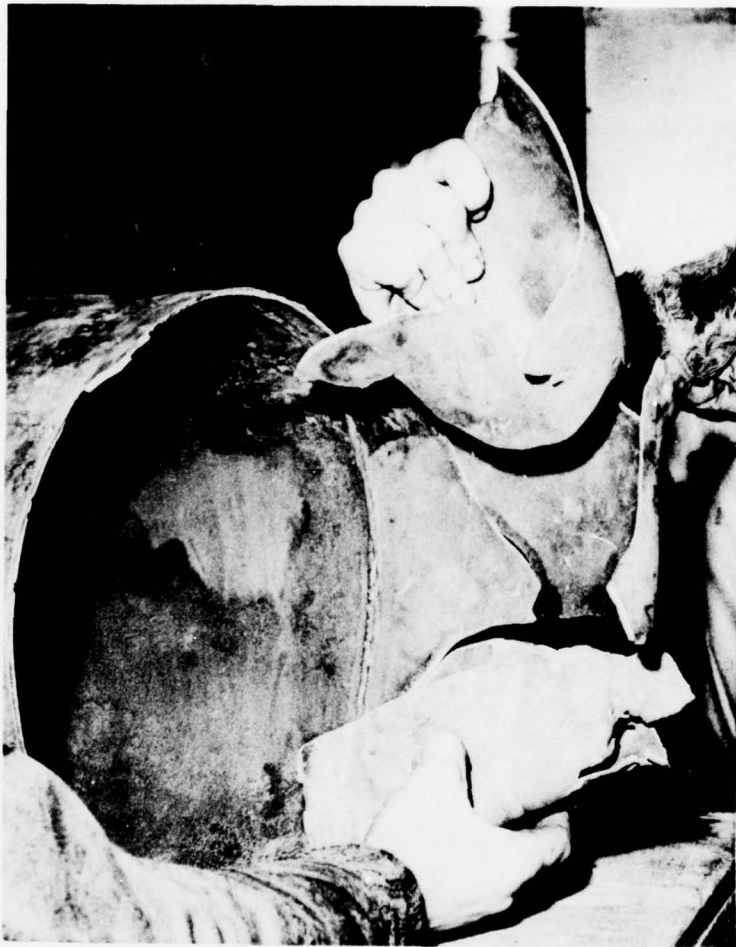
Figure 11 - Another view of the Fractured End of the Helium Tank with two of the separated pieces

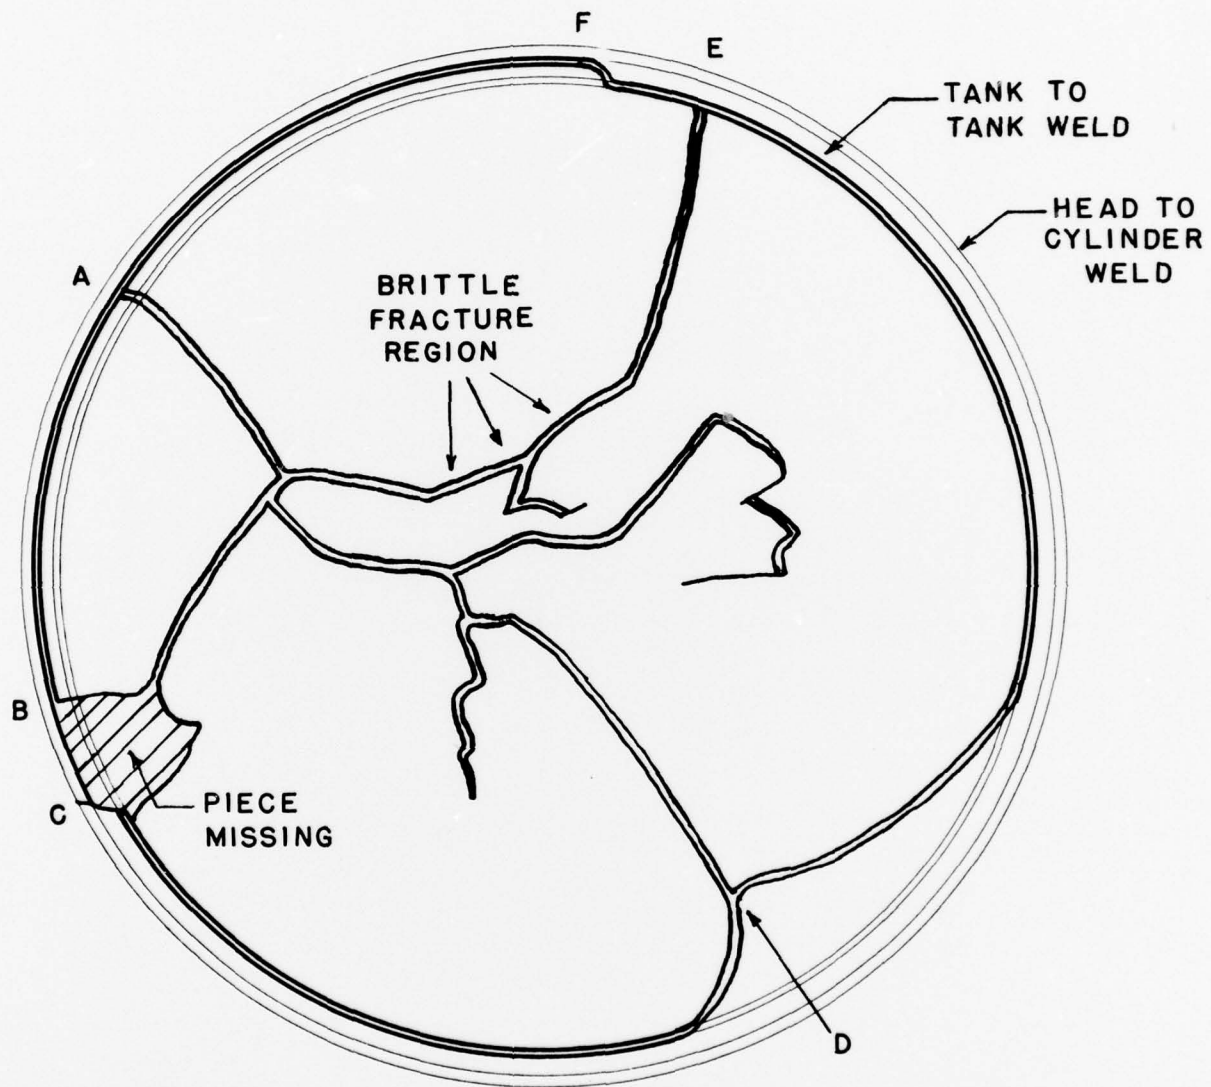
Although the recovered pieces of the dome were too badly distorted to be fitted together for photographing, it was nevertheless possible to match the fracture surfaces. An attempt has been made in Figure 12 to sketch schematically the principal fractures in the form of an end-on view of the tank. While this sketch is not accurate in detail it is considered to be accurate in the important features. It will be noticed that one of the five pieces which separated was not recovered.

the helium tank to the oxidizer tank and follows this weld in both directions to the points C and F. At these points it crosses to the weld joining the dome to the body of the helium tank and follows this weld along the arc CBAF. Near A is a noticeable discontinuity where a fracture running from C towards F might have met one running from F towards C. All of this fracture surface is of the oblique shear type. These features can also be seen in Figure 13 which is a close-up view of this fracture surface.

Figure 12 - Schematic Reconstruction of Fractured Hemispherical Dome of Aerobee - Hi Helium Tank

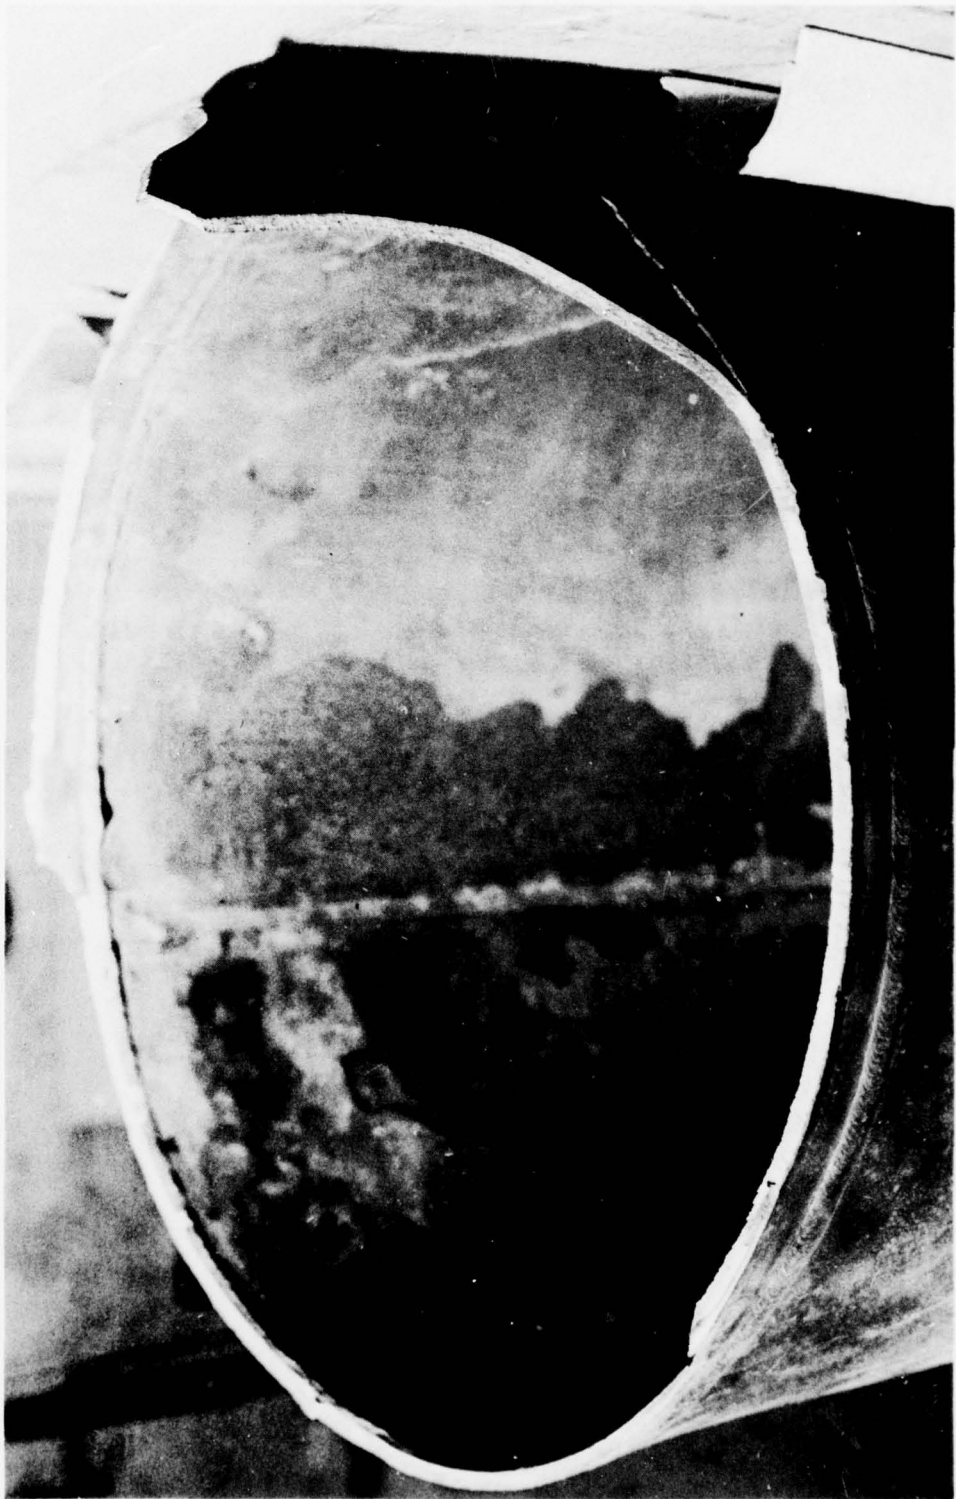
Figure 13 - Close-up view of fractured surface of Helium Tank

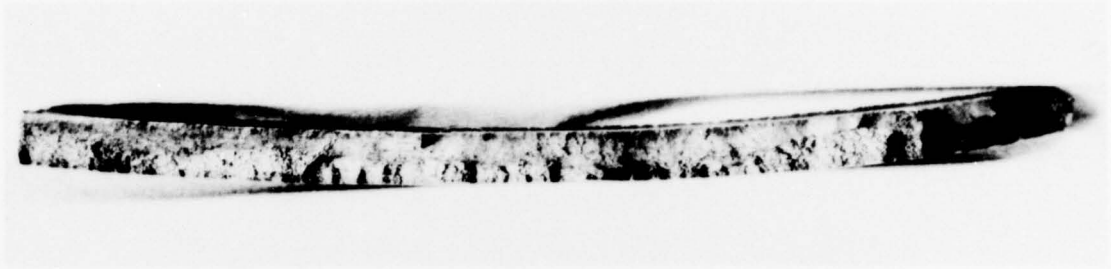
were characterized by granular fracture normal to the convex surface (i.e., the surface in contact with the acid), continuing part way through the section, and completed by the usual shear fracture to the inner concave surface. These features are clearly shown in Figure 14.

In view of the various circumstances: (1) sudden fracture under constant stress after sustaining the stress for some time, (2) contact with acid under stress, (3) short sections of granular fracture normal to the surface surrounded by oblique shear fracture, the most likely cause of initiation of fracture is stress-corrosion cracking. Microscopic examination confirmed the presence of typical intergranular stress corrosion cracks in the vicinity of the granular fractures. Such a crack is shown in Figure 15 which is a photomicrograph taken from a microsection normal to the dome of the tank near an area of granular fracture. Such cracks were found frequently on the convex surface, which had been in contact with the acid, in each of several microspecimens examined. No cracks were found on the concave surface which had not been in contact with the acid.

The evidence is therefore completely in accordance with the hypothesis of initiation of the failure by stress-corrosion cracking. A. Co. Materials Engineers have stated their concurrence in this diagnosis.

Figure 14 - Section of NRL #45 Dome Fracture showing Stress Corrosion Fracture on the acid side (bottom) and Shear Fracture on the Helium Side (top). 2X (Approx)

Present indications are that inhibition with 1/2 - 3/4% hydrogen fluoride (anhydrous) shows great promise. If this idea can be worked out satisfactorily, there may be no pressing need to complete the whole program of stress-corrosion testing.

excellent indication, is no guarantee that every tankage would survive. The decision which has already been made, to operate with a pressure of 3400 psig in the Helium tank instead of 3750 psig will clearly tend to reduce the risk of failure and is desirable so long as performance is not adversely affected beyond what can be tolerated.

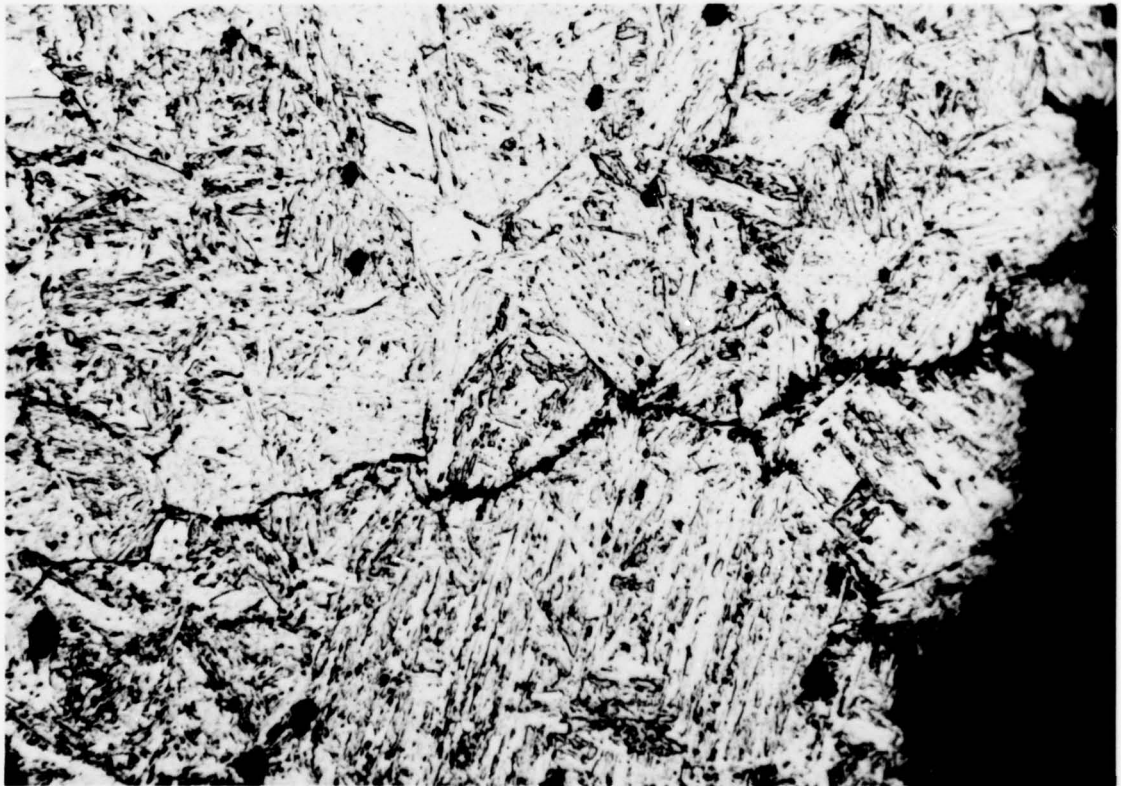
Figure 15 - Photomicrograph of stress corrosion crack in the vicinity of the Fracture shown in Figure 14. 1000 X, Etched Picral/HCl

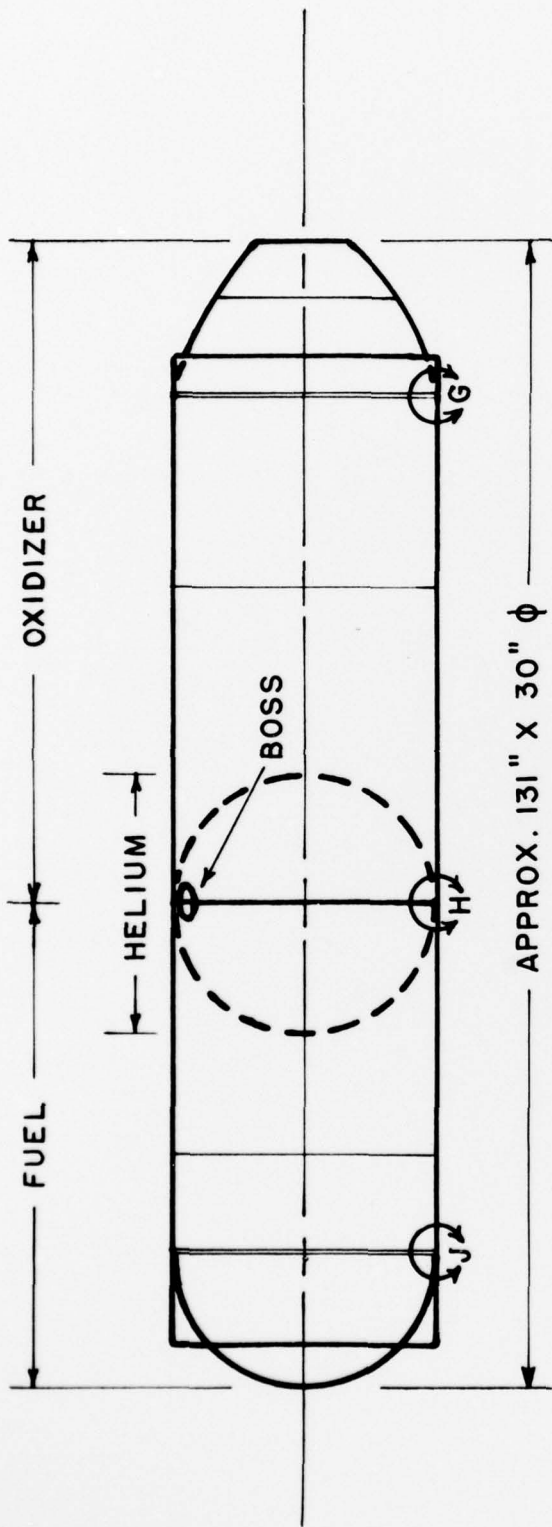
The first failure was a fracture of a helium sphere which originated at the boss shown in Figure 16. This boss is normally a type 410 stainless steel forging. In the case under consideration, a type 431 stainless steel boss, machined from bar stock, had been substituted because of procurement difficulties (the tank was intended only for test purposes). This boss did not have the structure or grain flow necessary to sustain the stresses and therefore split into four pieces at 1565 psig during pressure testing. These fractures propagated into the helium sphere a short distance and then terminated. Recurrence of this type of failure is not to be expected since no further spheres will be fitted with type 431 bosses. Subsequent proof testing of other spheres has demonstrated the ability of type 410 bosses to sustain the stresses (which are lower than in the actual tankage).

Figure 16 - Schematic of Vanguard Tank Assembly Showing Locations of Girth Welds only

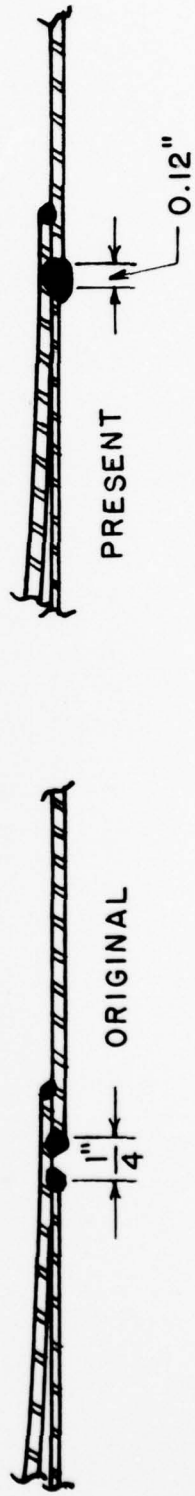
The second failure occurred to the fuel tank of a unit having a head to body weld of the original type shown in Figure 17. The head blew off at 390 psig, the fracture running between the two welds shown in the Figure, joining head to body and skirt to head, sometimes along the edge of one weld and sometimes along the edge of the other. It was thought to be a weld-associated failure and, as a consequence, the joint design was changed. The first modification was to bring the two welds closer together and then fuse them with a third bead. The current modification consists of tack welding and then joining the three pieces with one heavier, double fillet weld as indicated in Figure 17. This joint is considered to be much more reliable than the original and, providing proper control is exercised over the welding, should not be a particular source of future trouble.

Figure 17 - Detail of Weld J (G is Similar) as Originally Designed and as Now Designed
