CALSPAN CORP BUFFALO N Y

MAR 79 E J MACK, R J ANDERSON, D H BOCK

*AN OPERATIONAL RESEARCH INVESTIGATION OF THE
ICE-DETECTION CAPABILITY AND UTILITY OF THE
SURFACE CONDITION ANALYZER (SCAN) SYSTEM
AND ITS APPLICABILITY TO NAVY-WIDE USE*

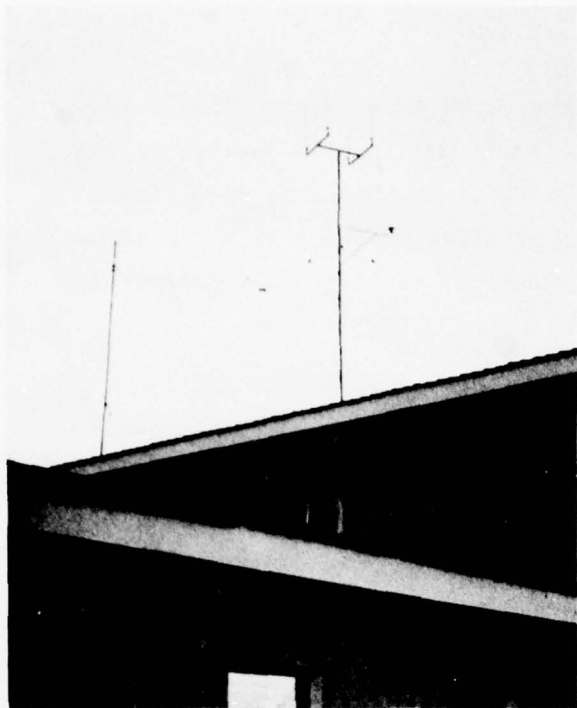
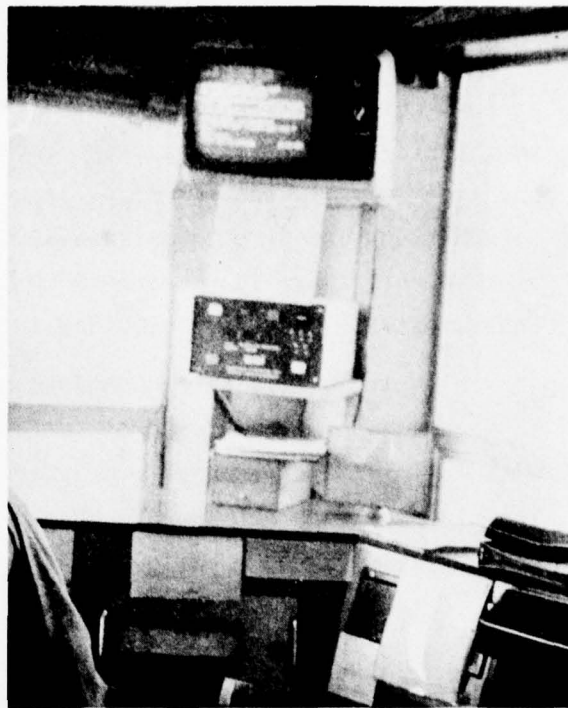
Figure 14 VIEWS OF SCAN SYSTEM COMPONENTS INSTALLED AT KEFLAVIK

Figure 14 provides photographs of other components of the SCAN system installed at USNASKEF. Figures 14c and d show, respectively, views of the remote processing unit (RPU) and transmitter electronics for sensor #4, located in an underground bunker housing the arresting gear mechanism. Figure 14a shows the radio telemetry receiving antenna and air temperature sensor on the roof of the Fire House. Figure 14b shows the display terminal (approximately centered in the photograph) located in a prominent position in the Fire Department's Communications Center.

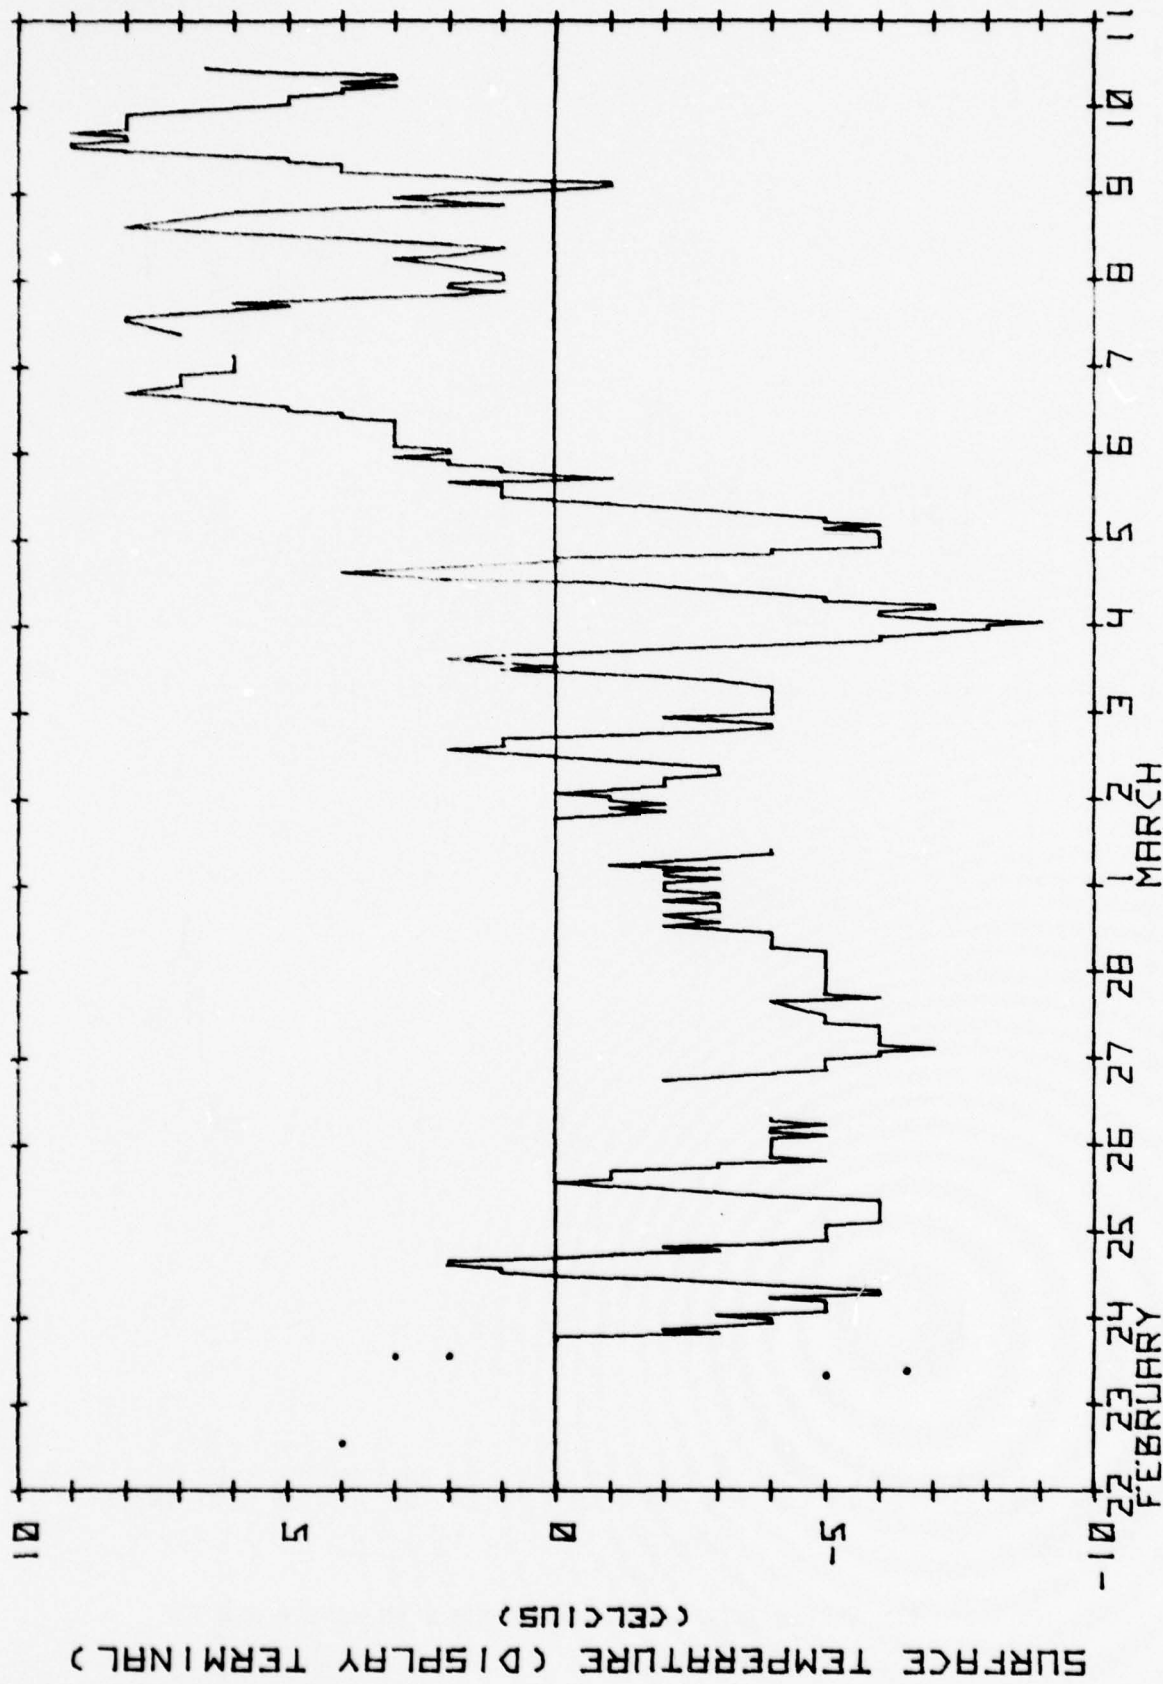
Figure 18: RECORD OF SURFACE TEMPERATURE RECORDED FROM THE DISPLAY TERMINAL FOR SCAN #4

An apparent drift in the electronics between the RPU and display terminal, for the one sensor monitored at Keflavik, caused displayed temperature to read 4°C warmer than actual sensed surface temperature -- a potentially serious, but correctable, error for effective and timely implementation of anti-icing strategy.
