**HISTORIC STRUCTURE REPORT**

# GRUBER WAGON WORKS

**PHILADELPHIA DISTRICT  
U.S. ARMY CORPS OF ENGINEERS**

**JOHN MILNER ASSOCIATES  
WEST CHESTER, PENNSYLVANIA**

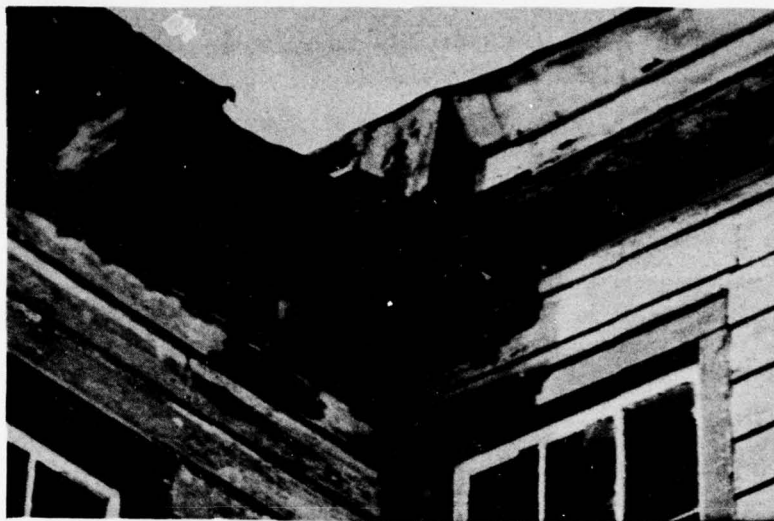
A) Deteriorated Roof Junction, Section D-1 and B  
(West Elevation of B)

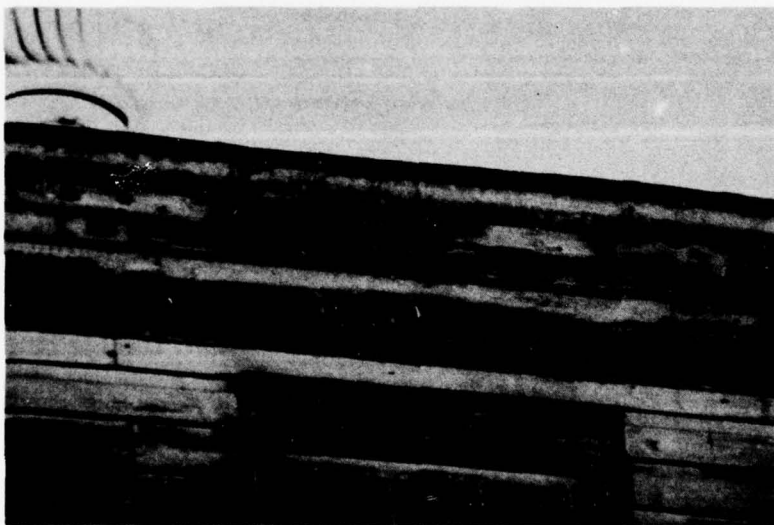
B) Deteriorated Cornice, Section B, West Elevation

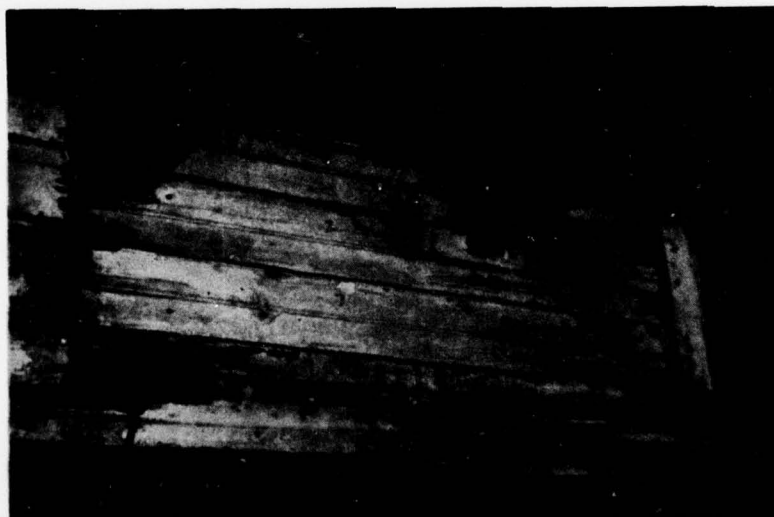
B) Broken Opening
