LANGAN ENGINEERING ASSOCIATES INC CLIFTON NJ
NATIONAL DAM SAFETY PROGRAM. SWANNANOA LAKE DAM
FEB 79 D LEARY

REPORT DOCUMENTATION PAGE		READ INSTRUCTIONS BEFORE COMPLETING FORM	
1. REPORT NUMBER NJ00310	2. GOVT ACCESSION NO.	3. RECIPIENT'S CATALOG NUMBER	
4. TITLE (and Subtitle) Phase I Inspection Report National Dam Safety Program Swannanoa Lake Dam #2 Morris County, NJ		5. TYPE OF REPORT & PERIOD COVERED 9 FINAL rept.

OVERVIEW
SWANNANOA LAKE DAM #2
1 DECEMBER 1978

SWANNANOVA LAKE DAM 2

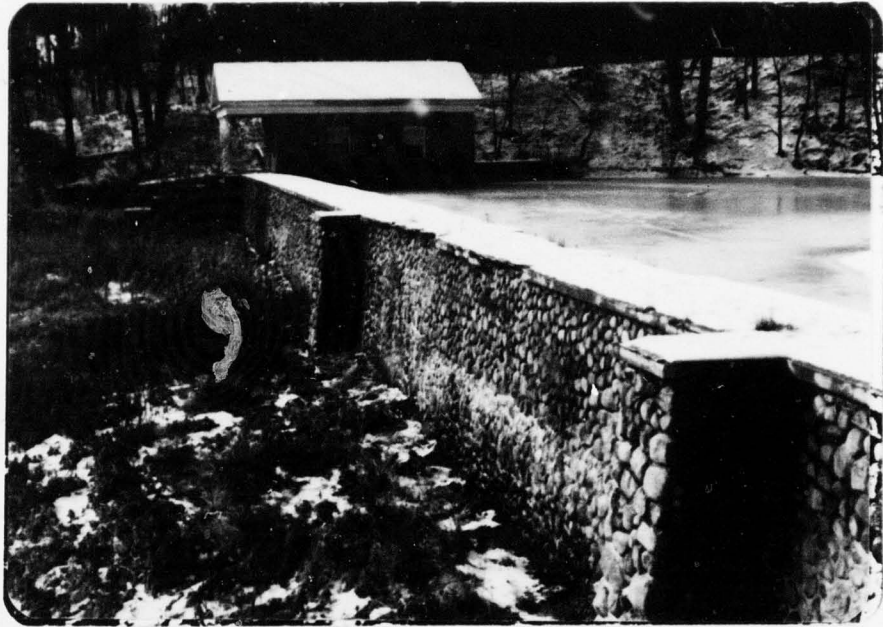
Downstream face of dam.

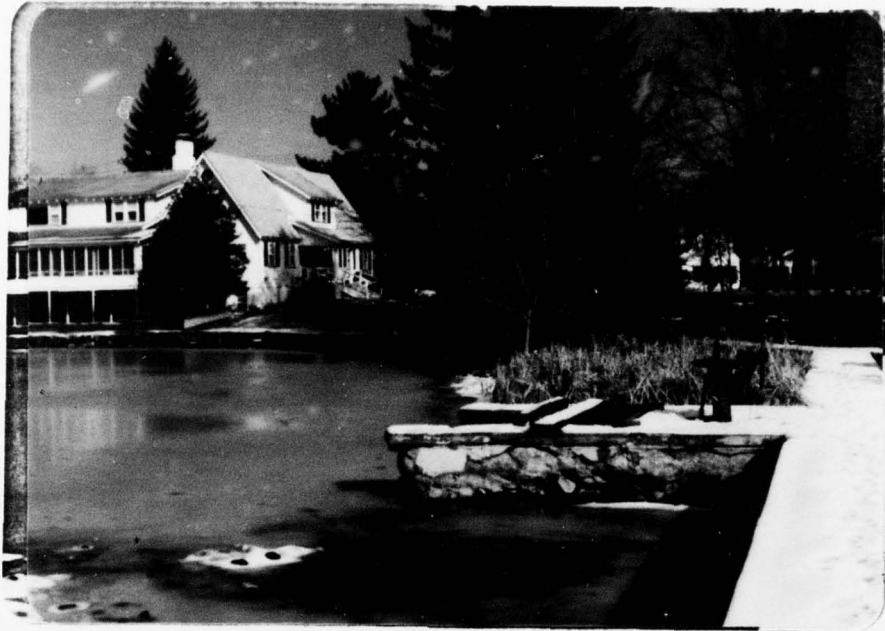
Discharge gate structure .

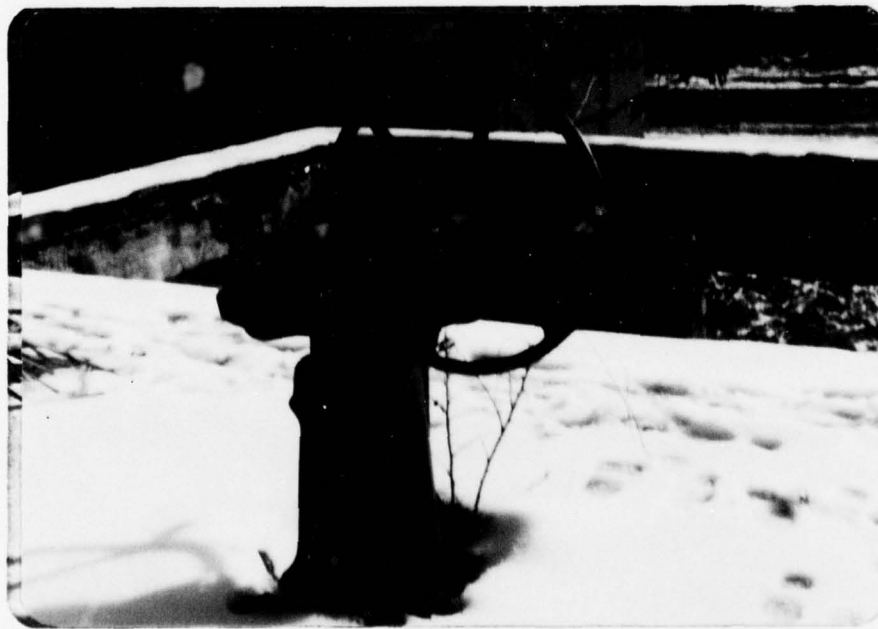
Operator to 4-ft-dia lift gate.

7. Repair and make permanently functional the operator and gate for the 3.5-ft-dia lift gate so that the drop-box spillway can function properly. This should be done very soon.

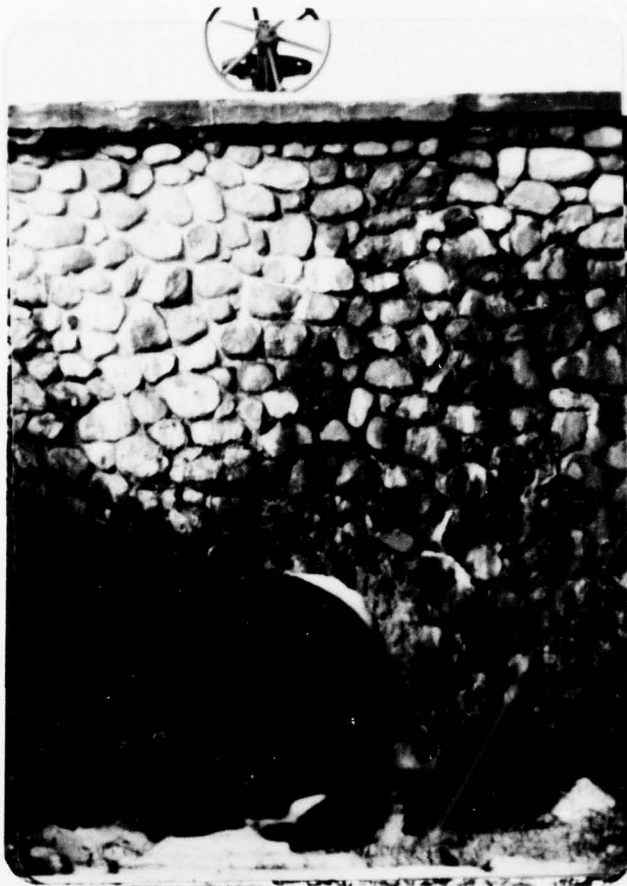
42-in-dia steel pipe leading
from 8-ft drop inlet spillway.

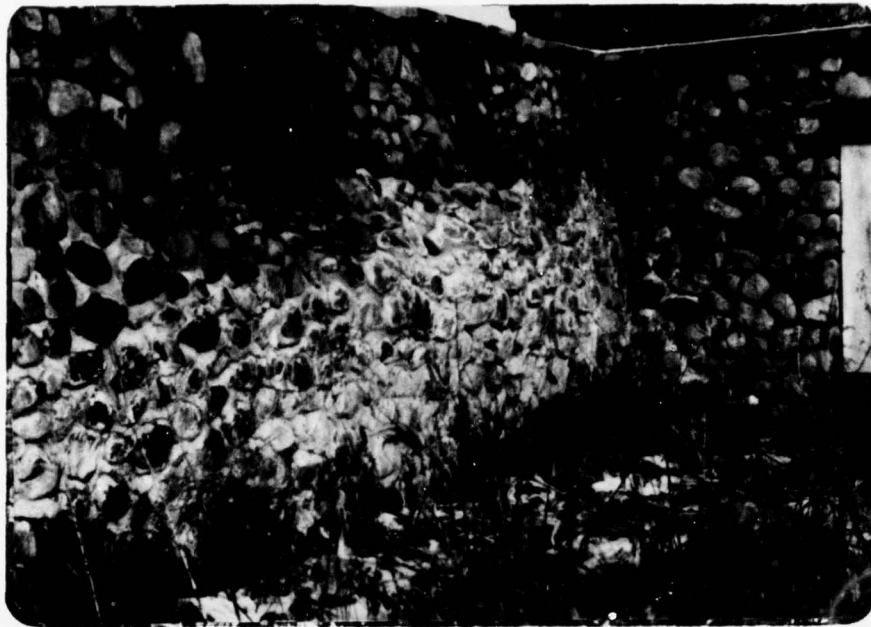
The results of our inspection indicate Swannanoa Lake Dam is in Poor Condition. The lower part of the downstream face of the dam is bulging over the major portion of its length. The bulge varies from about 1 inch to 10 inches. Leakage is occurring through the face of the dam at many locations and along the toe. The immediate downstream area is very wet and spongy and the dam has a slight downstream bow particularly in the area of maximum bulging. An approximately 3 ft by 4 ft area of the face of the dam has fallen away leaving a 10 inch to 18 inch deep void in the face of the dam. At this location the concrete was observed to have become a very weakly cemented sand with embedded stone.

Bulging of lower portion of dam.

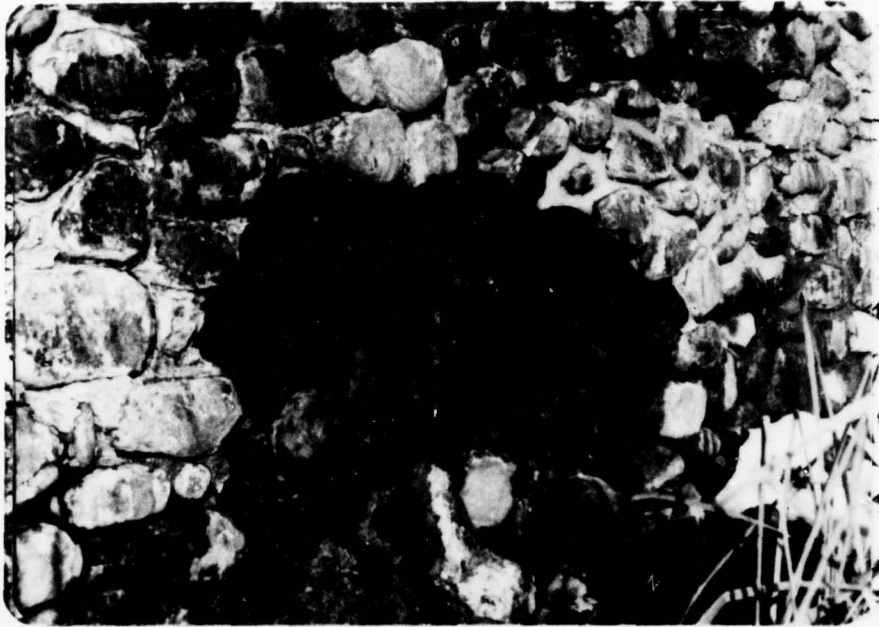
DESCRIPTION OF DAMAGE:
Seepage through masonry caused bulging of downstream stone wall facings at four locations. One bulge has broken open exposing deteriorated rubble concrete interior.

Bulge collapse and loss of interior
portion of downstream face of dam.

k. REMEDIAL ACTIONS TAKEN: Owner has lowered lake level and repaired masonry facing wall as recommended.

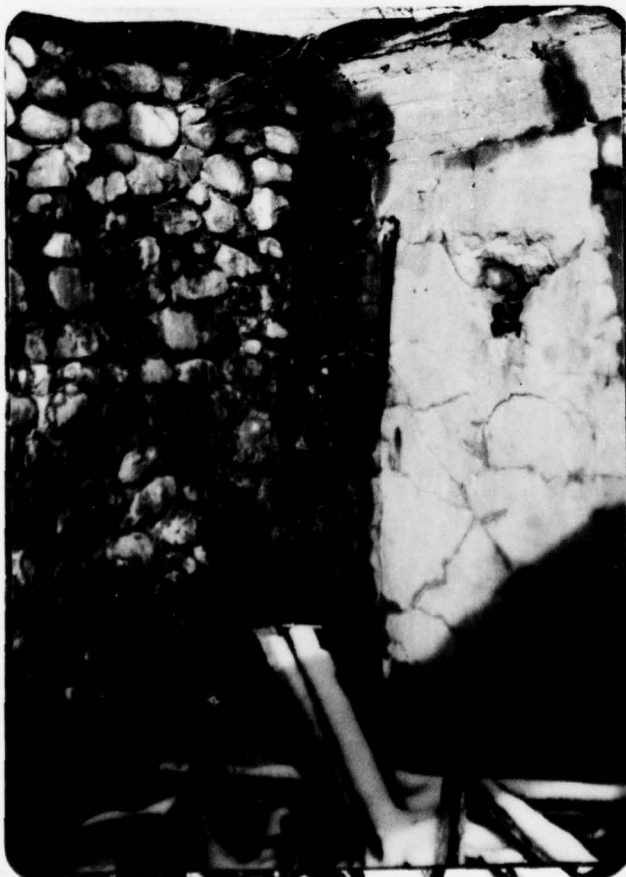
Seepage at downstream face
of dam in abandoned
generator house.

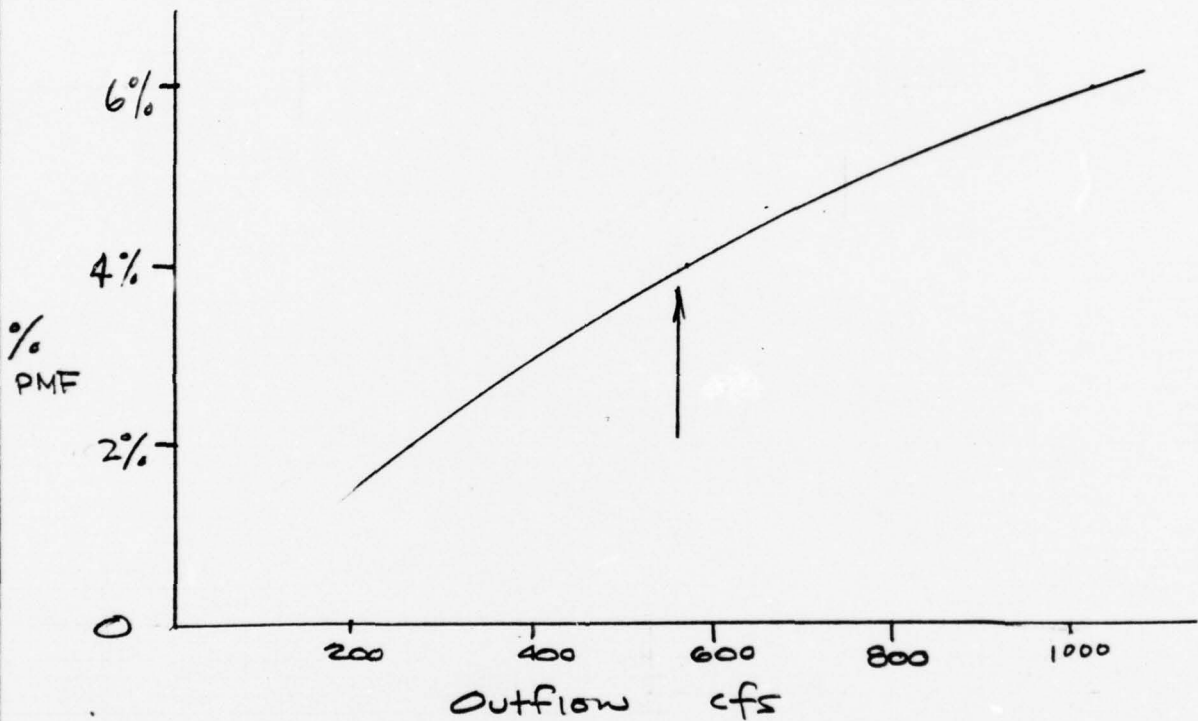
OVERTOPPING POTENTIAL

3. Dam overtops at approx el 773 with $Q = 560$ cfs
 \therefore dam can pass approx 3.9% the PMF
