PASSAIC RIVER BASIN  
ROCKAWAY RIVER TRIB.  
MORRIS COUNTY,  
NEW JERSEY

**SWANNANOA LAKE**

**DAM NO. 1**  
**NJ 00311**

**PHASE 1 INSPECTION REPORT  
NATIONAL DAM SAFETY PROGRAM**

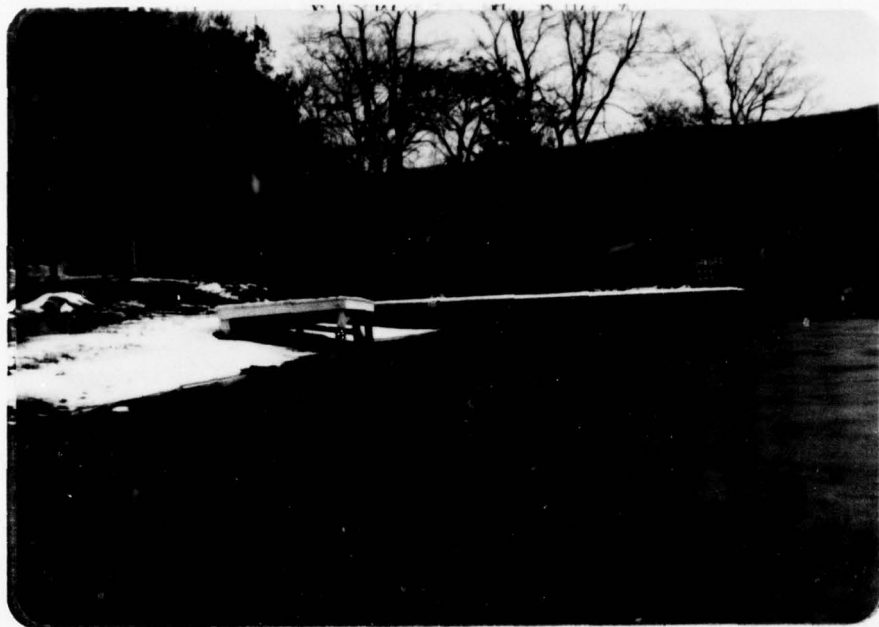
Left Abutment and left side  
of spillway.

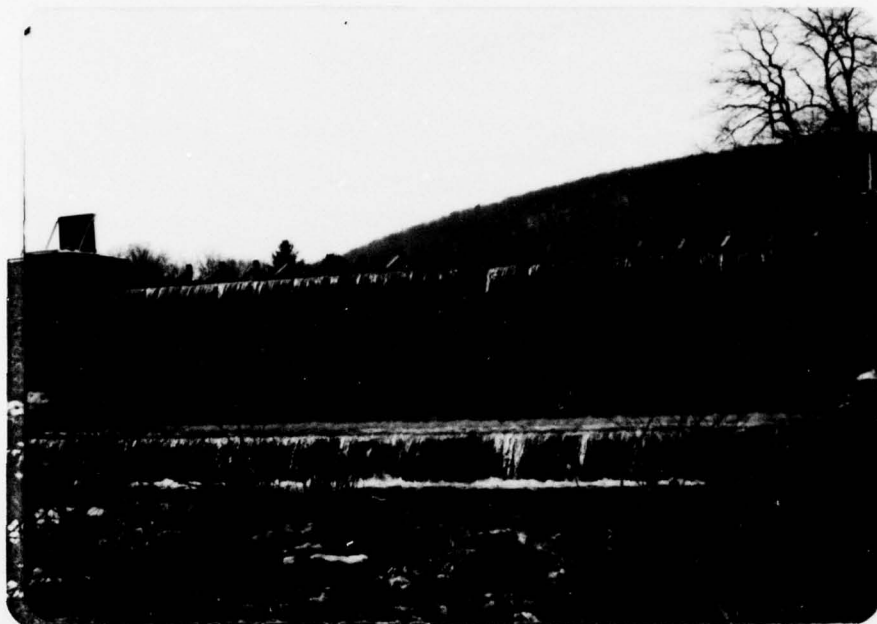
Spillway.

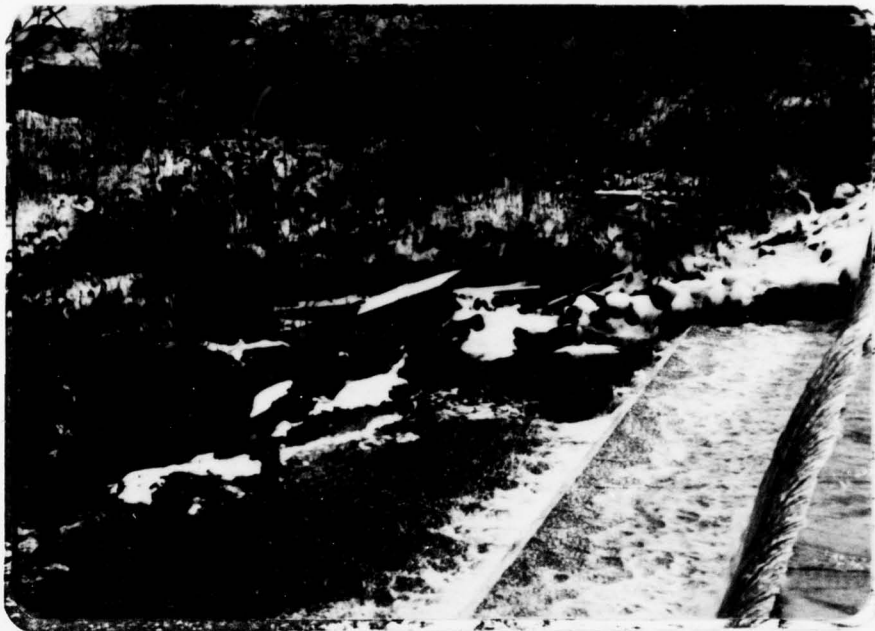
The spillway right downstream channel side wall has collapsed and the left sidewall is deteriorating. There are trees and bushes in the downstream channel and erosion has occurred along the sidewalls. There is cracking and spalling of the masonry concrete and cobble stones have fallen from the side walls of the downstream channel.

| VISUAL EXAMINATION OF | OBSERVATIONS | REMARKS OR RECOMMENDATIONS |
|---|---|---|
| | Right spillway d/s sidewall deteriorated. Left spillway d/s sidewall has missing cobbles. Splash bench lip is broken. | Sidewalls should be repaired. |

Deteriorated downstream spillway  
right sidewall.

(2) Repair the downstream sidewalls of the spillway and discharge channel.

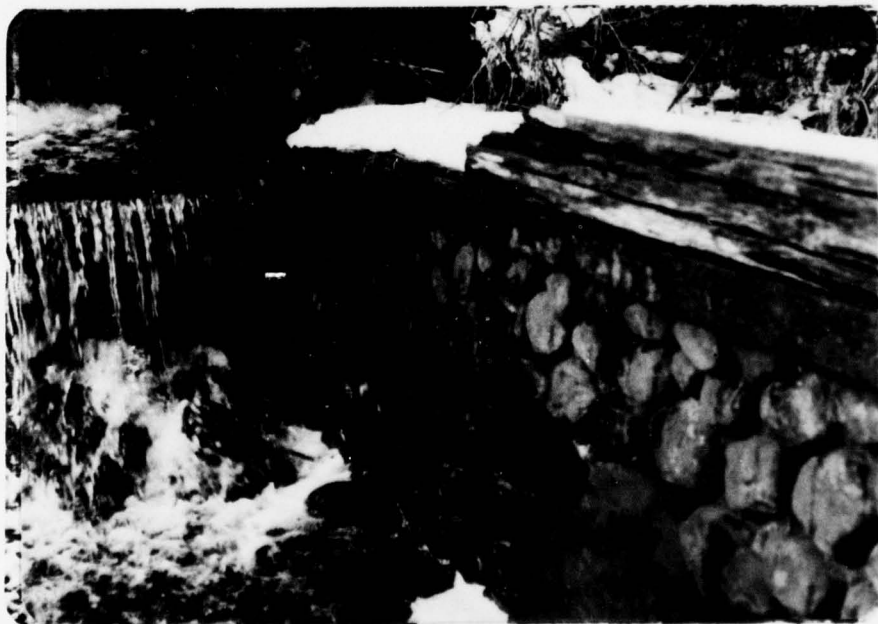
Cobbles loosened and removed from  
left downstream spillway sidewall.

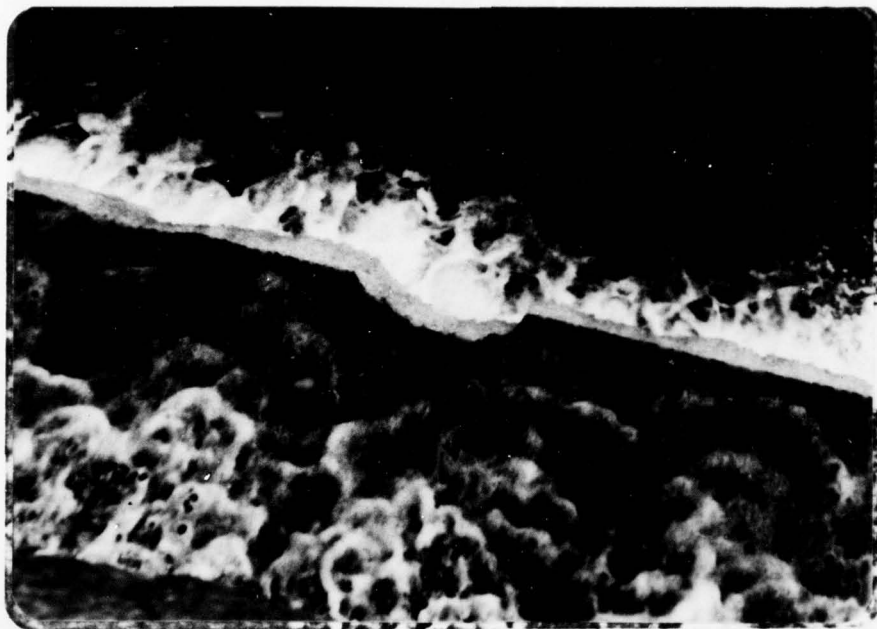
Broken concrete lip of splash  
bench at toe of spillway.

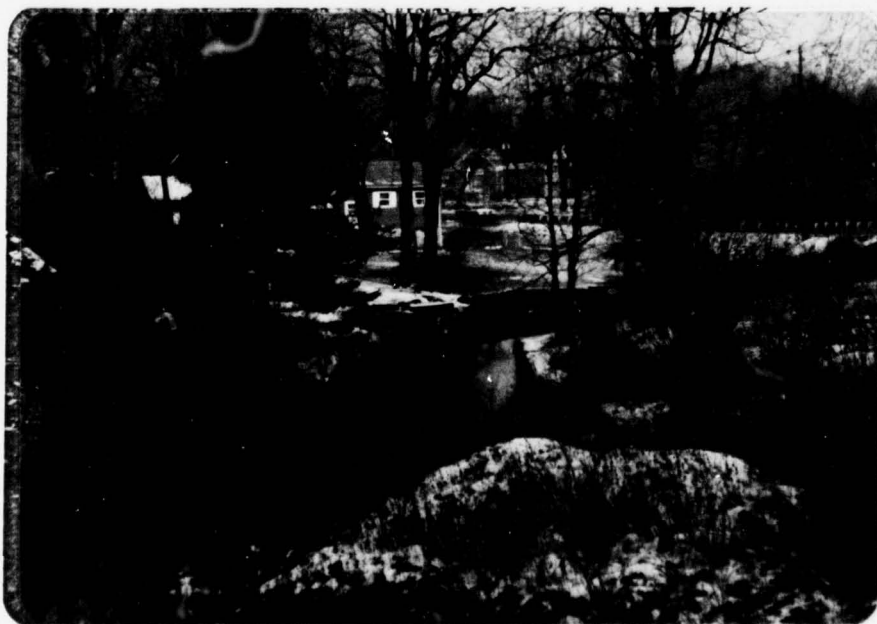
| VISUAL EXAMINATION OF | OBSERVATIONS | REMARKS OR RECOMMENDATIONS |
|---|---|---|
| DISCHARGE CHANNEL | Debris, trees & brush in channel. Channel side walls have deteriorated. Cavities are present. | Remove debris, trees & brush.<br>Repair sidewalls. |

Discharge channel. Looking downstream. 30 November 1978

(8) Remove debris, trees and brush from along the toe of the dam and the discharge channel.

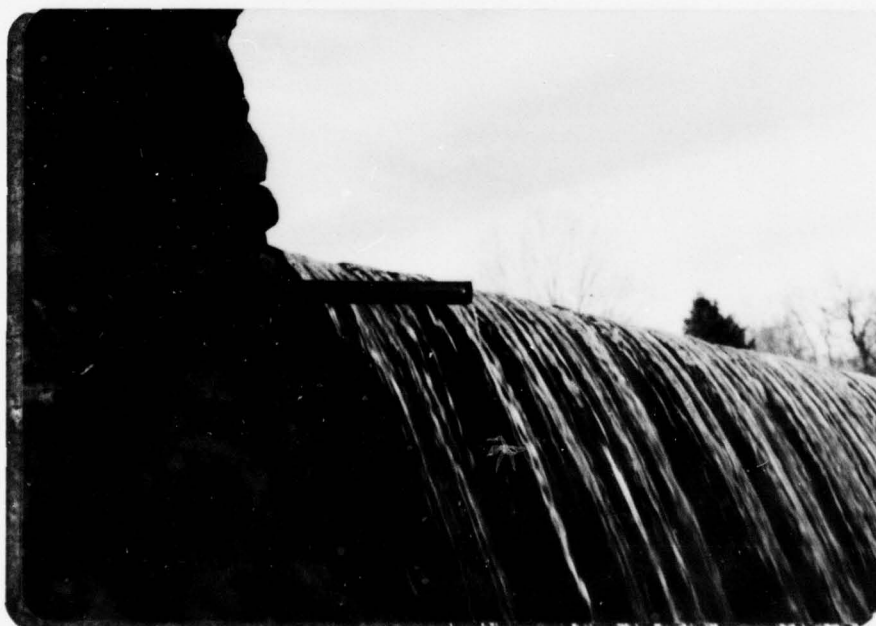
Weep pipe at right spillway  
retaining wall.

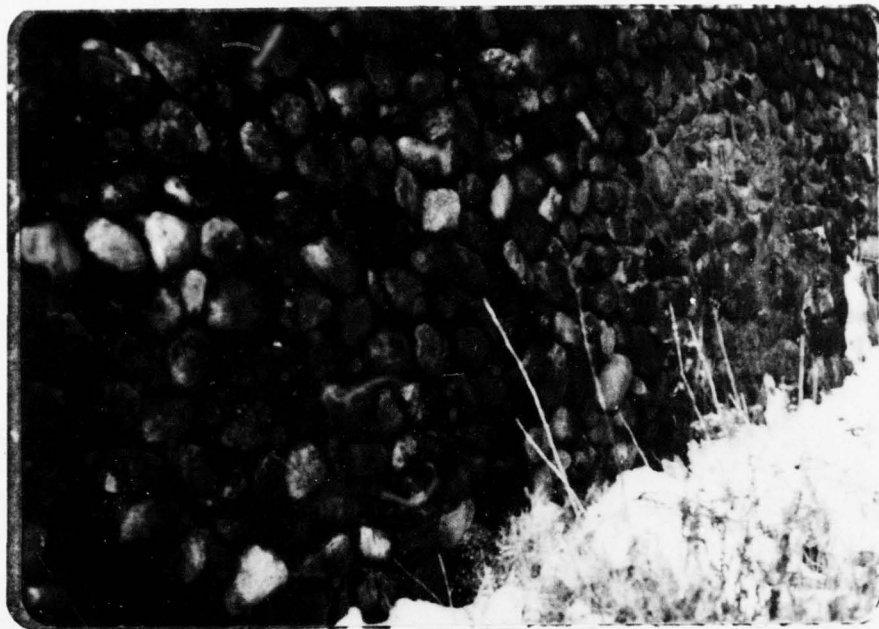
| VISUAL EXAMINATION OF | OBSERVATIONS | REMARKS OR RECOMMENDATIONS |
|---|---|---|
| STRUCTURAL CRACKING | Downstream face bulges 1"-3" out of the vertical plane of the wall.<br>Crack on right buttress at spillway. | Crack on right spillway buttress should be repaired. |

Repaired right downstream face of dam. Note slight bulging of face.

(3) Evaluate the need for additional downstream support of the dam and measures for relieving hydrostatic pressure from within and below the dam.
