DELAWARE RIVER BASIN  
ALMONESSON CREEK,  
GLOUCESTER COUNTY  
NEW JERSEY

# ALMONESSON LAKE DAM

## NJ 00401

### PHASE 1 INSPECTION REPORT NATIONAL DAM SAFETY PROGRAM

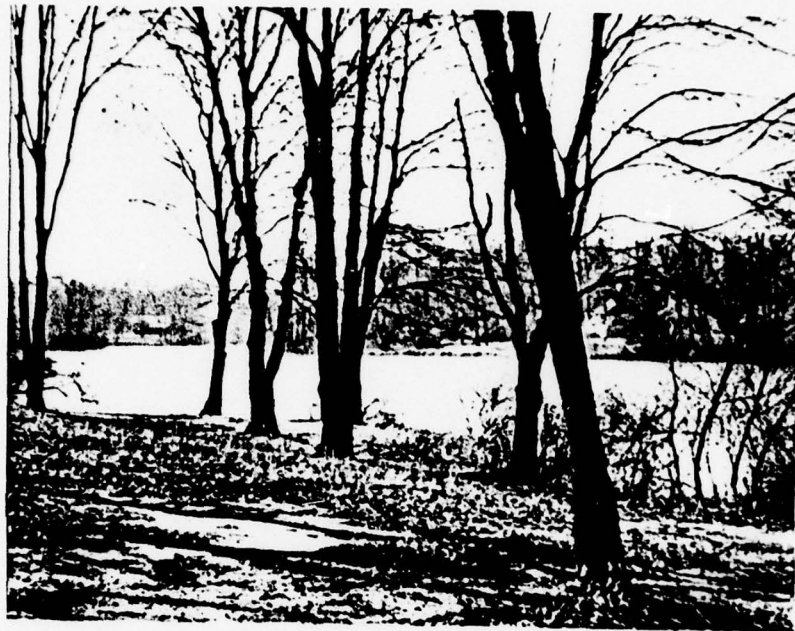
Almonesson Lake

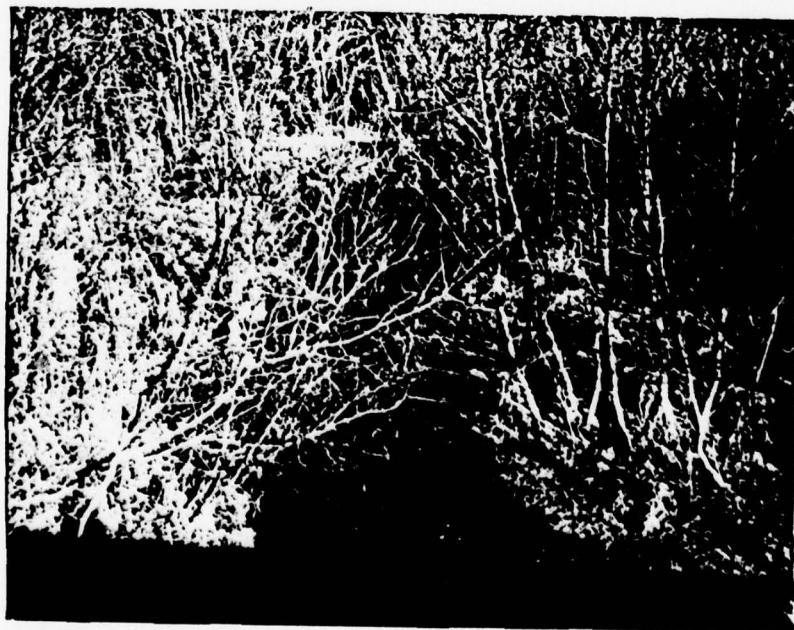
Downstream channel

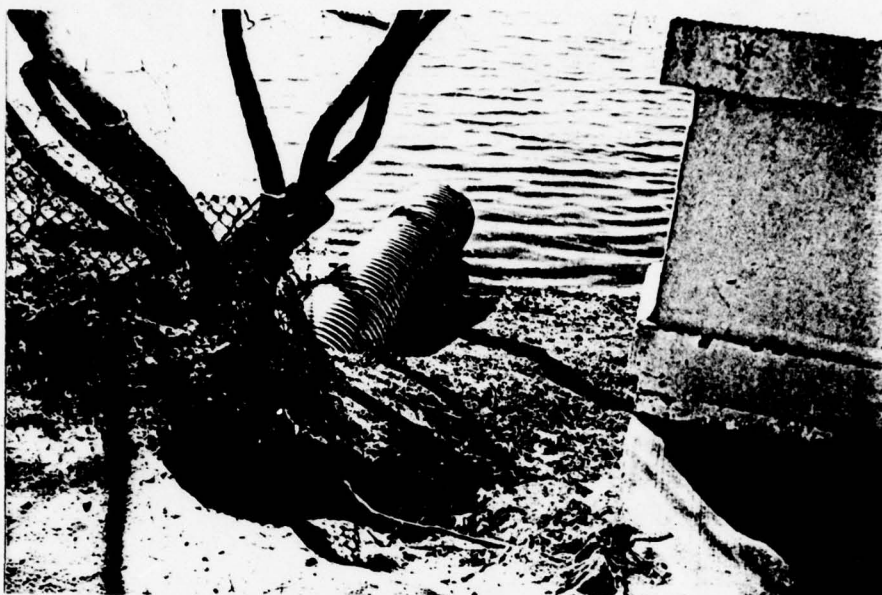
Based on the existing conditions inspected and the 1926 single source of design plans, the dam is deemed to be in moderately good condition except for the continual maintenance problem of roadway drainage at the end of the bridge wingwalls. Although no safety hazard is foreseen, a collapse of the culvert structure due to vehicular overloads could block the discharge channel and create a hydraulic blockage. However, in view of its structural condition, and depth of cover, this is quite unlikely. The roadway embankment is quite wide in relation to its height and as a water impounding structure, has adequate stability. The depth and limits of the timber sheet piling core (see Figure 2) are unknown but certainly contribute to the adequate length of the flow network. Although some evidence of seepage was observed on the natural terrain immediately northwest of the dam, it could not be ascertained that this was an evidence of percolation or the result of overland flows from the higher ground immediately to the east.

Roadway drain at S.E. wingwall

(5) Construct curbs and additional catch basins along the roadway gutters to better control the surface runoff.

(1) Regrade and provide slope protection for the downstream embankment areas at the bridge wingwalls.

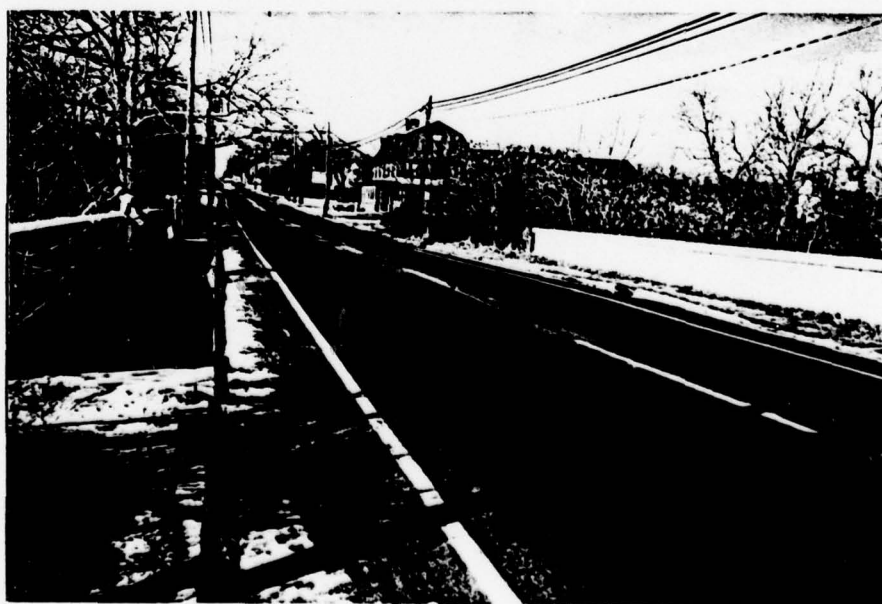
View West along Cooper Street

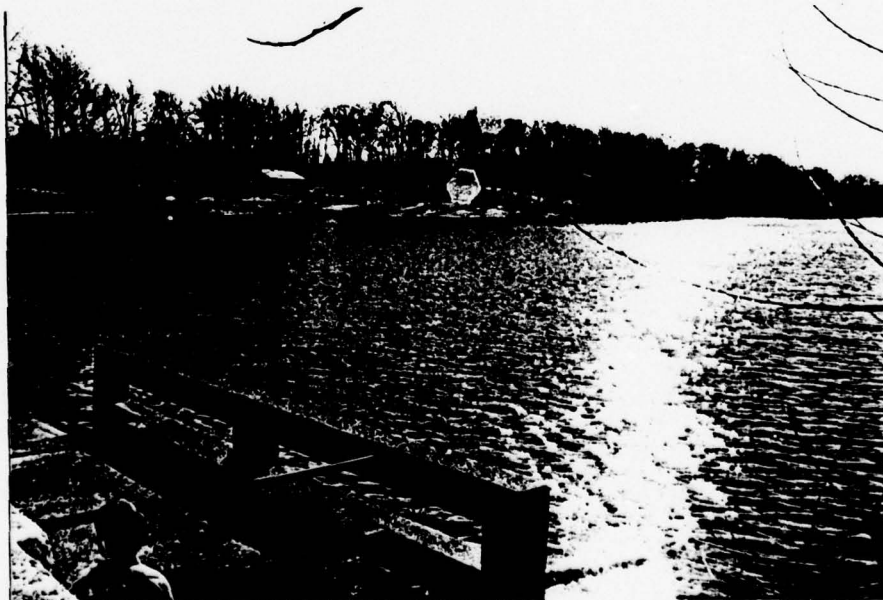
View S.E. from spillway of lake
