# JUMPING BROOK DAM

## NJ 00084

PHASE 1 INSPECTION REPORT  
NATIONAL DAM SAFETY PROGRAM

Name of Dam Jumping Brook Dam Fed ID# NJ 00084 and  
NJ ID# 598

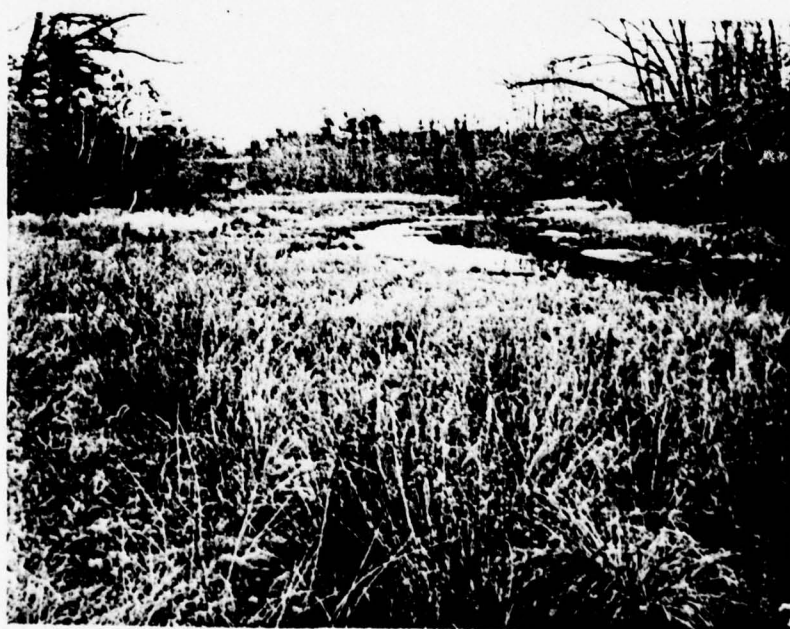
The lack of operational procedures are not seen as a detrimental factor in assessing the hazard potential of this dam since the spillway functions effectively as a low waterfall in the riverbed (due to the heavy siltation of the reservoir). The original embankment sections have been stabilized by filling and sedimentation

Upstream Reservoir
