GLENDOLA RESERVOIR

NJ 00096

PHASE 1 INSPECTION REPORT NATIONAL DAM SAFETY PROGRAM

April, 1979

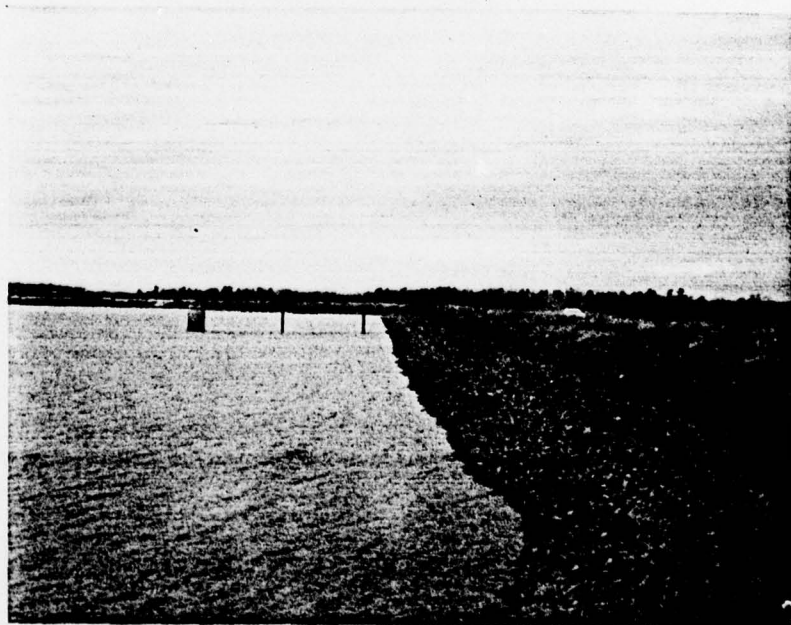
The only appurtenant structure is the 80-foot concrete wetpool intake tower in the reservoir for the 36-inch inlet/outlet pipe. The access bridge and working platform are in a satisfactory, well-maintained condition.

Intake structure

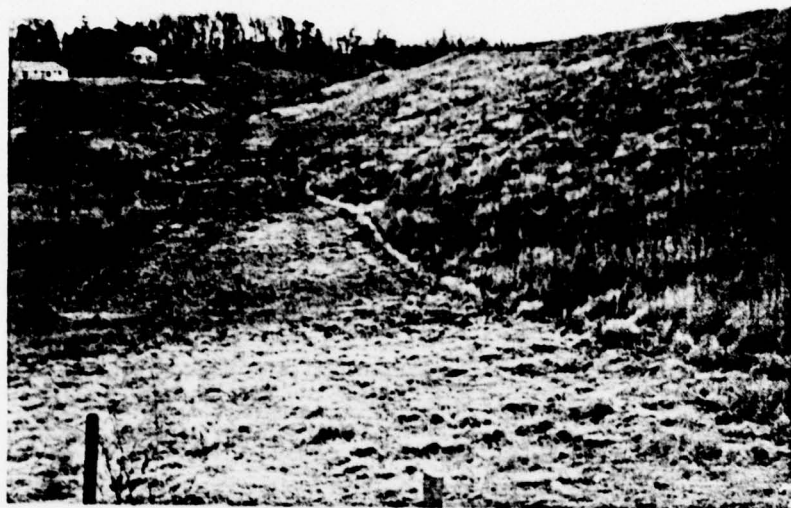
There are wet zones at and beyond the toe in several areas and some seepage appears to be emanating from the embankment. There is a line of a dozen or more relief wells in the vicinity of Robins Swamp Brook that feed into a collection box located approximately at the midpoint. The outlets are several inches below grade and appear to be flowing freely. Additionally, there are also piezometers in and beyond the toe. At one water was flowing out of a hole at the top (through the rusted casing). The toe drains and relief wells are apparently functioning on a continuous basis to relieve the hydrostatic head. However, in certain areas, the significant seepage observed may indicate that either the relief structures are silting up, or, to some extent, the wells are inadequate. A berm area at the downstream toe forms a terrace that extends some 200 feet beyond the toe and then slopes abruptly down into a relatively large borrow area that most probably was excavated during the construction of the dam.

Downstream toe of dam

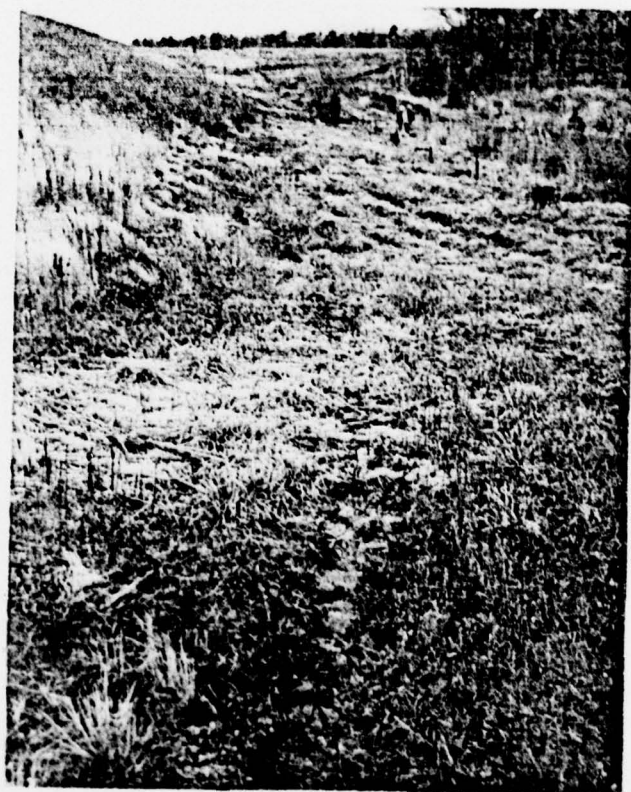
seepage was noted at the ground surface along the downstream toe at the high easterly portion of the dam embankment.

Seepage at downstream toe

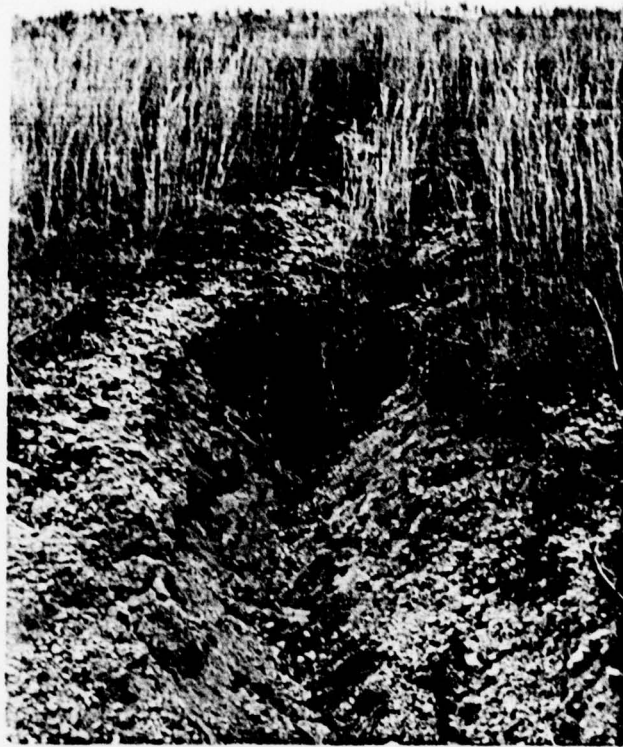
The major portion of the horseshoe-shaped embankment lies just west of Gully Road and is over 60 feet high in the vicinity of the Robins Swamp Brook channel. The embankment extends along the northeast side and the remainder of the reservoir is bounded by the natural high ground. The reservoir side slope varies between 2:1 and 3:1 and is protected with riprap, although only the top few feet could be observed. The riprap appears in good condition with only minor subgrade erosion. There is no riprap on the downstream slopes but concrete and macadam have been placed at the northwest corner, apparently to retard erosion. The dam crest is 20 feet wide and stabilized with a 6" gravel roadway which is in good condition. The embankment backslopes have a fairly uniform cover of grass and secondary growth near the toe, but in numerous areas where the grass has not taken, there are erosion gullies which are quite severely incised. There are numerous rodent burrows on the slopes and erosion gullies are scoured out immediately down the slope, apparently caused by the burrow openings.

Erosion of downstream slope of dam

- a. Regrade the eroded backslopes and fill the burrow holes.
- b. Overseed the slopes with consideration given to supplying a different type of ground cover which might take better hold on the dry arid slopes.
- c. Continue study and analysis of piezometer readings to evaluate whether the continued cleaning and/or backflushing of the relief wells is sufficient in the long-term aspects of controlling the seepage at the downstream toe. Quite possibly, new wells or an extension of the zone protection might be indicated in the analysis.

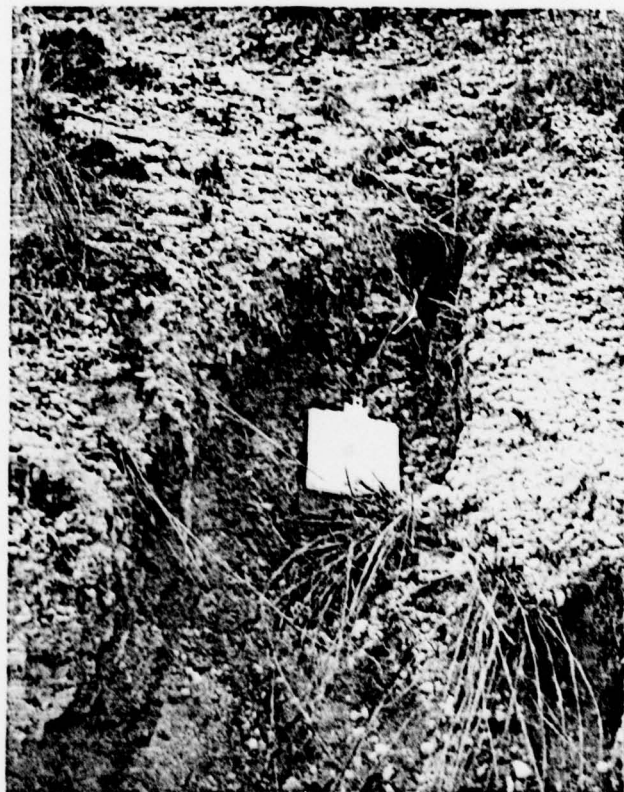
Erosion of downstream slope of dam

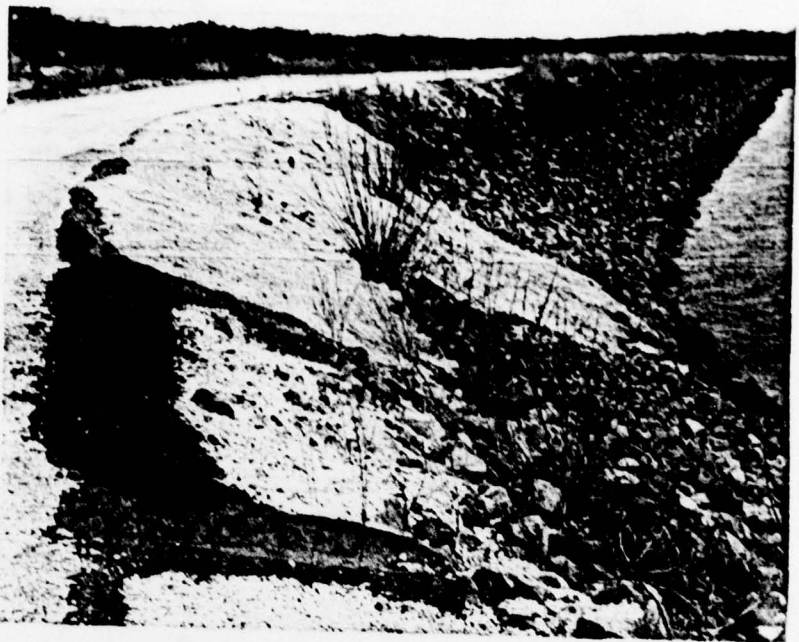
Repaired embankment

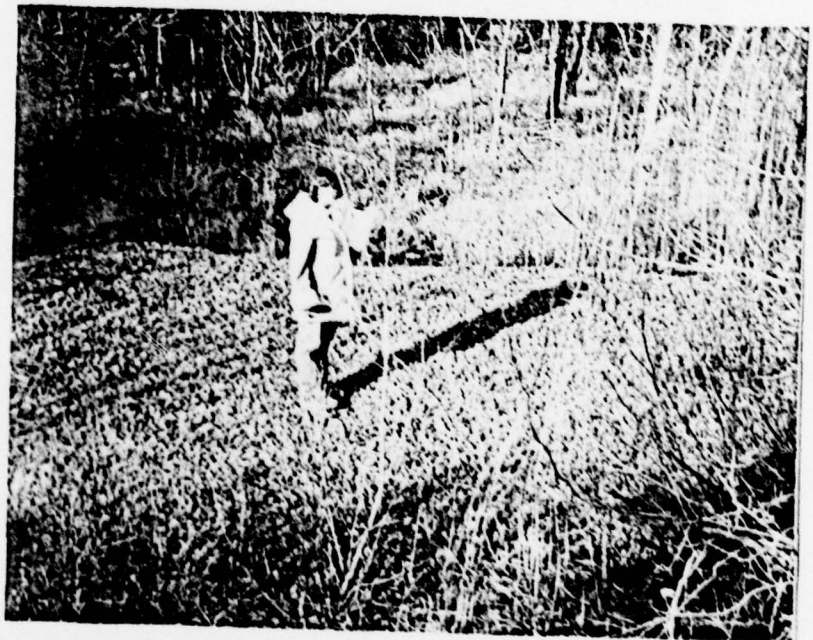
Location of boil

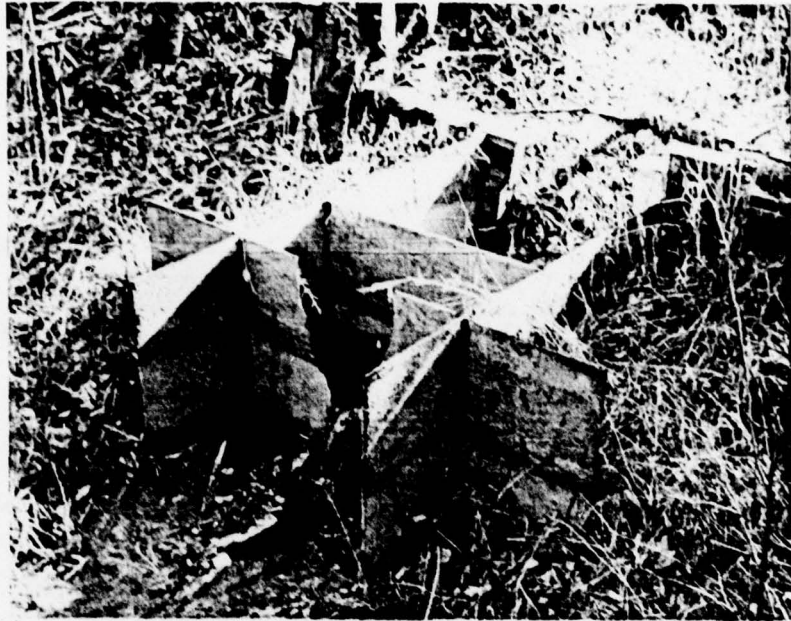
V-noched weir measuring toe drain flow

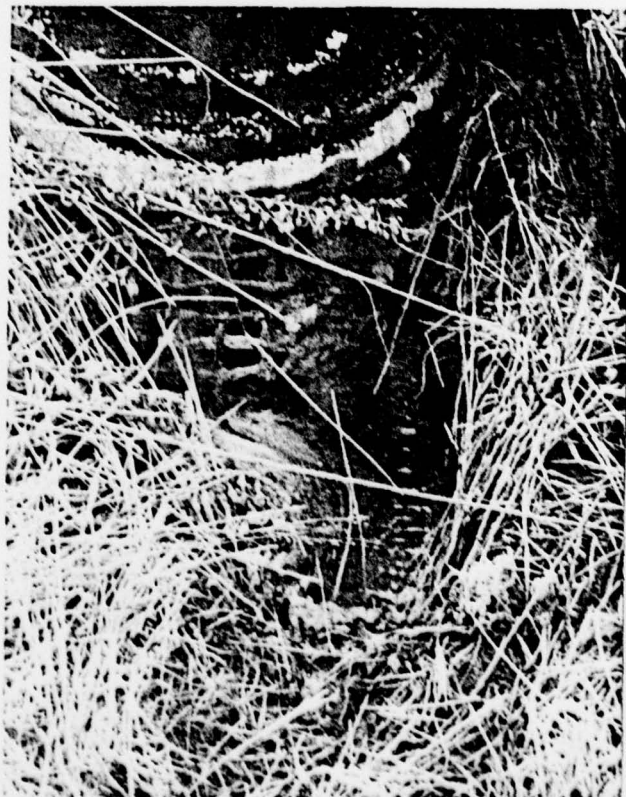
VISUAL EXAMINATION MONUMENTATION/SURVEYS	OBSERVATIONS	REMARKS OR RECOMMENDATIONS
	None	
OBSERVATION WELLS	See piezometers	
WEIRS	None	
PIEZOMETERS	Every 100 ft. 20% of the piezometers are out of operation. Located at toe at 20' depth below toe. They are observed every month.	
OTHER Relief Wells	50' depth below toe.	Apparently becoming clogged.

Relief well
