# PINE LAKE PARK DAM

## NJ 00091

### PHASE 1 INSPECTION REPORT NATIONAL DAM SAFETY PROGRAM

79 04 16 088  
March, 1979

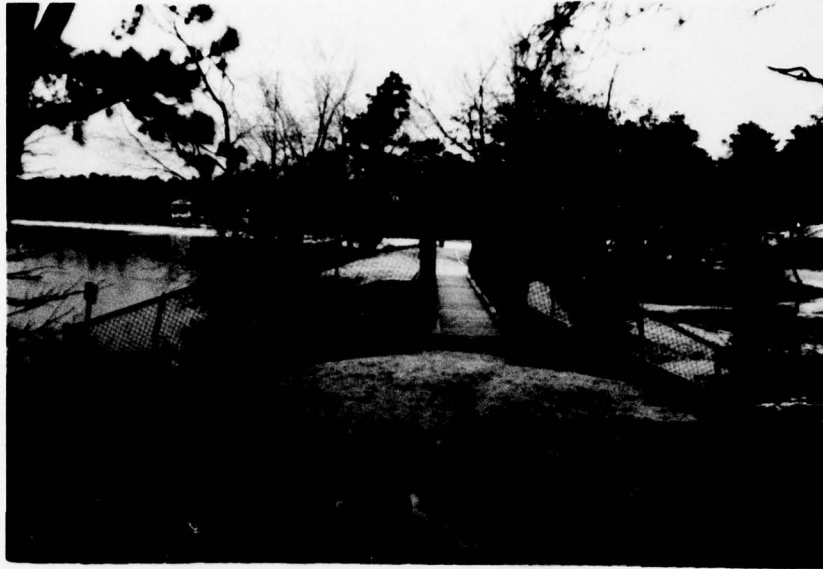
PHOTO 1

The timber portion of the walkway over the spillway was in good condition and structurally sound. The chain link fences forming its railings were in fair condition, needing minor repair. The chain link fences adjacent to the wingwalls also were in need of minor repair.

WALKWAY OVER SPILLWAY.  
TOP OR CREST OF DAM.

1. Repairs to the walkway, which had been initiated at the time of visual inspection, should be completed.
2. The chain link fences adjacent to the spillway wing walls should be straightened where needed and any damaged sections replaced.
3. Vegetation on the dam embankment should be removed. Trees and brush should be cut at the ground surface in a way that will cause minimal disturbance to the embankment.
4. The eroded areas on the dam embankment should be properly filled and compacted. Such work should be done immediately after the vegetation has been removed.

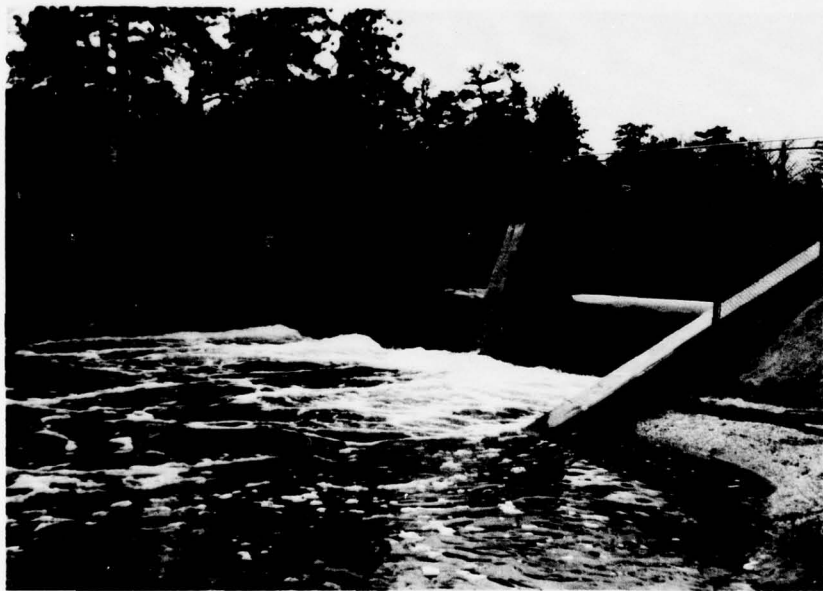
PHOTO 2

The concrete spillway, although appearing structurally sound, contains a significant number of cracks and spalls which should be repaired in the near future. In addition, the walkway and fences appurtenant to the spillway should be repaired in the near future by sandblasting, coating with epoxy and grouting where needed.

The crest of the spillway appeared uniformly aligned although it was completely submerged at the time of inspection. The center pier which supports the pedestrian bridge or walkway was in fair condition with spalling and erosion at the water line. However, it appeared to be structurally sound. Spalled areas were noted on all wingwalls especially at the water line. Also, adjacent sections of the wingwalls were misaligned at construction joints in two places: 1. downstream south wingwall - vertical misalignment of 1 to 2 inches and 2. downstream, north wingwall - horizontal misalignment of 1 inch. The vertical construction joint in the downstream, south wingwall was open approximately 2 inches and partially filled with mortar.

SPILLWAY.

5. Riprap should be installed and longitudinally centered at the normal water line on the upstream face of the dam along the entire length of the embankment.
6. The concrete spillway should be thoroughly inspected and repaired as outlined below:
  - a. Drain the lake to an elevation equal to the inverts of the sluices.
  - b. Sand blast all concrete and apply an epoxy preservative coating to all surfaces.
  - c. Pressure grout all major cracks and patch all spalls and eroded surfaces.

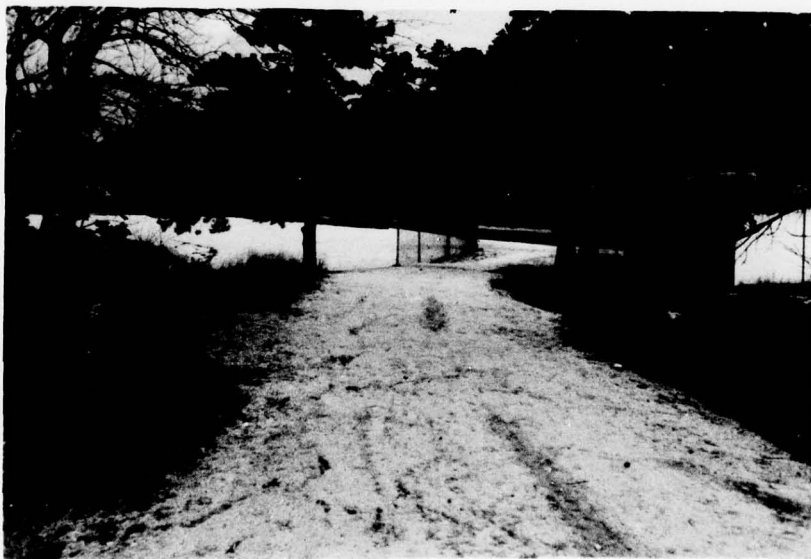
PHOTO 4

The embankment is generally free of settlement and appears to be structurally sound. However, it contains detrimental vegetation as well as erosion on its upstream and downstream faces and lacks slope protection on its upstream face. These conditions should be repaired in the near future and thereafter maintained. The repairs include the removal of trees and brush, the filling of eroded areas and the installation of riprap on the upstream face.

At the north end of the dam, the embankment blends into an adjacent beach area which is bordered by a public road. The beach slopes upward from the water to form a crest along its rear edge near the road. The elevation of the low point of the crest was found to be 34.6, which is 2.2 feet below the elevation of the top of the dam. The beach has an overall length of approximately 1000 feet, 200 feet of which adjacent to the dam serves as an emergency spillway. It was in the section of the beach that is used as an emergency spillway that elevations were determined. The remaining 800-foot length of beach also appeared to be relatively low.

CREST OF DAM AND EROSION ON UPSTREAM FACE, BEACH  
NORTH OF DAM (EMERGENCY SPILLWAY).

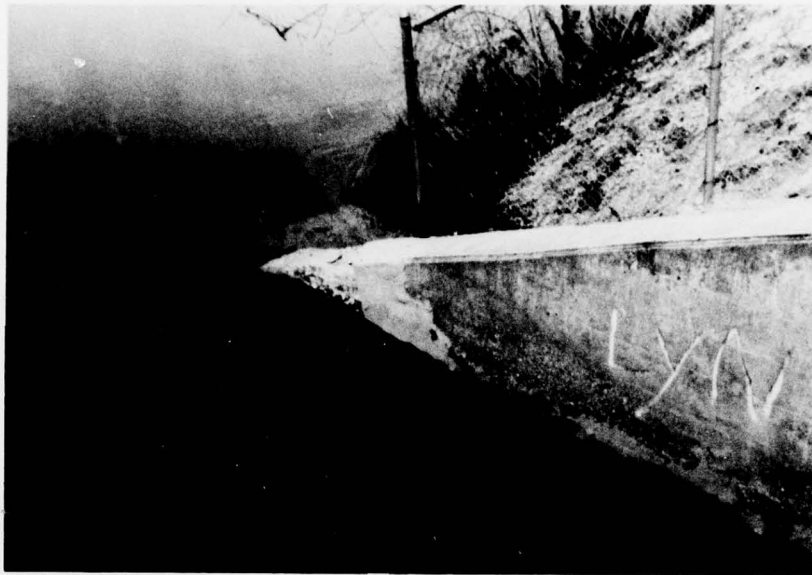
PHOTO 5

CONCRETE SPALL AND REPAIRS ON NORTH-UPSTREAM WINGWALL.

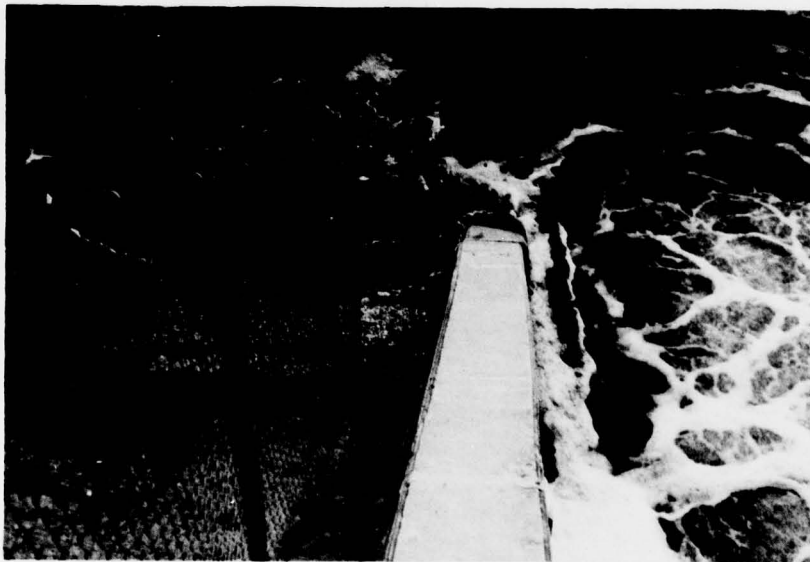
PHOTO 6

The misalignment of the spillway wingwalls noted in paragraph 3.1.c. did not appear to indicate a serious structural deficiency in that component of the dam. It could not be determined which side of the construction joint shifted. Furthermore, past inspection reports indicate that a similar state of misalignment and widening of constructions joints has existed since 1946. Therefore, it appears that these conditions have not significantly advanced during the past 30 years or more.

HORIZONTAL DISPLACEMENT AT CONSTRUCTION JOINT AND  
REPAIRS ON NORTH-UPSTREAM WINGWALL.

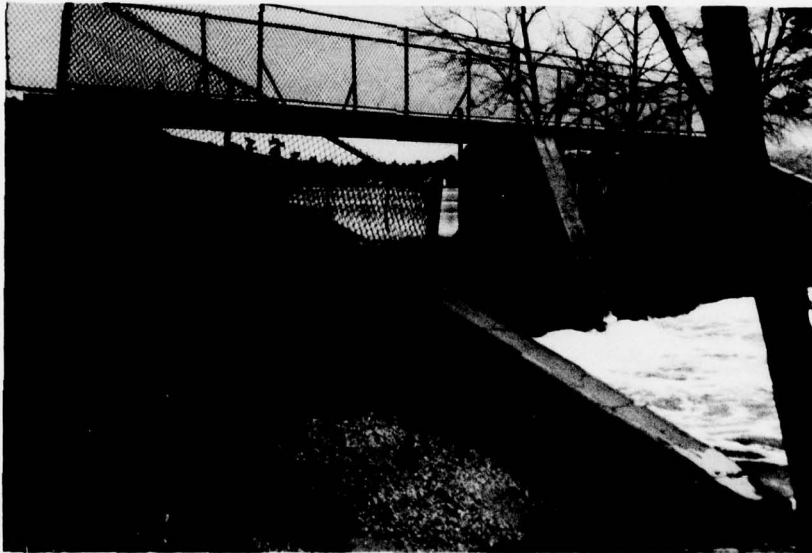
PHOTO 8

SPALL ON PIER. CRACKS AND SPALL ON SOUTH-  
DOWNSTREAM WINGWALL. EROSION AT WINGWALL.

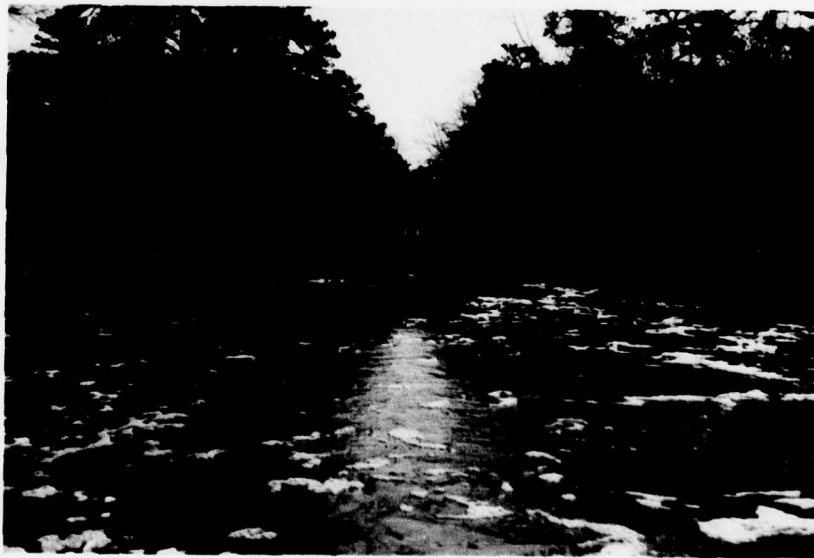
PHOTO 10

VIEW LOOKING DOWNSTREAM. ROAD BRIDGE  
OVER STREAM.
