MISCELLANEOUS PAPER GL-79-4

## EVALUATION OF THE EFFECTIVENESS OF MEMBRANES FOR PREVENTION OF CRACK REFLECTION IN THIN OVERLAYS

March 1979

Interim Report

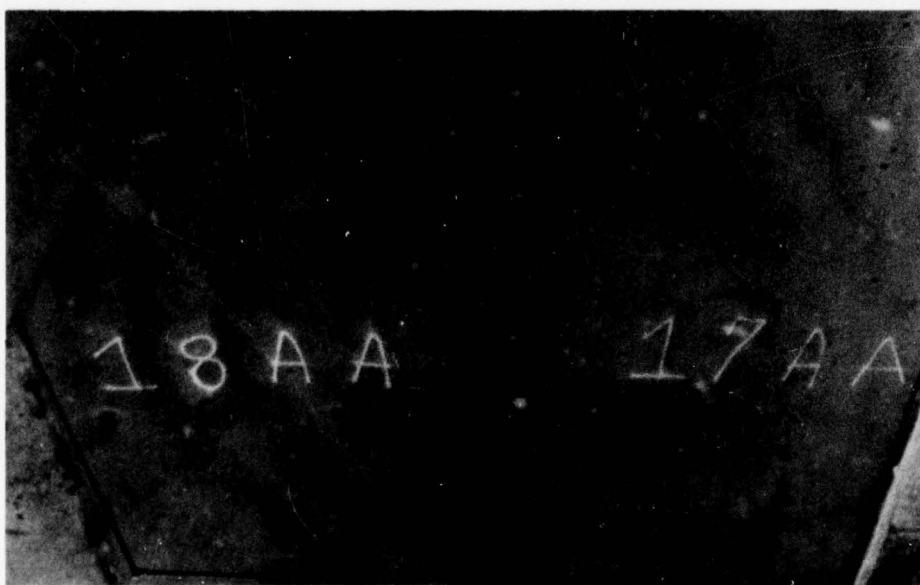
Photo 72. Fort Lewis--Bidim C-22 fabric section;  
north side of Faith Avenue

b. Condition of surface 6 months after overlay

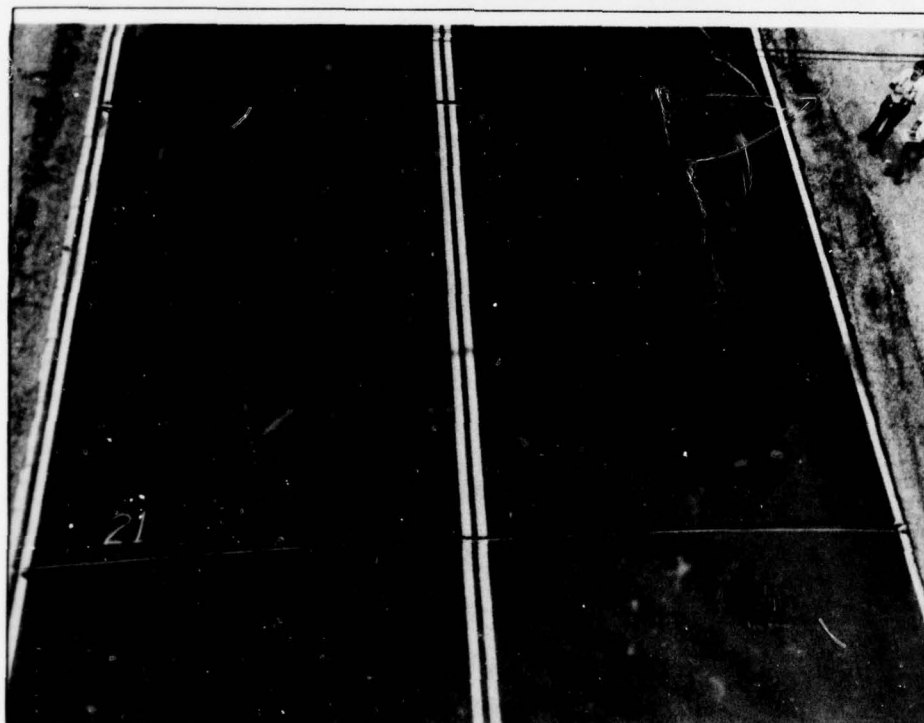
Photo 114. Fort Devens--Bidim C-22 fabric section,  
Barnum Road

b. Condition of surface 6 months after overlay
