# LAKE HOPATCONG DAM

**NJ 00327**

**PHASE 1 INSPECTION REPORT  
NATIONAL DAM SAFETY PROGRAM**

April, 1979

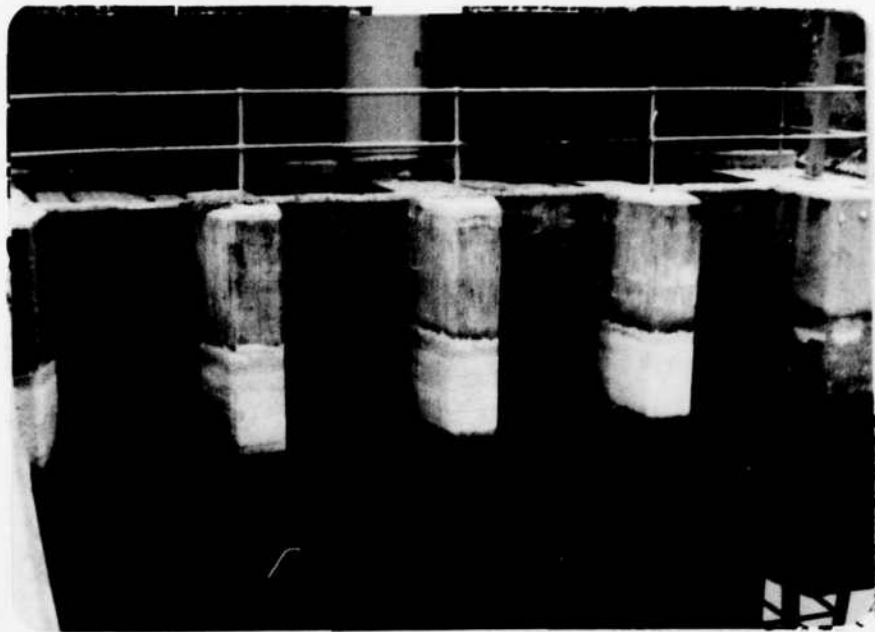
Gatehouse intake tunnels. Note trash racks not in place.

- 5. Repair deteriorated right sidewall of spillway discharge channel and asphalt pavement of fountain discharge channel. This should be done soon.**
- 6. Clean and install trash racks in gatehouse forebays. This should be done soon.**
