MALAGA DAM  
NJ 00443

PHASE 1 INSPECTION REPORT  
NATIONAL DAM SAFETY PROGRAM

February, 1979

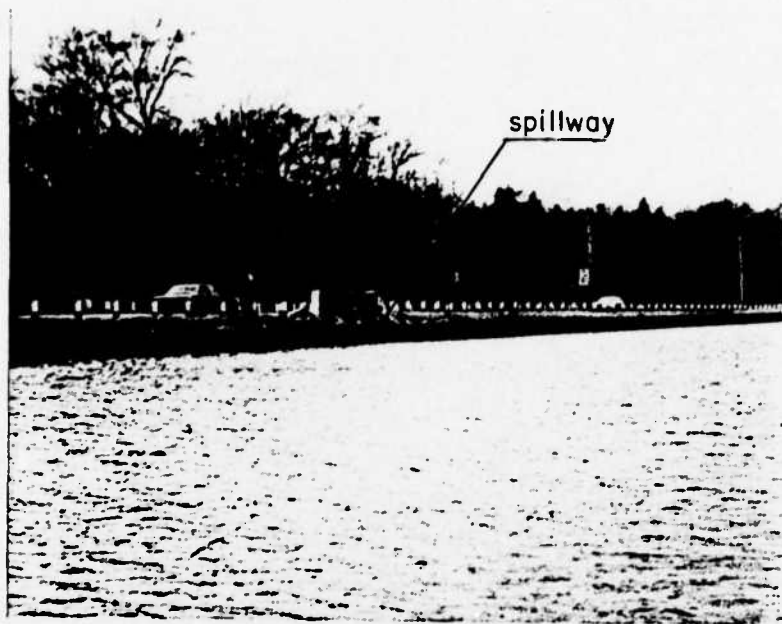
View Southwest along dam

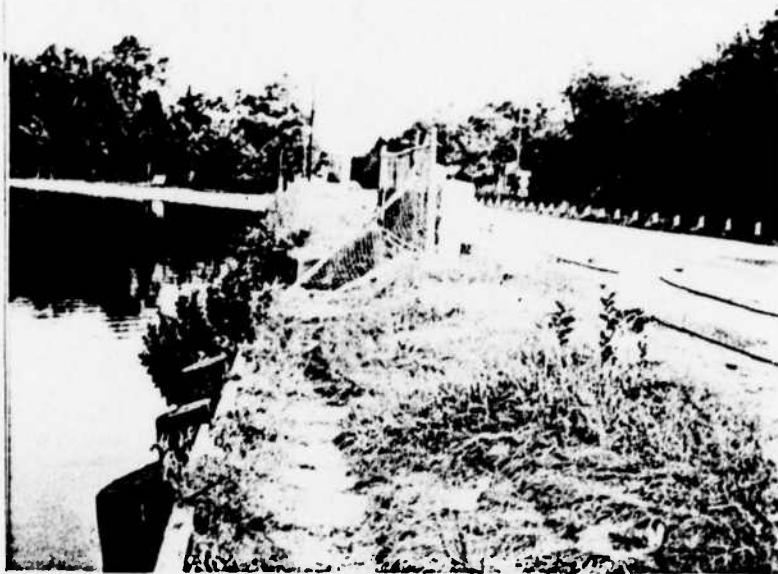
View East along dam

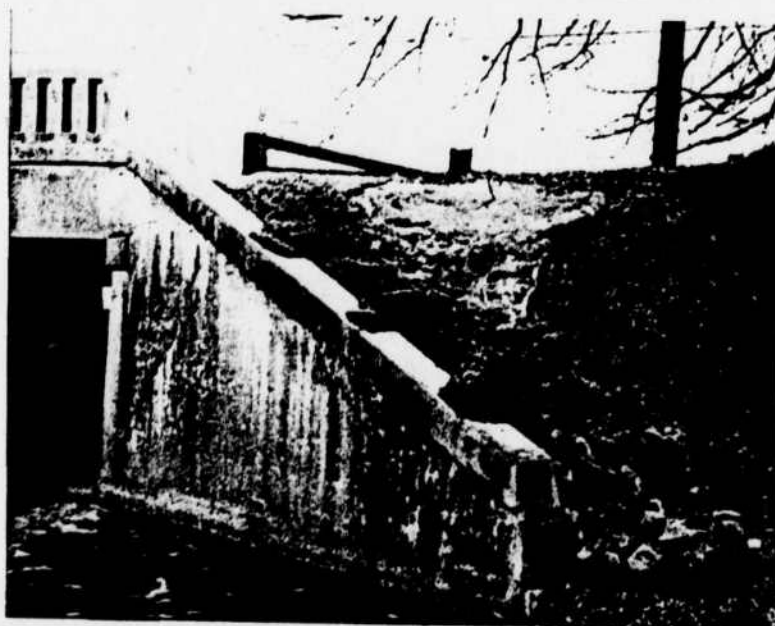
Downstream view of East abutment

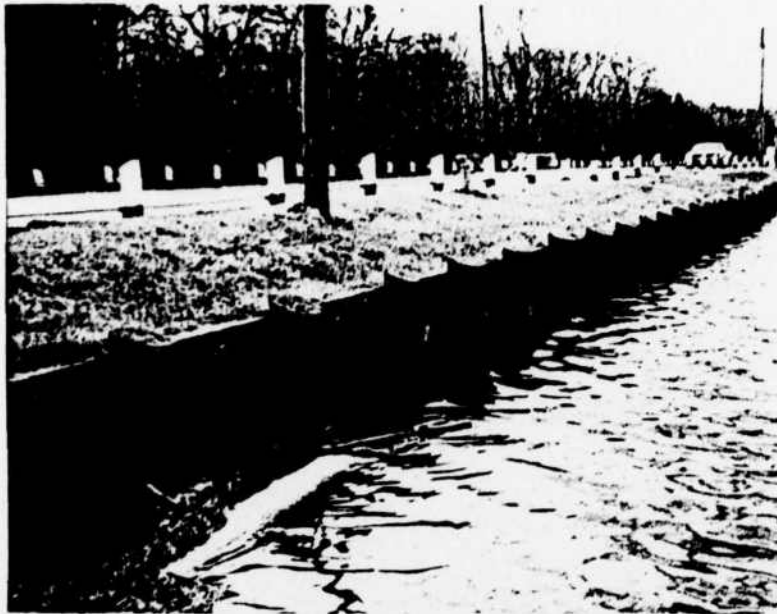
The timber bulkhead is very old and numerous areas are rotted and disintegrated beyond repair. The vertical piling appears fairly solid and is in true alignment except for occasional short portions but the sheeting and whaling are in poor condition above grade. There is no evidence as to the depth of the bulkhead or when it was built except it predates the 1929 road construction.

Timber sheeting on North side of dam

- 1) removal of the trees and major root systems on the downstream embankment to lessen the piping potential
- 2) rebuild the deteriorated timber bulkhead at some future time.

However, the cost of these remedial measures should only be considered after completion of further design and economic studies (e.g. placing a riprap blanket against the timber bulkhead might be a more economical solution than replacement in kind.)

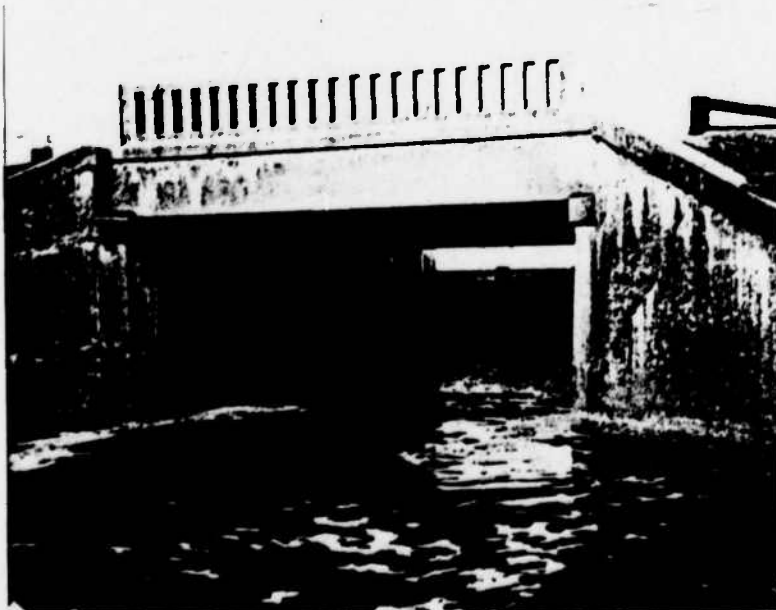
Downstream view of bridge and spillway
