ATLANTIC COAST BASIN
COHANSEY RIVER
CUMBERLAND COUNTY
NEW JERSEY

**SEELEYS MILL DAM
NJ 00065**

**PHASE 1 INSPECTION REPORT
NATIONAL DAM SAFETY PROGRAM**

April, 1979

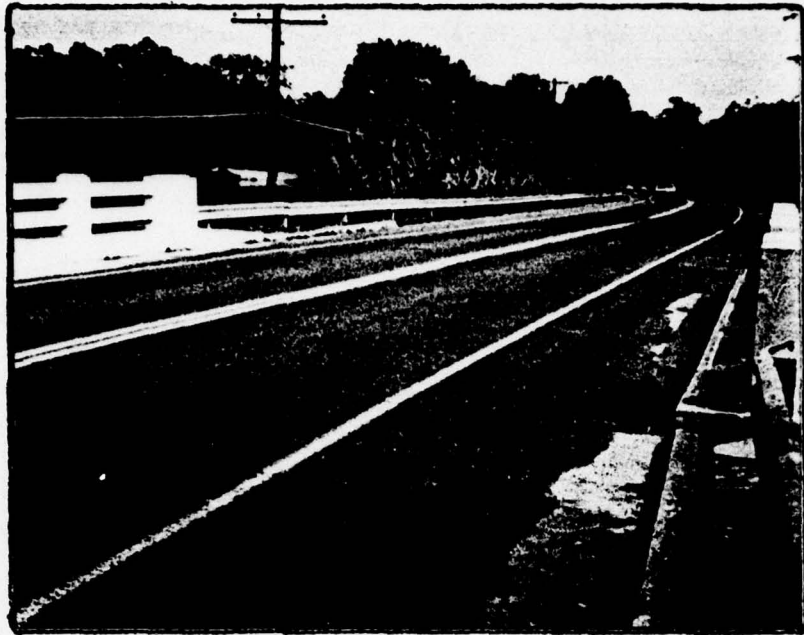
The upstream side of the roadway shoulder to the left of the spillway has a narrow crest width of only 5-10 feet and is slightly above the roadway pavement. This crest zone, together with the 150-foot dike which extends back up along the east shore and forms the right abutment are in a loose, bulked condition. The crest is very narrow in numerous areas and would be highly susceptible to washouts if overtopped. Except for economic considerations, it is not clear why the 1956 road design continued the profile grade downward to the intersection of Finley Road and the Deerfield-Seeley Road which runs along the east shore of Seeleys Pond. This intersection is several feet below the dam crest and provides a potentially breaching zone, especially along the 150-foot spur which is poorly maintained and covered with heavy brush and several large trees. This places the narrow berm of fill along the north shoulder of the roadway and the re-entrant dike in a rather

Based upon the visual inspection, all elements of the Seeleys Pond Dam are believed to be in sound structural condition except for the narrow, ill-defined earth crest that forms the effective top of dam in the area that extends from approximately 150 feet to the left of the spillway bridge over to the south-east corner of the pond and northward 150 feet to the vicinity of the left abutment. This berm is very irregularly shaped and poorly compacted. The remainder of the roadway embankment is quite wide in relation to its height and is of sound stable construction. The bridge and spillway structure are also in sound structural condition and show only minor evidence of deterioration. However, the inspection team expressed major concern over the embankment crest zone which is not protected by roadway pavement.

View East along dam crest (Cty. Rte. 617)

- The upstream zones of the embankment crest should be rebuilt with a berm of uniform width and level elevation so that the full spillway capacity can be utilized.
- The trees and root systems should be removed from the upstream slopes and the slopes protected.
- The 48" sluice gate should be repaired and its entrance unplugged.

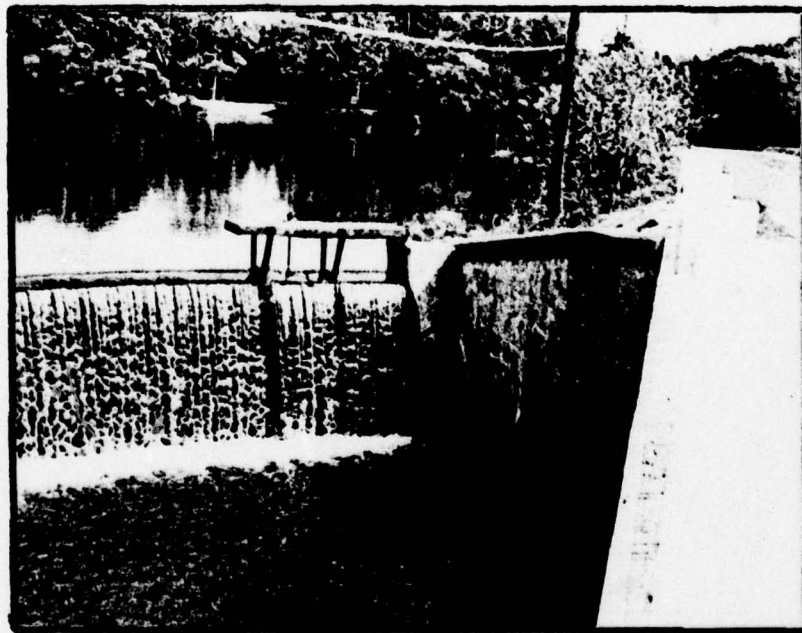
immediately south below the spillway. A 4-foot diameter sluice gate is located at the left end of the spillway but is inoperable.

Nothing was observed by the inspection team regarding operational procedures. The sluice gate has apparently been inoperative for many years and the dam has functioned completely as an uncontrolled overflow structure.

48" \emptyset sluiceway at left end of spillway

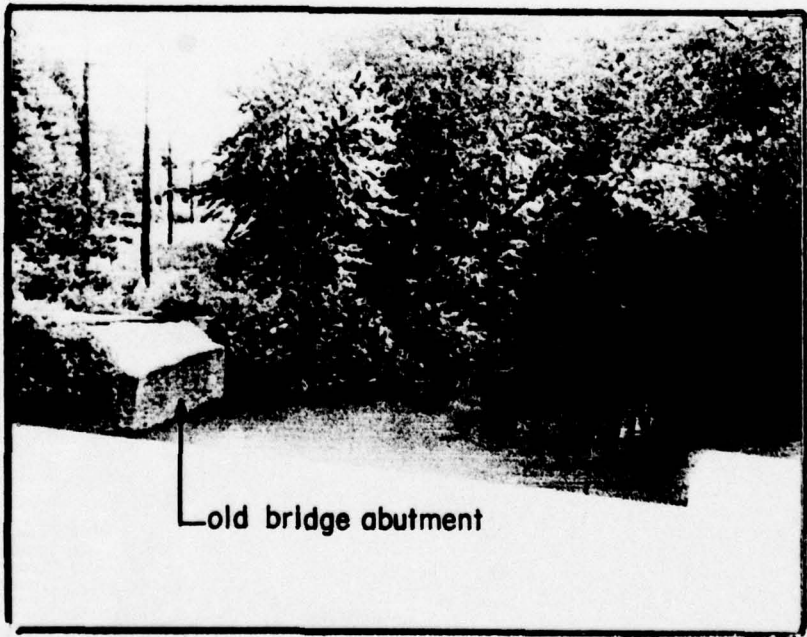
The spillway and the paved invert beneath the bridge appears to operate satisfactorily and show no evidence of damage from excess velocities. The downstream channel is not scoured out indicating the length of paved invert is sufficient for the energy attenuation.

old bridge abutment

Downstream channel

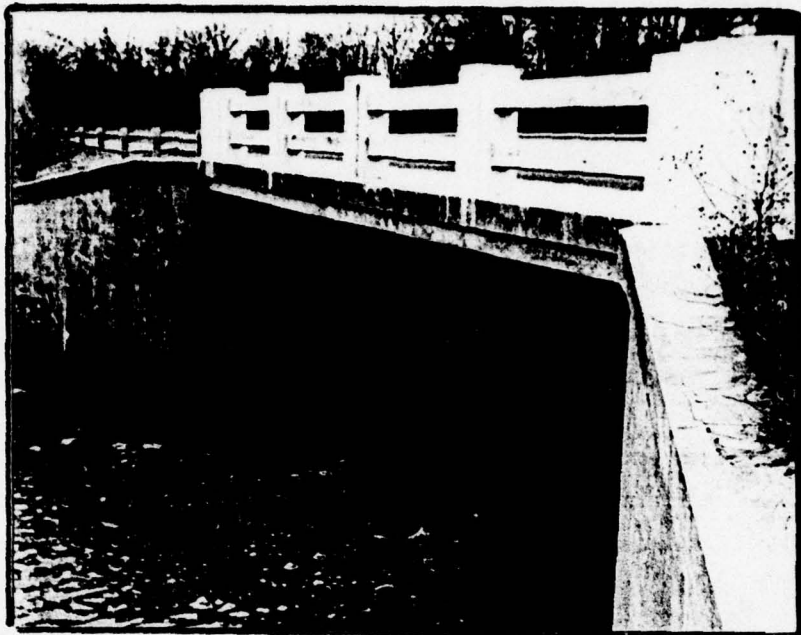
The highway bridge is in moderate to good condition. There is minor cracking and spalling of the concrete and the structural steel needs repainting but these conditions are of minor concern. The bridge is founded on piling and has negligible differential settlement or tilting.

County bridge just below spillway

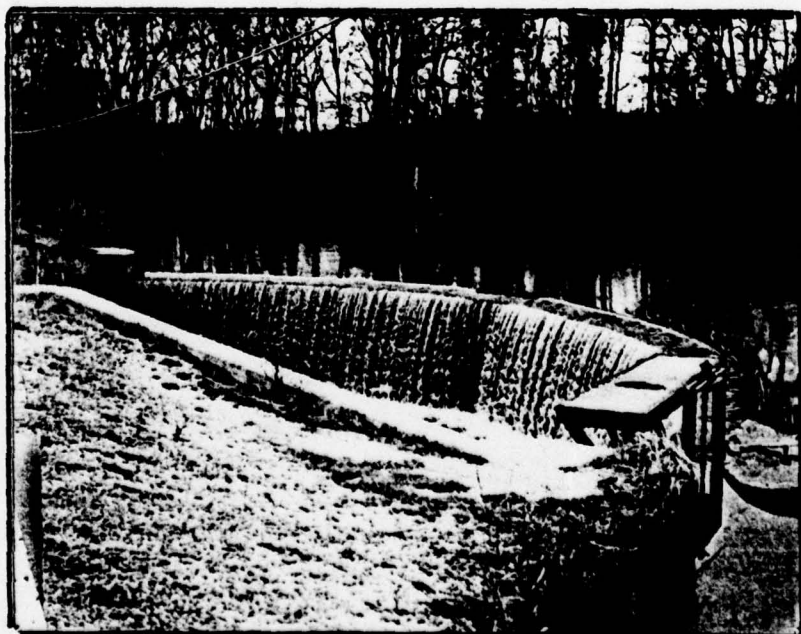
The circular spillway is built on a 45-foot radius and has a concrete crest width of approximately 18 inches. Due to the uniform overflow during the inspections, the condition of the lower steel sheetpiling could not be observed. The concrete cap beam appears to be at a uniform grade and there was no evidence of broken zones or pieces missing. The juncture with the thrust block at the end of the arch and the wingwall is tight and shows no crushing or horizontal movement. The bridge has a 12-foot clear headroom between low steel and the 8-inch invert slab. Approximately 30 feet of steel sheet piling extend along the upstream face paralleling the dam axis each side of the north wingwalls. The 48-inch vertical lift slide gate is inoperable and from rough soundings taken near the entrance, its entrance is completely silted up.

Spillway
