RARITAN RIVER BASIN  
MILLSTONE RIVER  
MERCER COUNTY  
NEW JERSEY

# CARNEGIE LAKE DAM

NJ 00150

PHASE 1 INSPECTION REPORT  
NATIONAL DAM SAFETY PROGRAM

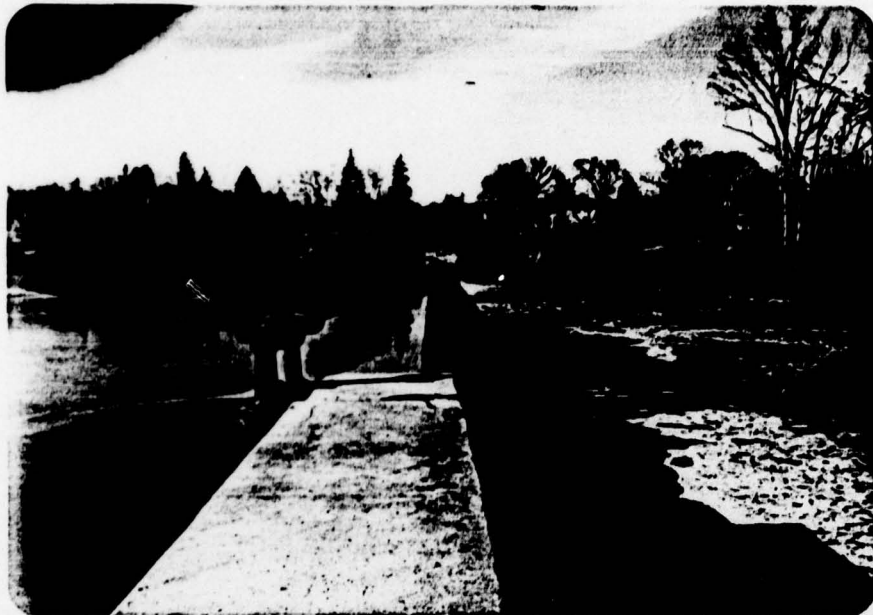
View of crest from right abutment

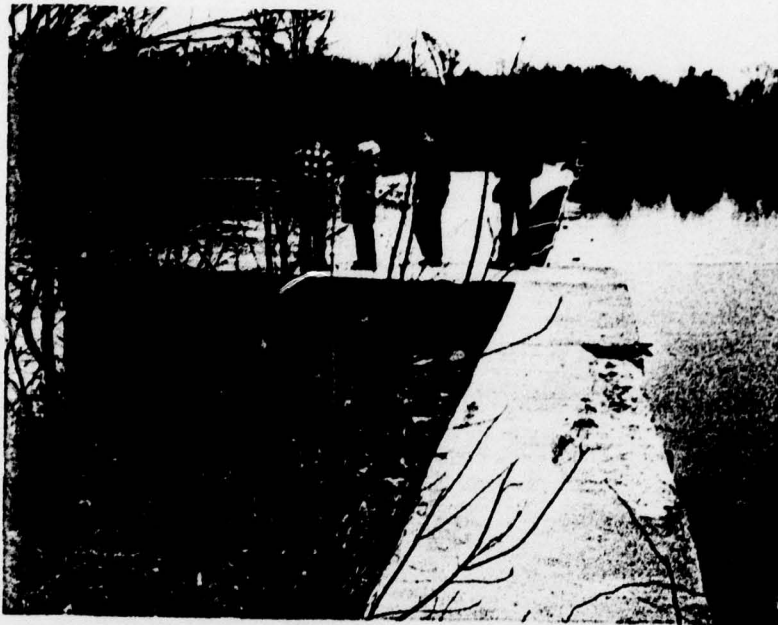
View of crest from left abutment

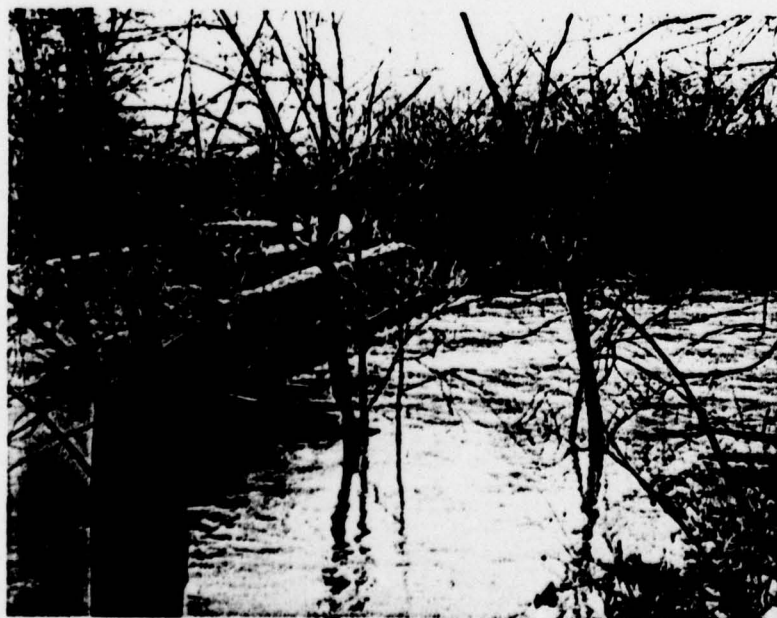
Kingston bridge after heavy rainstorm
