**LOWER LAKE NIMHAM DAM
PUTNAM COUNTY, NEW YORK**

NY 137

**PHASE I INSPECTION REPORT
NATIONAL DAM SAFETY PROGRAM**

JOSEPH S. WARD & ASSOCIATES
CONSULTING ENGINEERS
91 ROSELAND AVENUE, P.O. BOX 91
CALDWELL, NEW JERSEY 07006

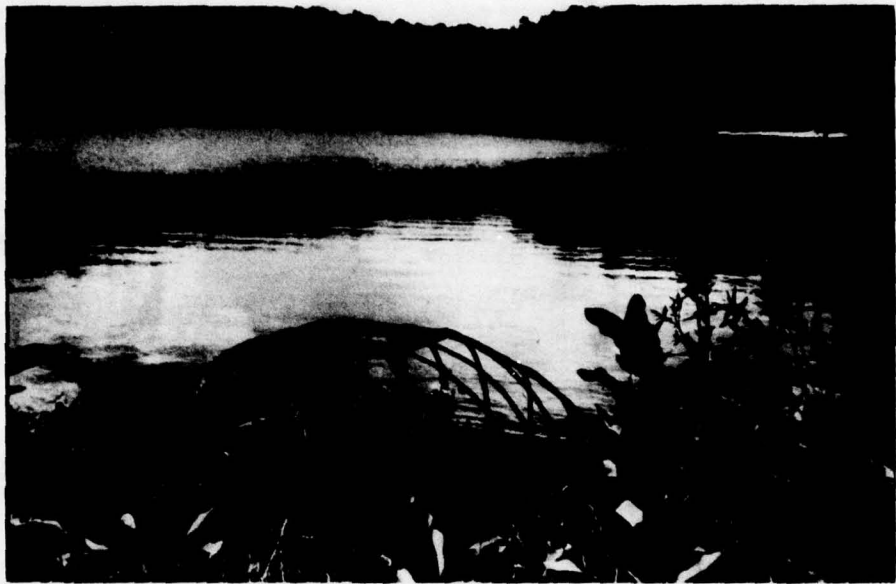
The inlet structure connecting Upper Lake Nimham to Lower Lake Nimham was described previously in Section 2.3. The drop inlet portion is shown in Figure 1. On the day of the inspection, the discharge pipe was submerged so flow into the lower lake could not be observed. Measurements of lake levels were made with reference to Smalley's Corners' Road. The lower lake level was measured to be approximately 6½ feet below road elevation and the upper lake level was measured to be approximately 2½ feet below road elevation; the measured difference in elevation is about 4 feet. These measurements verify the difference in elevations of the lakes given on the USGS quad. The observable portions of the inlet structure appeared to be in generally good condition.

FIGURE 1 DROP INLET - UPPER LAKE NIMHAM

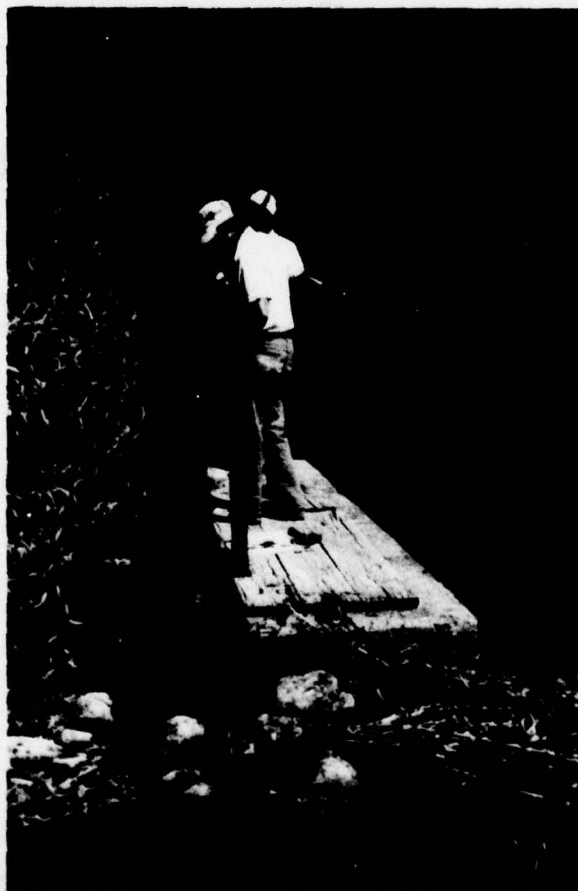
The outlet structure was described previously in Section 1.2a. The concrete surfaces of the overflow inlet chimneys were in good condition with only minor scaling evident. On the day of the inspection, there was about 1 inch of water at the bottom of the chimneys and a slight flow through the 48-inch diameter outlet pipes (Fig. 6, Appendix D). The turning nuts and screw rods of the sluice gate controls were rusted and the gates did not appear to have been operated for some time (Fig. 7, Appendix D). Since a turning wheel or wrench was not available at the Town of Kent offices, and since no representative of the Town of Kent accompanied us during the inspection, the sluice gates were not opened.

FIGURE 2 TWIN CHIMNEY DROP INLET SPILLWAY - LOWER LAKE NIMHAM

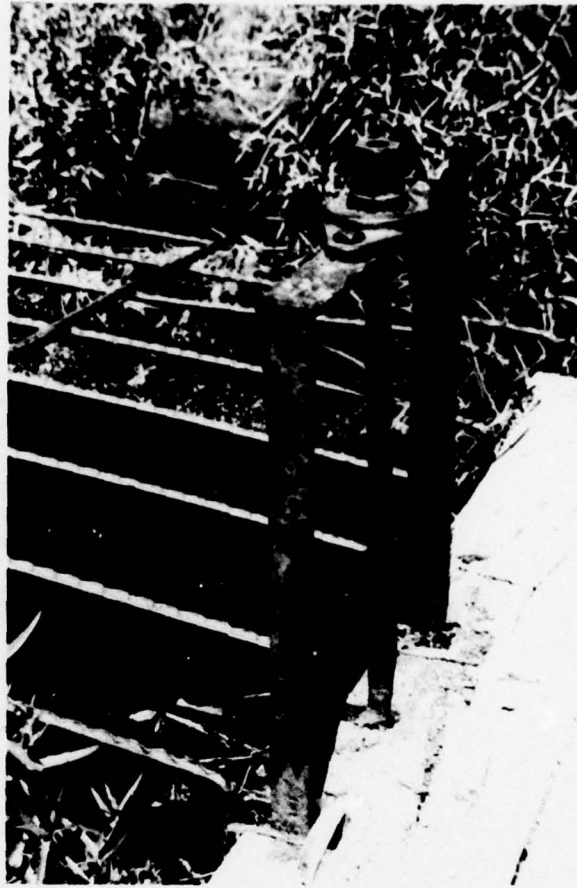
There is evidence that maintenance of operating facilities has been neglected. The riser rods of the sluice gates are beginning to rust and the wooden platform atop the gate boxes could use a coat of preservative or paint.

FIGURE 7 TURNING NUT AND RISER ROD FOR SLUICE GATE

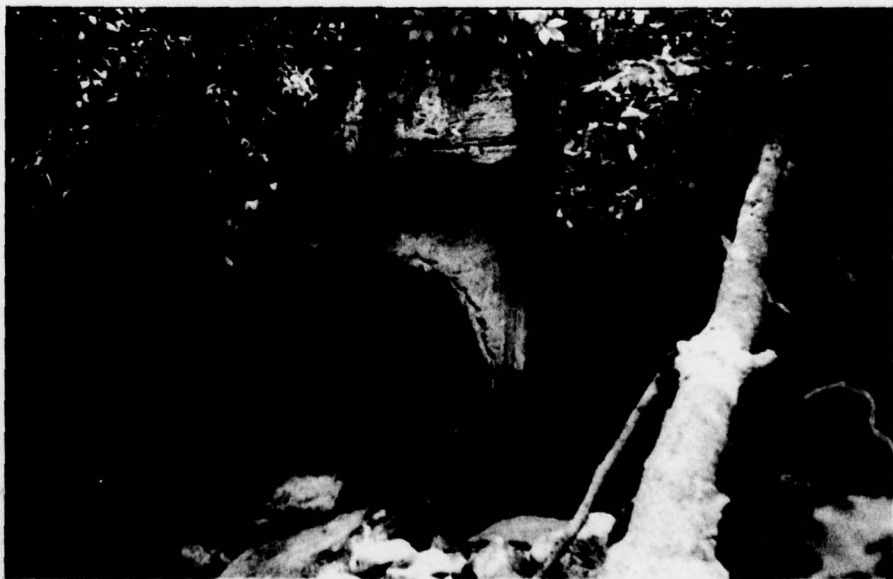
The two 48-inch diameter concrete pipes were observed to empty onto a concrete apron at their downstream terminus (Figs. 8 and 9, Appendix D). There were numerous large boulders on the apron, some of which are embedded into the concrete. One such boulder extends about 12 inches above the invert of the left outlet pipe and will probably impede free flow of water through the pipe (Fig. 8, Appendix D). A high water stain was observed at about midheight in the pipe. On the day of the inspection, there was about 9 inches of stagnant water above the invert of the pipe at the apron. The stagnant water extended upstream about half the way through the pipe. The 24-inch diameter gate openings could be observed in the overflow inlet chimney walls at the upstream end of the 48-inch diameter outfall pipes. There was a longitudinal crack about $\frac{1}{4}$ inch wide in the crown of the left outfall pipe. Both 48-inch pipes appeared to be sagging at a point about $\frac{3}{4}$ of the way from the inlet chimney. The junctions between the pipes and the reinforced concrete headwall were moderately spalled and some reinforcing steel was visible (See crown of pipe in Fig. 9).

FIGURE 8 LEFT OUTLET PIPE

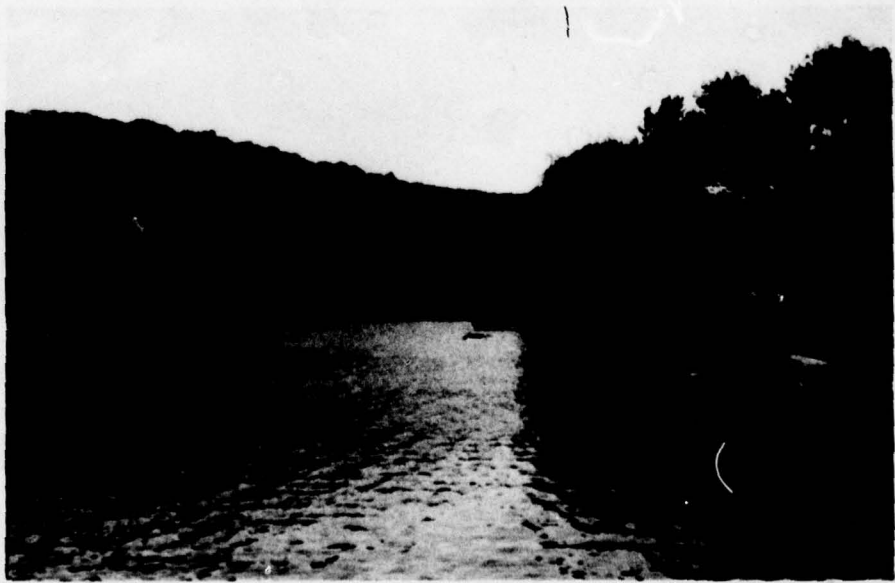
FIGURE 10 TYPICAL RESERVOIR AREA
