**IMPACT DAMAGE ON TITANIUM LEADING EDGES FROM
SMALL HARD OBJECTS**

University of Dayton Research Institute
300 College Park Avenue
Dayton, Ohio 45469

November 1978

TECHNICAL REPORT AFML-TR-78-173

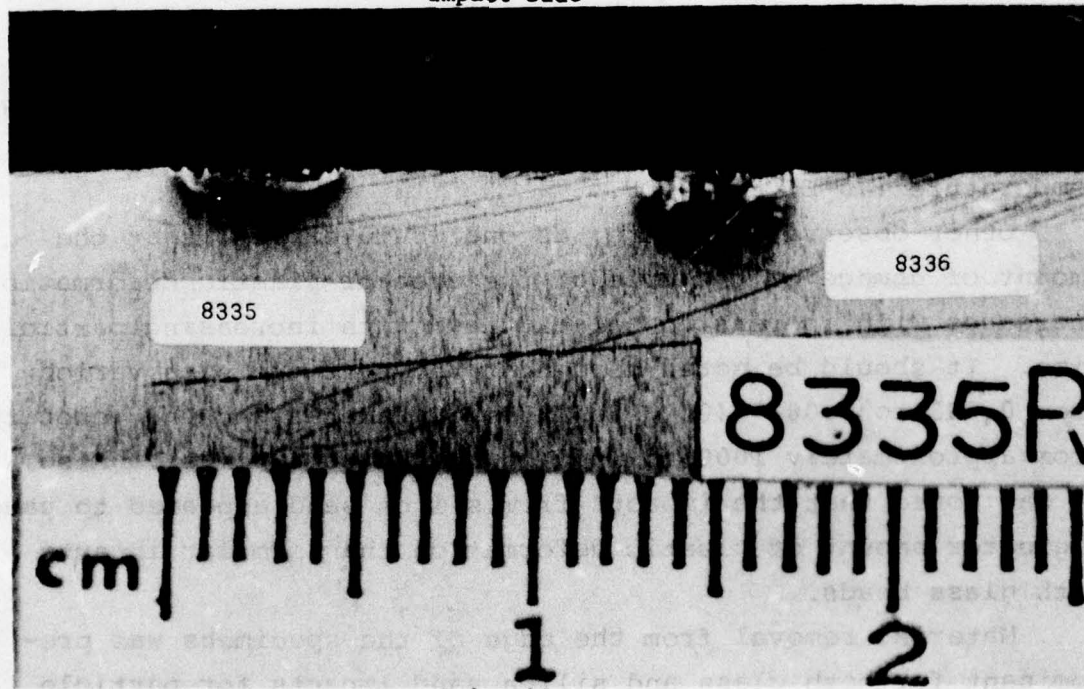
Material removal from the edge of the specimens was predominant for both glass and silica sand impacts for particle sizes above 0.020" (0.51 mm) diameter. Photographs of typical damage showing material removed are shown in Figures 6 through 12.

Figure 6. Photographs of damage due to glass bead impacts at 30° (Shots 8335 and 8336).

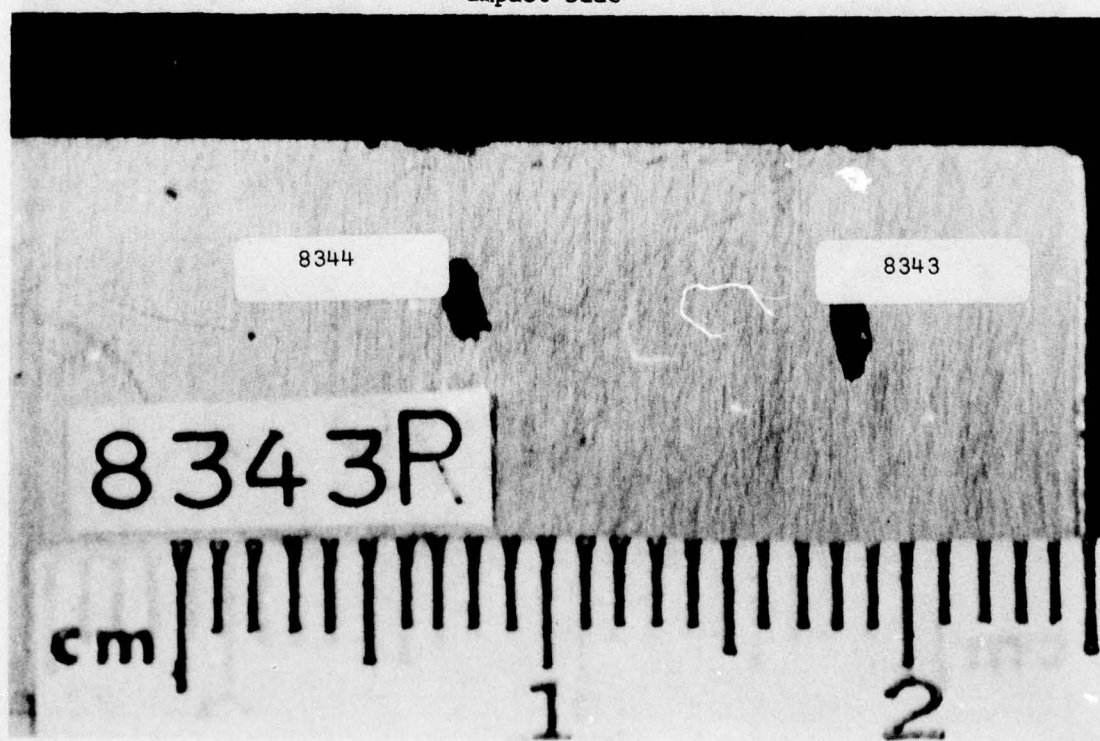
Two other facts were evident from this first series of tests upon observation of the impacted specimens. There appeared to be no observable difference in the induced damage under the conditions noted when (a) the impact angle was changed from 30° to 10° and, (b) the temperature was raised from room temperature (70°F) to 250°F.

Figure 7. Photographs of damage due to glass bead impacts at 10° (Shots 8343 and 8344).

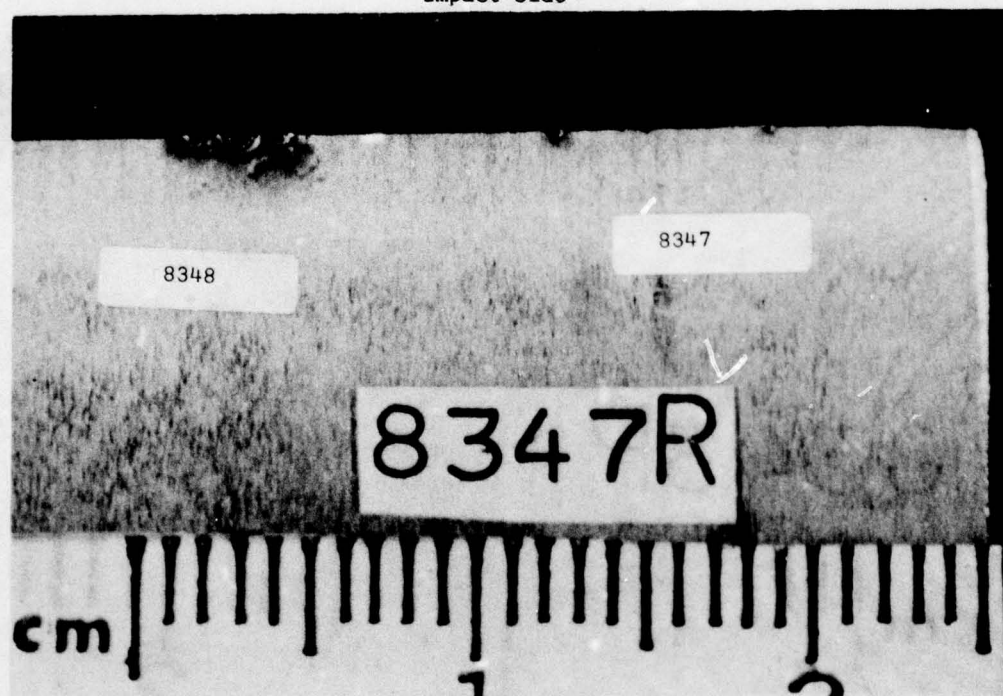
Figure 8. Photographs of damage due to glass bead impacts at 30° and 250°F (Shots 8347 and 8348).

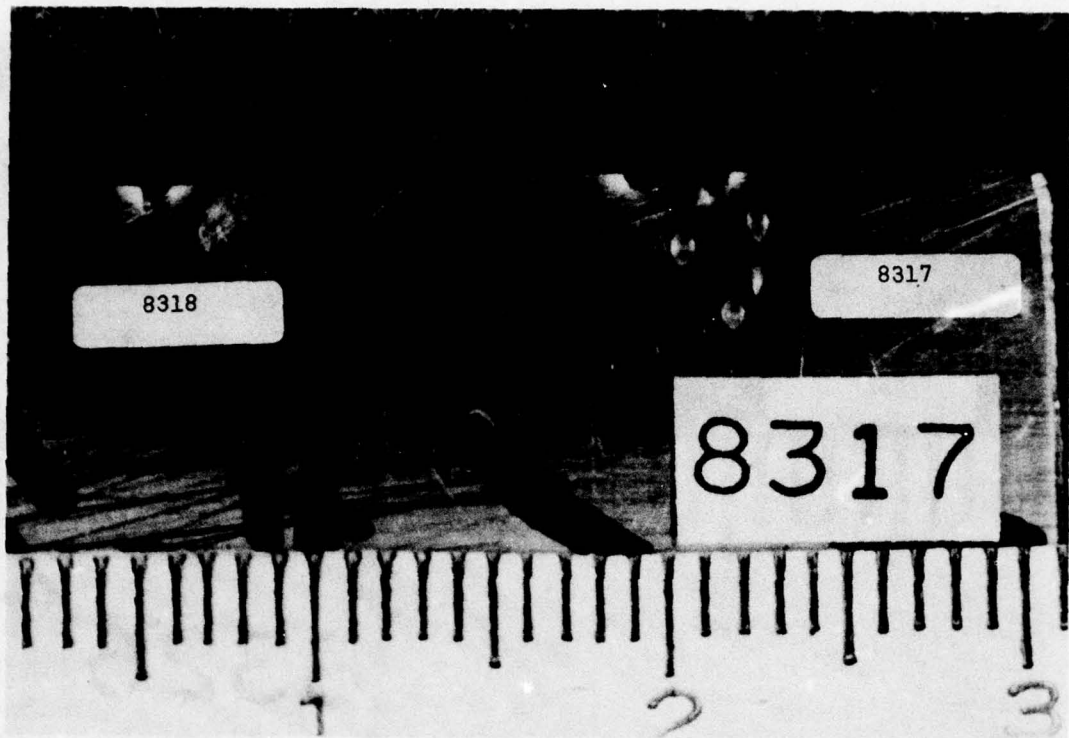
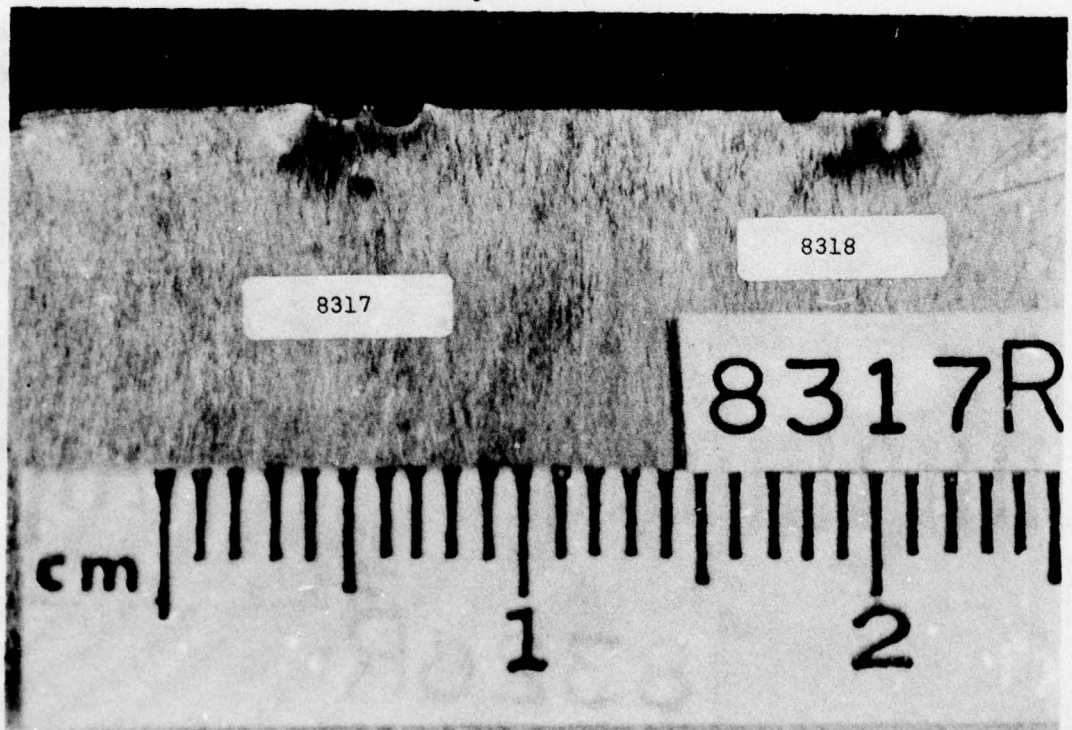
Figure 9. Photographs of damage due to Pyrex bead impacts at 30° (Shots 8317 and 8318).

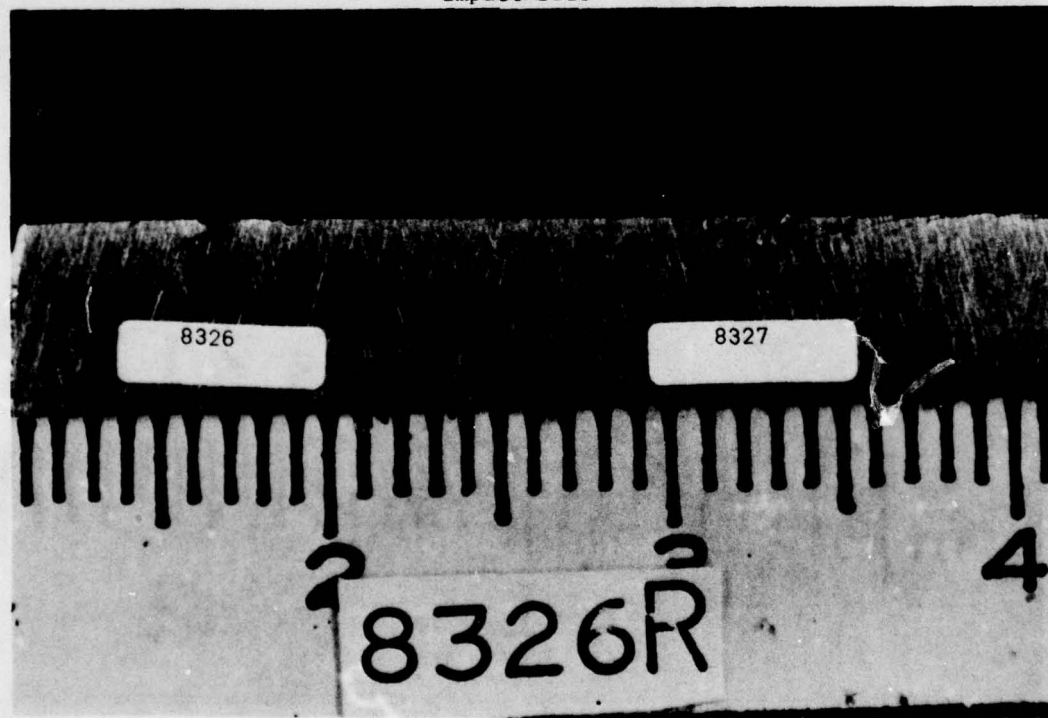
Several things were observed from the results of this series of tests. First, observations of the post-test tapered-edge specimens indicated that silica sand impacts caused more severe damage than glass beads, probably due to their generally irregular shape. Second, impacts by glass beads less than 0.020" (0.51 mm) produced very little damage on the specimen surface. These very small particle impacts generated a peened or pitted surface on the tapered edge of the specimen without material loss. At higher velocities (1500 ft/s (458 m/s) a very small amount of plastic deformation could be observed. It was concluded that impacts of particles under 0.020" (0.51 mm) size does not appear to be a threat to blades of titanium in the velocity range up to 1500 ft/s (458 m/s).

Figure 10. Photographs of damage due to silica sand impacts at 30° (Shots 8326 and 8327).

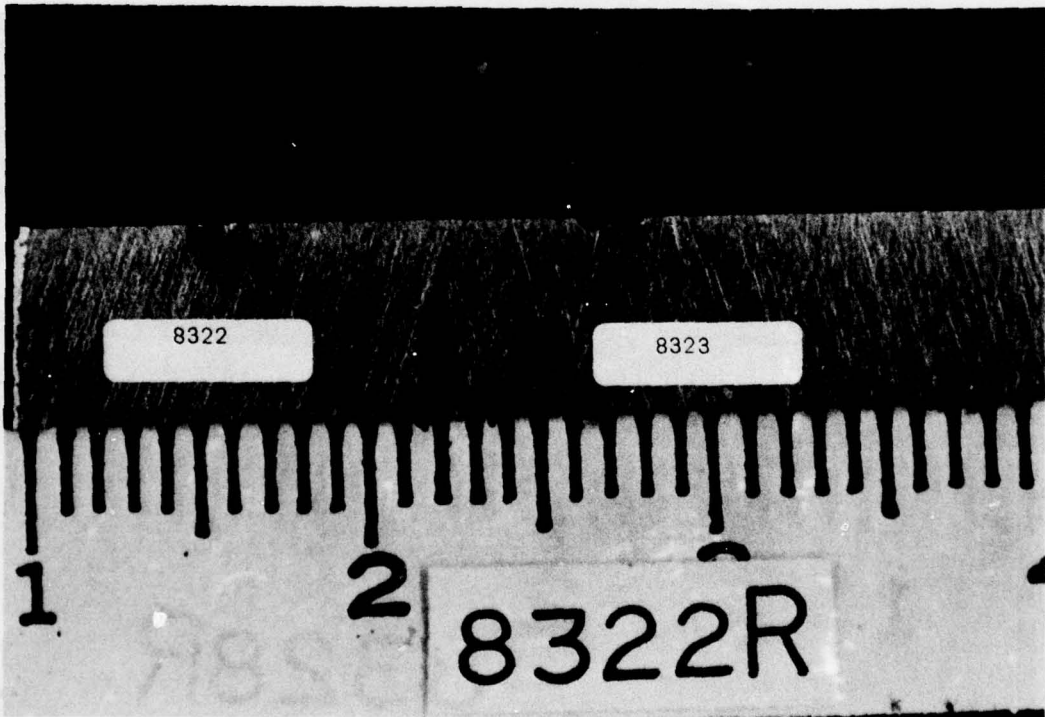
Figure 11. Photographs of damage to silica sand impacts at 30° (Shots 8322 and 8323).

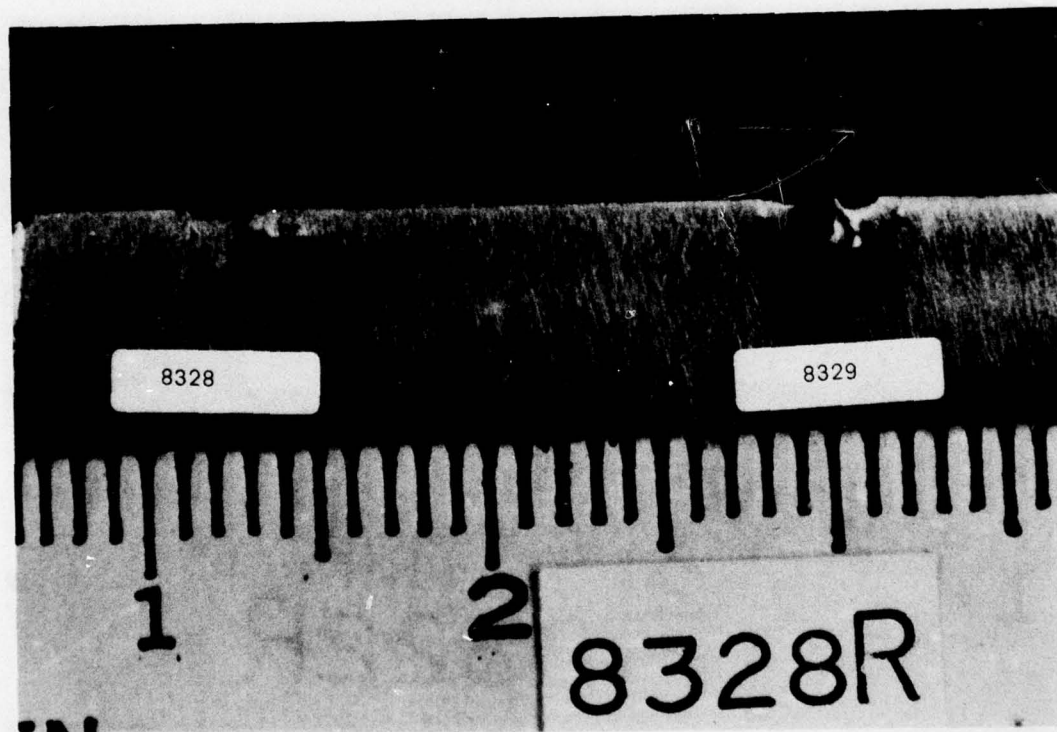
Figure 12. Photographs of damage due to silica sand impacts at 30° (Shots 8328 and 8329).

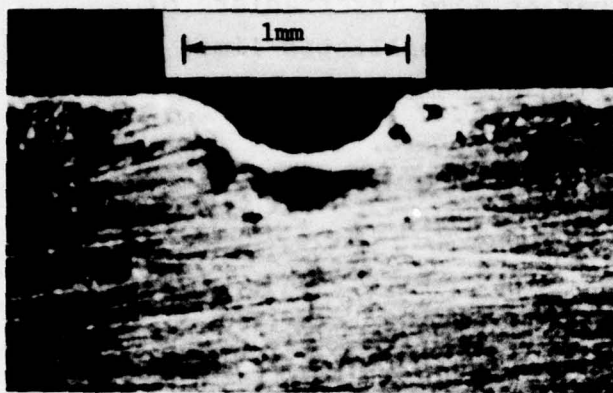
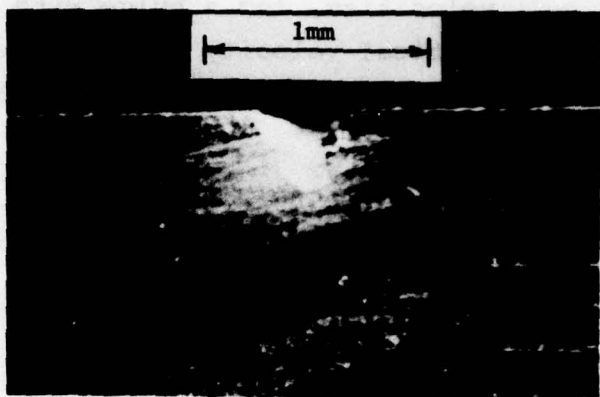
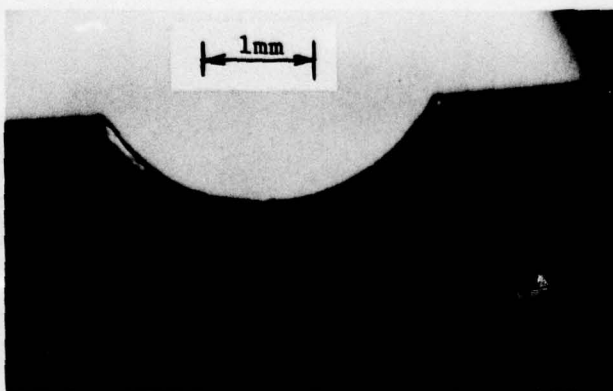
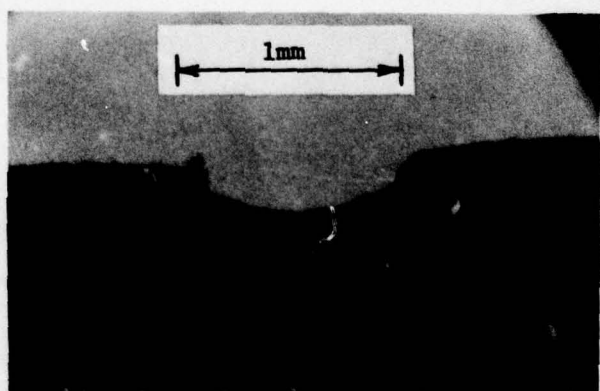
Figure 18. Photographs of several shots showing different types of damage.

To further compare the extent of damage in the various specimens, typical shots were chosen from the four batches of tests to represent various degrees and sizes of damage. The six shots chosen are replotted in Figure 17; the photographs showing the corresponding damage before fatigue testing are shown in Figure 18. The test conditions are summarized in Figure 17. Tests 8375, 8368, and 8444 appear to have similar amounts of damage in terms of fatigue life as can be seen in Figure 17 by noting the location of those points with respect to the constant K_T lines. Examination of the photographs in Figure 18 shows that all three shots have the same type of damage, namely a semicircle removed from the leading edge. Note that all three damage sites are geometrically similar, Shot 8375 being approximately one-third the size of the other two. Shots 8433, 8434, and 8432 show apparently increasing damage, respectively, in Figure 17. In Figure 18, it is seen that these three shots correspond to a bulge, material removal, and a bulge with a tear, respectively. It is not obvious whether or not there was any local tearing in Shot 8434. The material removed in

this shot was, in any case, three times the dimensions of that in Shots 8368 and 8444. Shots 8433, 8434, and 8432 all represent impacts of the largest projectile 0.125" (3.22 mm) at approximately 800 ft/s (240 m/s). Note that the worst case of damage, Shot 8432, represented a situation where the material first bulged and then apparently ripped from the extensive local deformation. The fatigue crack initiated at the rip in this case.

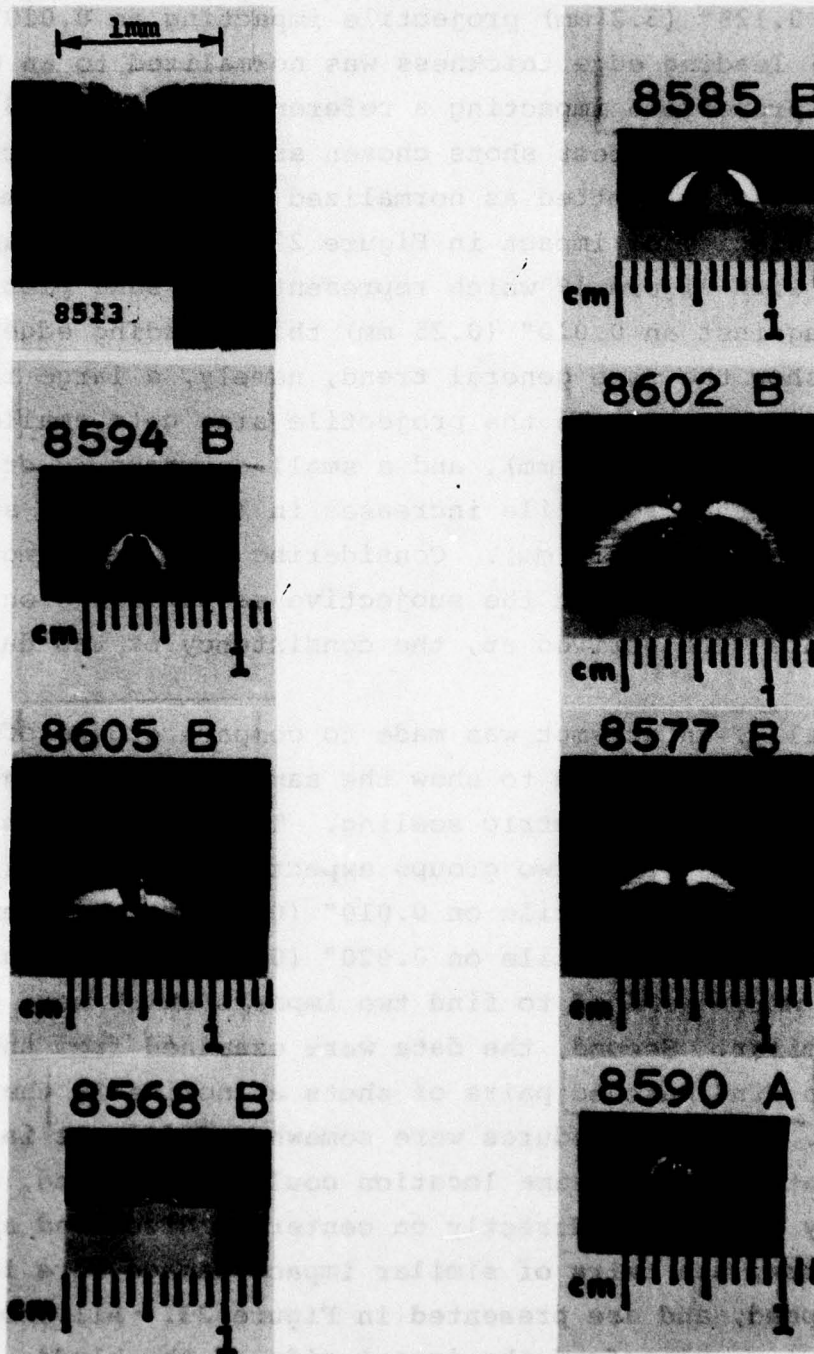
identification of specimens was subjective. Figure 21 shows rear side photos of the seven specimens selected as well as previous shot 8513 on an 0.010" (0.25 mm) thick specimen.

Figure 21. Photographs of typical leading edge damage as seen from rear side.

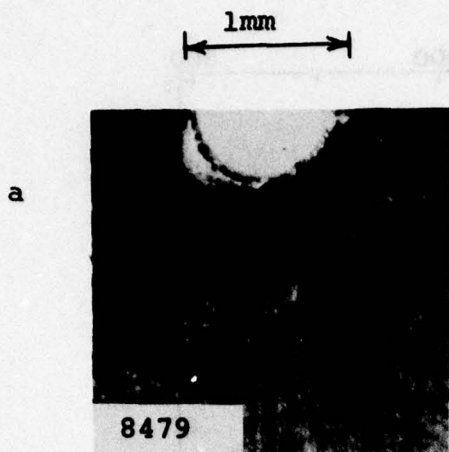
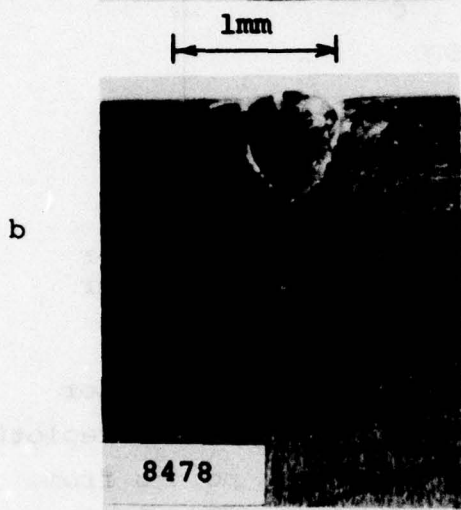
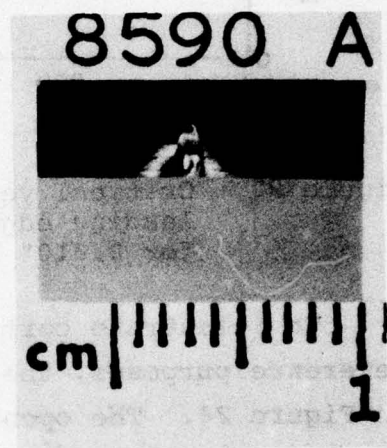
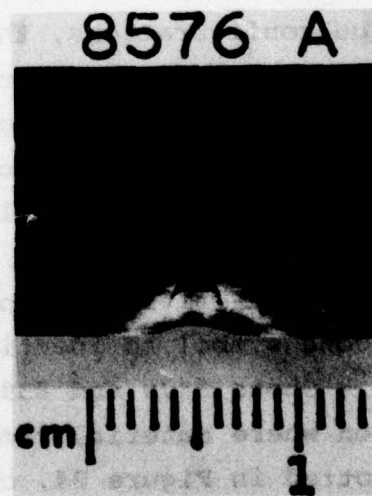
Photographs of pairs of specimens showing similar damage.

Shots 8479 and 8597, Figure 23a, are examples of perforation where material removal has occurred. These two points, plotted in Figure 24, come out to the right or along the curve or scatter band representing the critical velocity points. Both

shots represent damage typical of that which occurs above the critical velocity. The slightly more jagged surface of the perforation in Shot 8597, occurring at the lower of the two velocities being compared, indicates that this point is close to critical velocity as can be seen from Figure 24.

Shots 8478 and 8590, Figure 23b, occur at velocities close to one another. The damage in both cases looks similar, although in Shot 8590 the leading edge has started to tear. This was one of the shots characterized as at critical velocity, in Figures 22 and 24. Shot 8478 occurs at a slightly lower velocity and shows a dent without a tear. This would be considered to be slightly below critical velocity and appears as such in Figure 24.

Shots 8488 and 8576, Figure 23c, both show very similar damage involving severe denting but no tearing of the leading edge. The velocities of these shots are close to one another and are considered to be slightly below critical. These points, plotted in Figure 24, fall within or to the left of the scatter

Shots 8491 and 8601, Figure 23d, are a pair of shots showing very similar damage in the form of complete perforation with material removal. These points would both be expected to fall above the critical velocity. Note, however, the great difference in velocities. Although, as expected, Shot 8491 is well to the right of the critical velocity scatter band in Figure 24, Shot 8601 falls within the band. Shot 8601 is a good example of the variability in damage which can be expected and the difficulty in determining the critical velocity with a great deal of accuracy from a limited number of shots.

Shots 8569 and 8606, Figure 23e, occurred at almost identical velocities and look very similar in type of damage. Both show a crater, indicating complete perforation, although both have rather jagged features along the crater. This indicates that the critical velocity has just been exceeded. The plot of Figure 24 appears to verify this information, the two points falling within or slightly to the right of the critical velocity band.

Shots 8568 and 8602, Figure 23f, were chosen as representative of damage occurring at the critical velocity. Both show an extensive bulge with a slight tear on the leading edge. Both occurred at almost the same velocity and plot within the critical velocity scatter band. This example illustrates the concept of geometric scaling quite well since the two shots were made on leading edge thicknesses of 0.015" and 0.030" (0.38 and 0.76 mm) with projectiles of 0.125" and 0.250" (3.2 and 6.4 mm) diameter, respectively, and also appear to be consistent with baseline data generated on .010" (0.25 mm) thick leading edges.
